As per Blackwater Gold's Accidents and Malfunctions Management Plan, the information below acts as the 30 follow up report to the "Initial Spill Report - December 6, 2025 - DGIR 254688" submitted on December 7th, 2025.

Blackwater
Mine

30 Day Follow up Report

DGIR 254688 Attachments

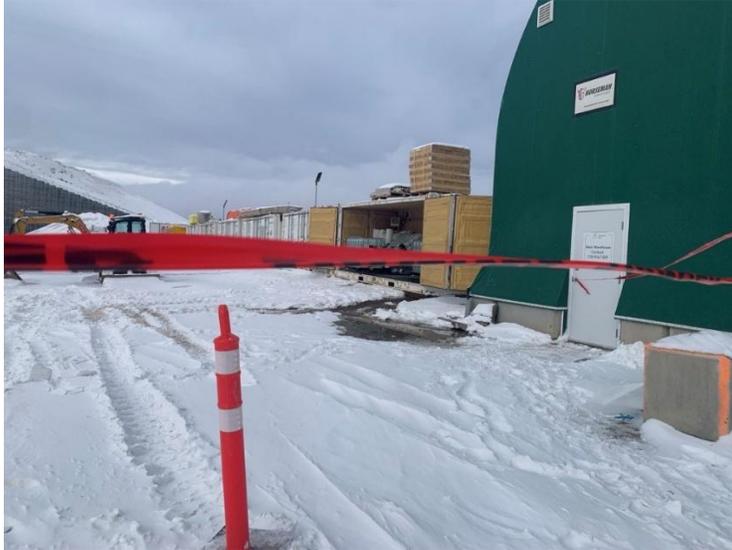
On December 6th at approximately 10:15 am, an operator was placing tote of caustic soda in reagents seacan and punctured a tote behind the one he was placing with the tip of his zoom boom fork that was protruding past the tote that he was placing, resulting in a spill to ground. Initially estimated at 200 L. Following initial clean up and containment, it was noticed that the caustic soda had breached the initial containment area, resulting in an update to the estimated quantity to a total of 500 L. This was not initially accounted for owing to snow-covered ground. The affected area was on the south side of the BWG warehouse contained on the Plant Site footprint.

Photo 1: Spill Photo (12/6/2025)

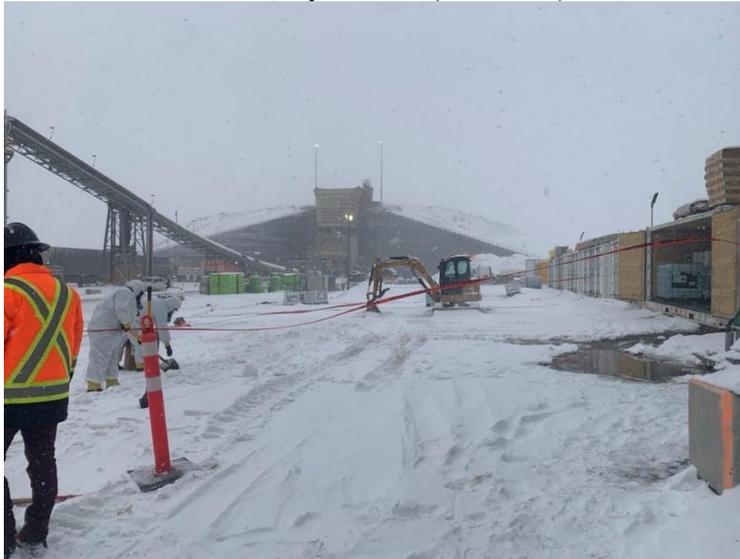
Photo 2: Spill Photo (12/6/2025)

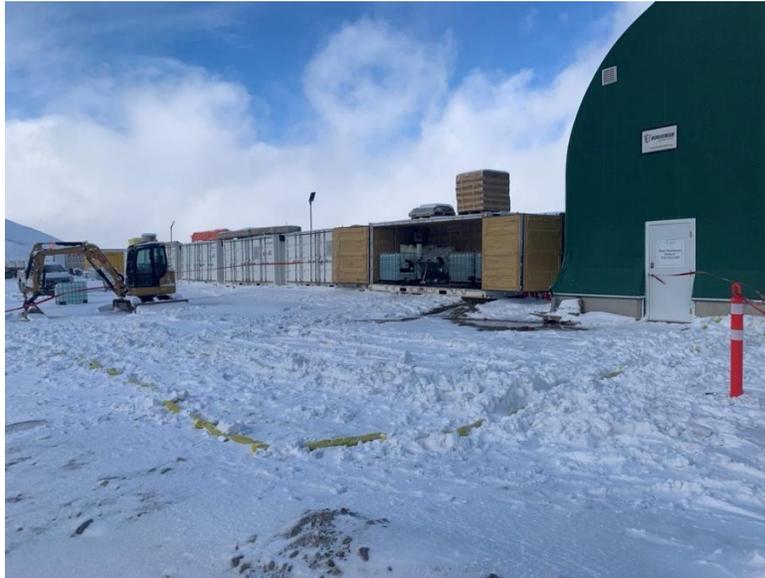
Photo 3: Spill Photo (12/6/2025)

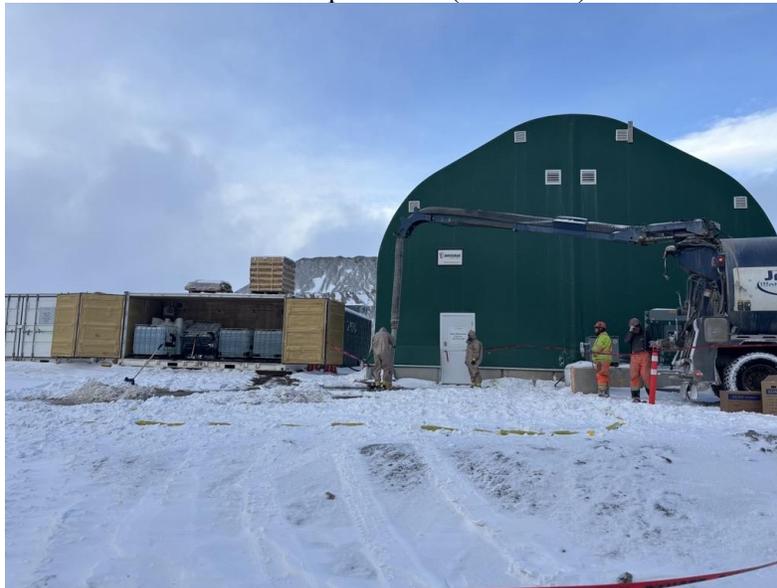
Photo 4: Cleanup (Vac Truck) photo (12/6/2025)

The spill source was stopped by tilting the tote so that the remaining liquid would not spill out. The caustic from the tote was spilled initially into a secondary containment portion of the seacan that the tote was in but then overflowed to ground. Spill response included placing sorbent socks around the ground affected area and a vac-truck was deployed to remove the liquid from the secondary containment as well as the pooled liquid on the ground outside of the seacan. The contaminated material from the vac-truck was taken to the mill and processed there. The liquid that remained had breached the initial containment area and was excavated with heavy machinery as well as the initial spill area within the containment. The excavated material was put into a wiggle wagon and was disposed of through the plant site crusher and processing mill.

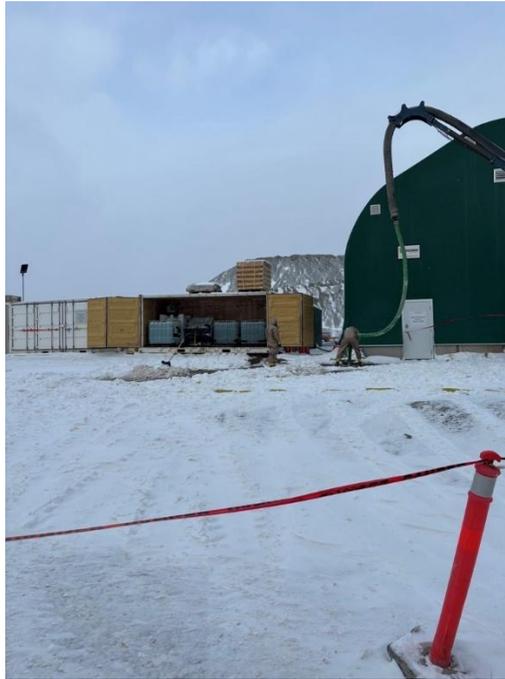
Photo 5: Cleanup (Vac Truck) photo (12/6/2025)

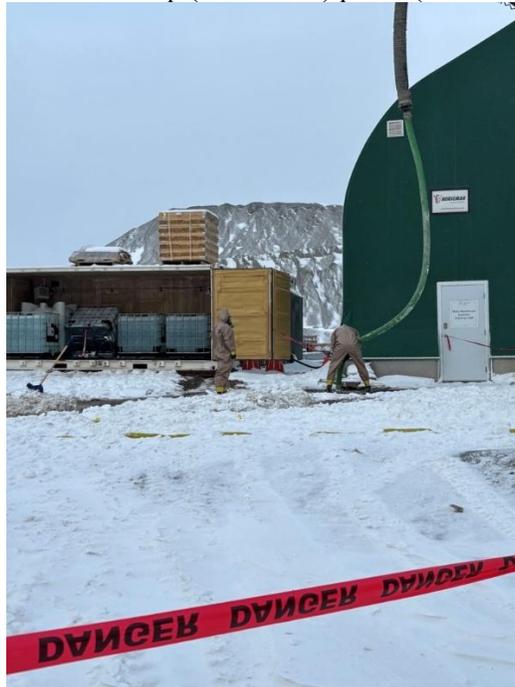
Photo 6: Cleanup (Vac Truck) photo (12/6/2025)

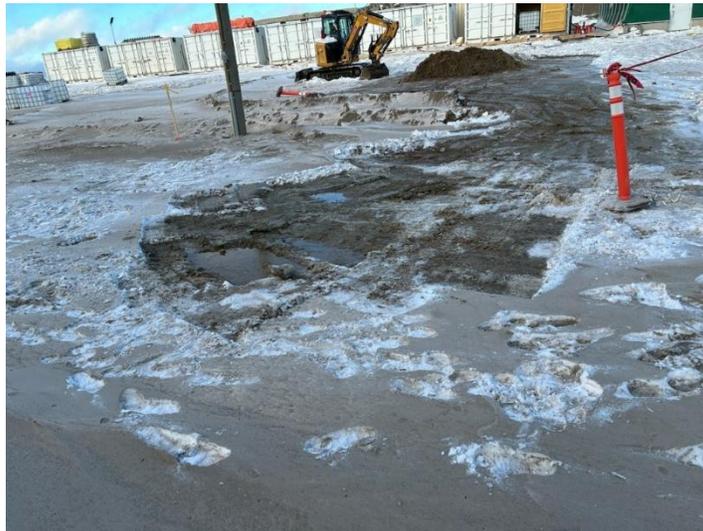
Photo 7: Spill photo (12/7/2025)

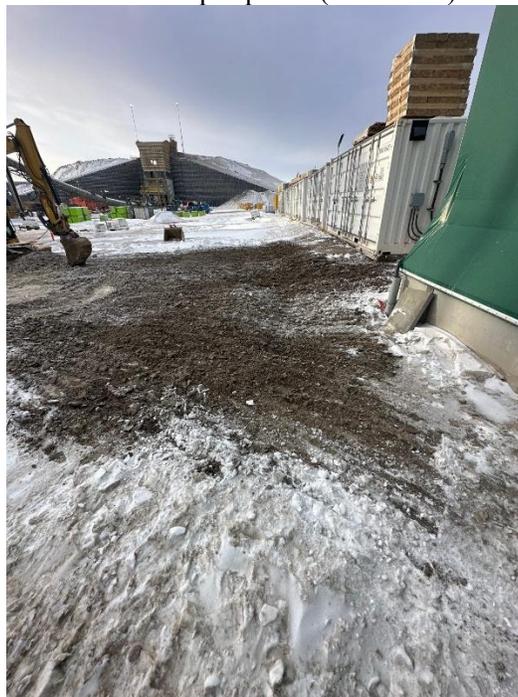
Photo 8: Spill cleanup (12/9/2025)

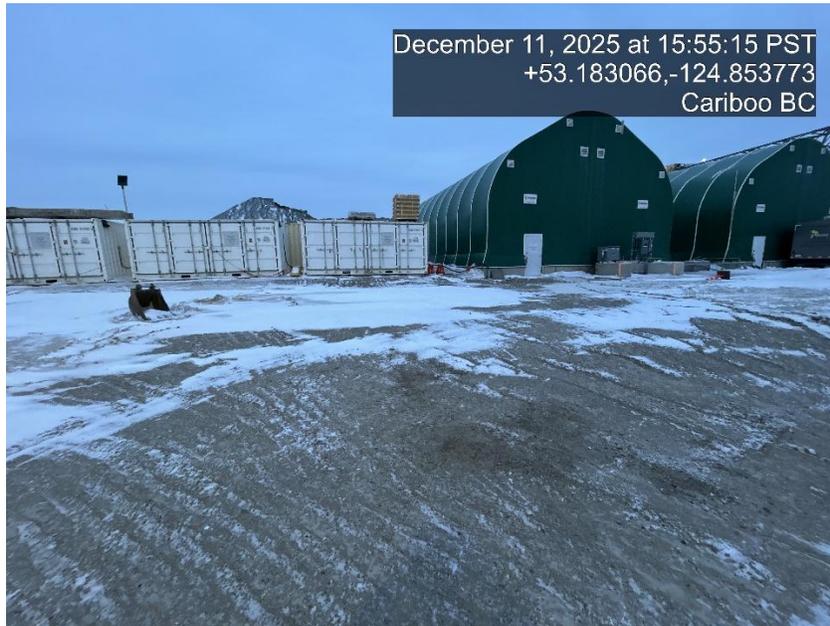
Photo 9: Post Cleanup (12/11/2025)

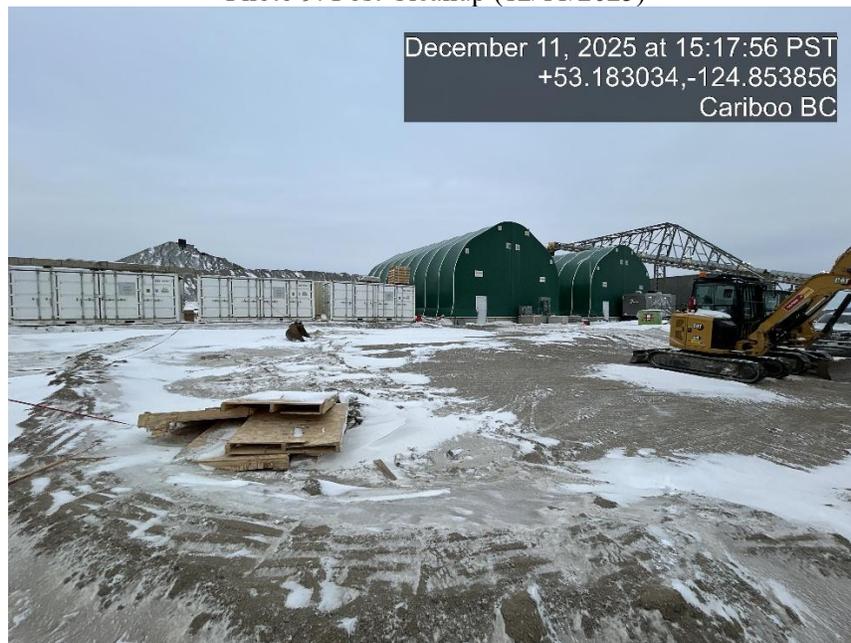
Photo 10: Post cleanup (12/11/2025)

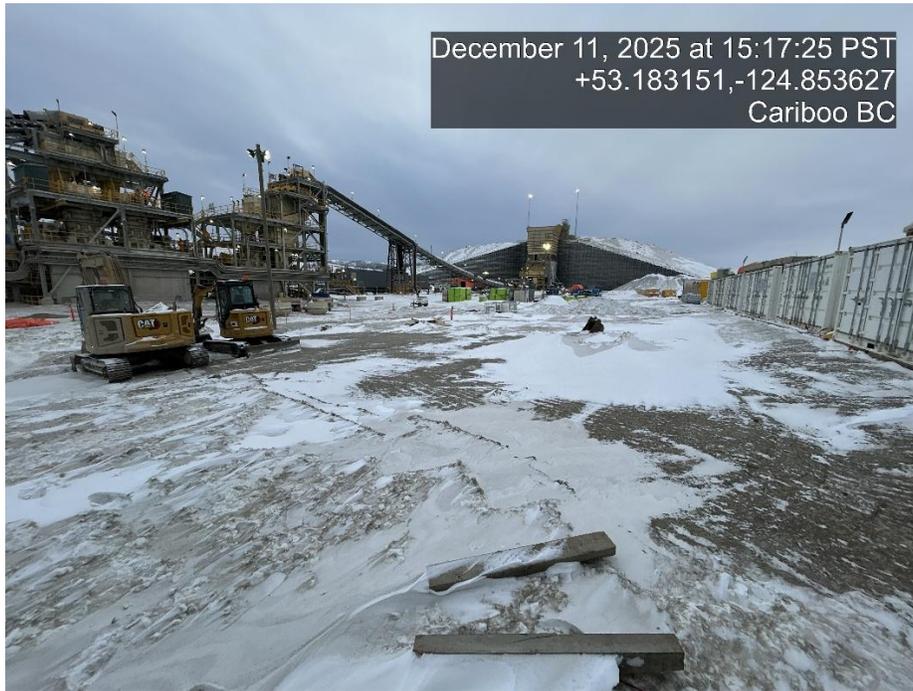
Photo 11: Post cleanup (12/11/2025)

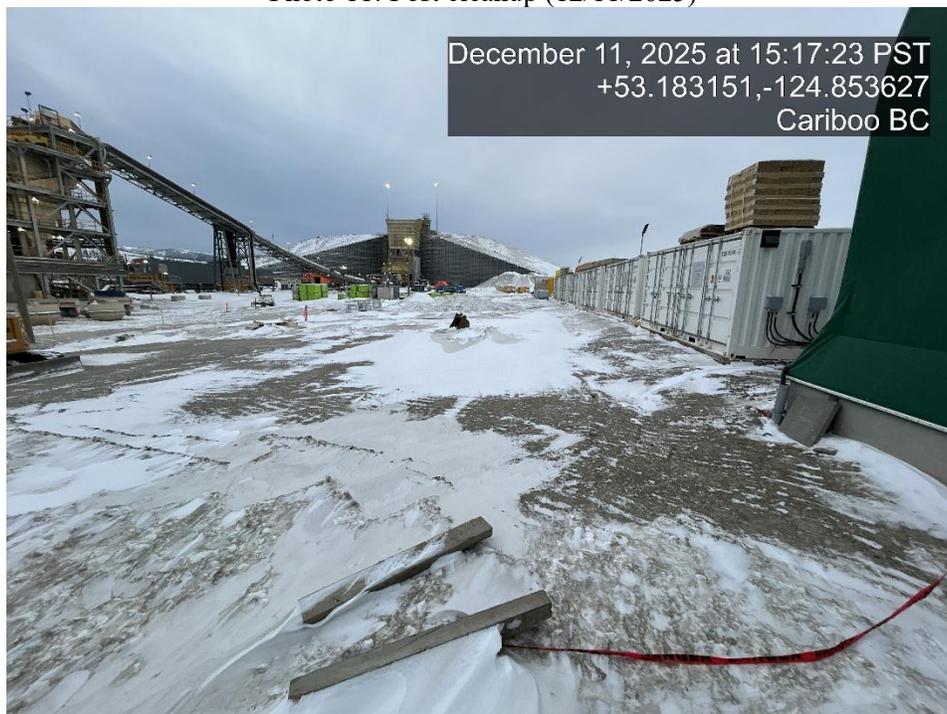
Photo 12: Post cleanup (12/11/2025)
