**Blackwater Gold Mine
IEM Site Visit Report 026
January 27 – 28, 2025**

Prepared By
EDI Environmental Dynamics Inc.
3810 18th Ave
Prince George BC V2N 4V5

EDI Project
21P0403
January 2025

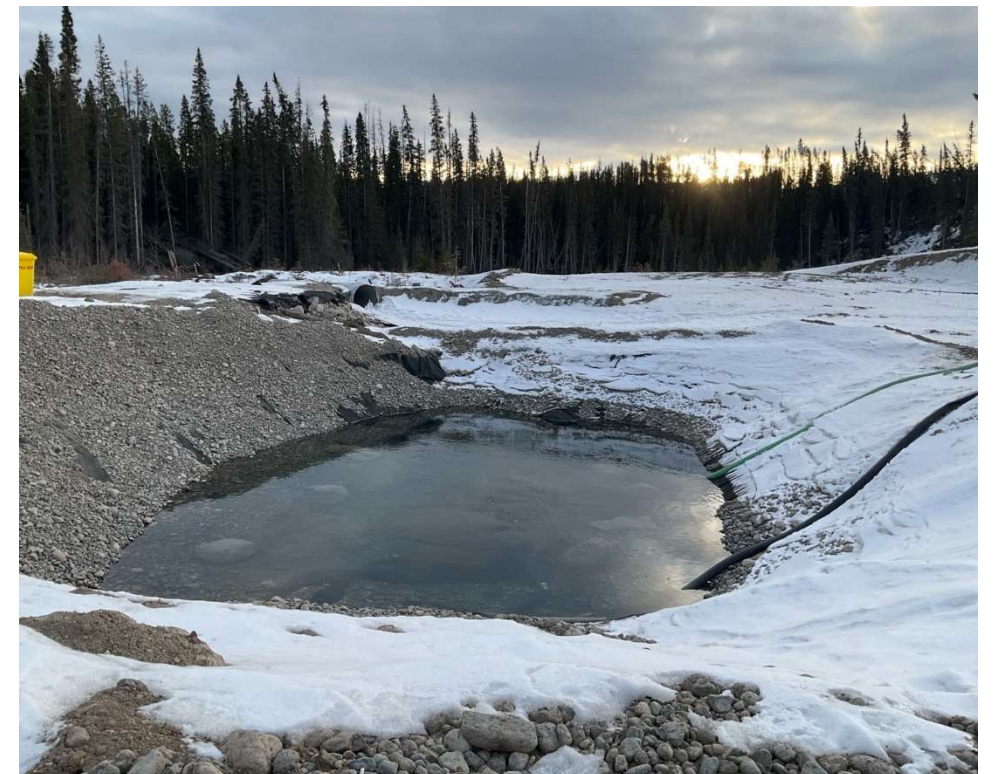
Photo 112946-1. Foundation drain (former groundwater collection point) downstream of the IECD that was previously discharging water to Davidson Creek, now has water pumped and discharged upstream of the IECD.

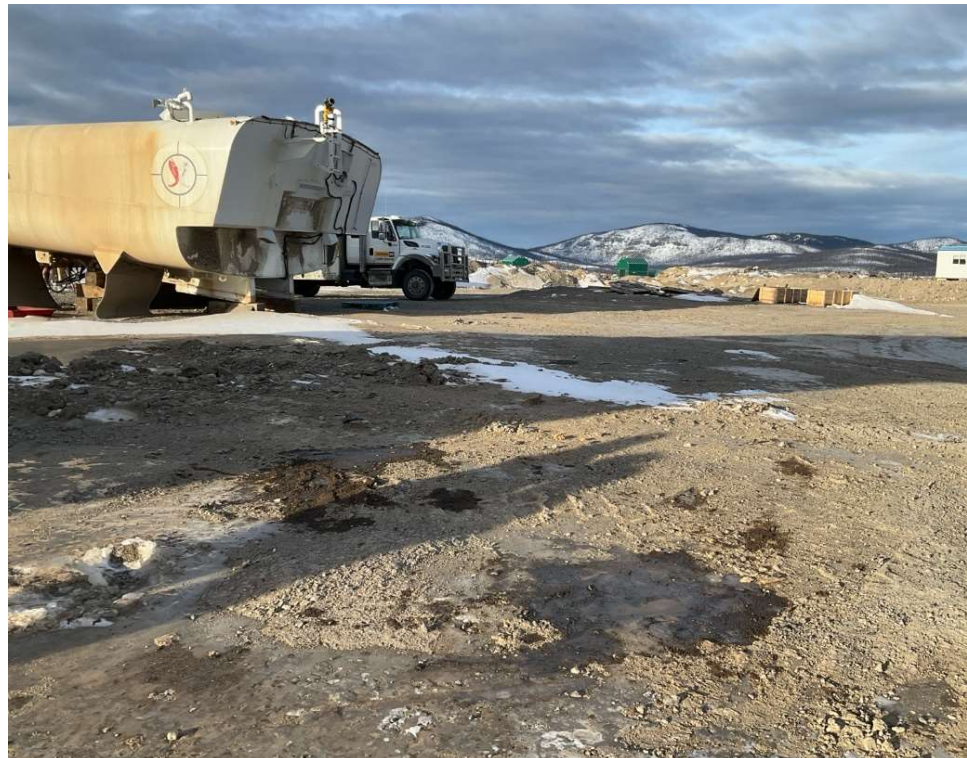
General Mine Site	
During a visit to a heavy equipment laydown known locally as ‘Andrew’s Hill,’ numerous hydrocarbon spills were observed at various locations across the laydown area (Photos 112948-1 and 112948-4; Record ID-112948). Confirmation crews had completed a clean up of the laydown and that all equipment had been removed from the area was provided on February 5, 2025.	Closed
A haul truck (Unit 306) which appeared to be in the midst of being repaired at the ‘Andrew’s Hill’ laydown, was observed with totes nearby being utilized to capture (and store) hydrocarbons drained from the truck (one observed beneath the truck acting as a drip tray, and one full tote immediately adjacent to the truck) (Photo 112949-1). As this appeared to be an active ongoing repair (due to the presence of tools and replacement parts nearby), a non-compliance was not issued, however, a request to confirm the tote of waste hazardous material next to the truck had been removed, or, if it was planned to be left at this location for some time, that it had been placed into appropriate secondary containment was submitted.	No

Photo 112948-1. Example of multiple hydrocarbon spills (dark staining) observed at the 'Andrew's Hill' laydown. BWG has confirmed area has since been cleaned up.

A response was provided on February 5, 2025 which indicated the truck, and tote, had been removed from the laydown, and the tote containing hydrocarbons had been placed into appropriate secondary containment.	
A spill to ground (of what appeared to be coolant) was observed beneath a low bed truck staged at the ‘Andrew’s Hill’ laydown (Photo 112950-1; Record ID-112950). Confirmation the spill had been cleaned up and truck had been removed from the laydown was provided on February 5, 2025.	Closed
Hydrocarbon staining was observed on the ground in the parking area of the ‘U dorm’ office spaces (located adjacent to the ROM pad) (Record ID-112952). A response was provided on February 5, 2025 which indicated (since the time of the site visit) the area had become snow covered which meant BWG were unable to confirm whether identified stains had been cleaned up. BWG have indicated following snow melt, the area will be inspected and any identified hydrocarbon staining would be cleaned up.	Closed

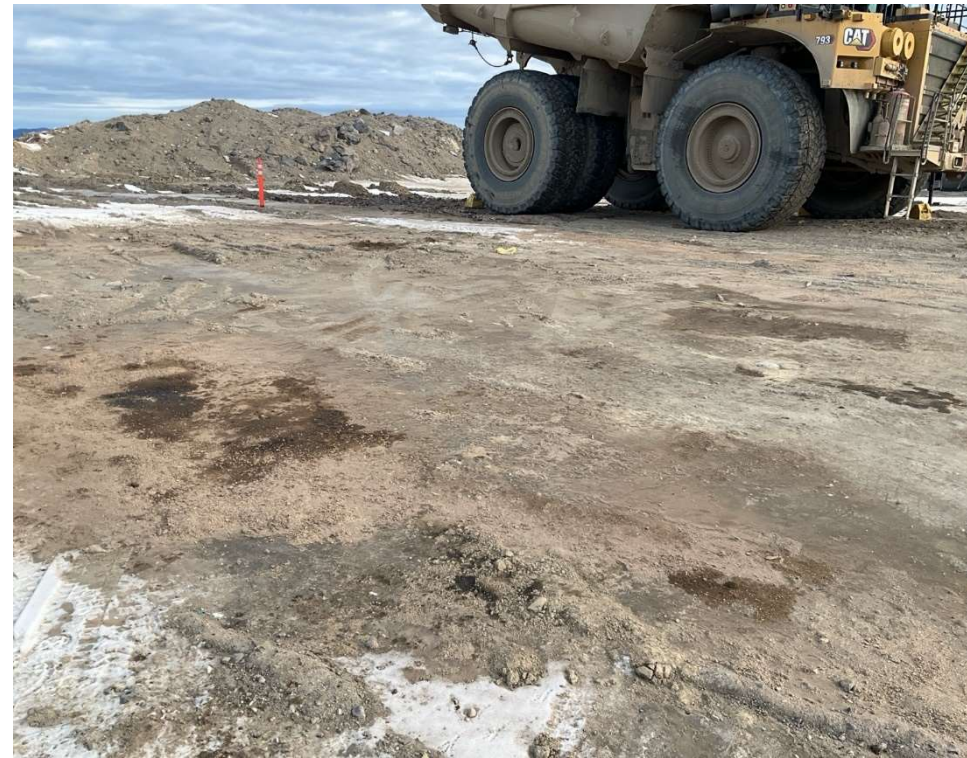
Photo 112948-4. Additional example of multiple hydrocarbon spills (dark staining) observed at the 'Andrew's Hill' laydown. BWG has confirmed area has since been cleaned up.

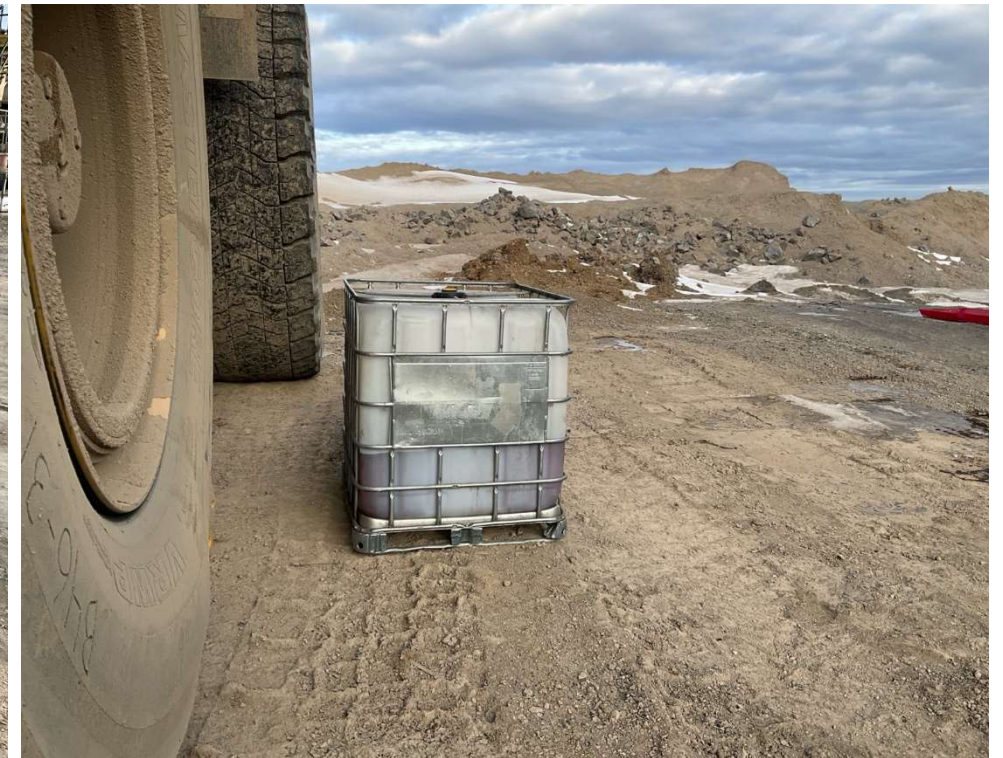
Photo 112949-1. Tote containing hydrocarbons drained from haul truck 306 at the 'Andrew's Hill' laydown. BWG confirmed tote has been removed and placed into appropriate secondary containment.

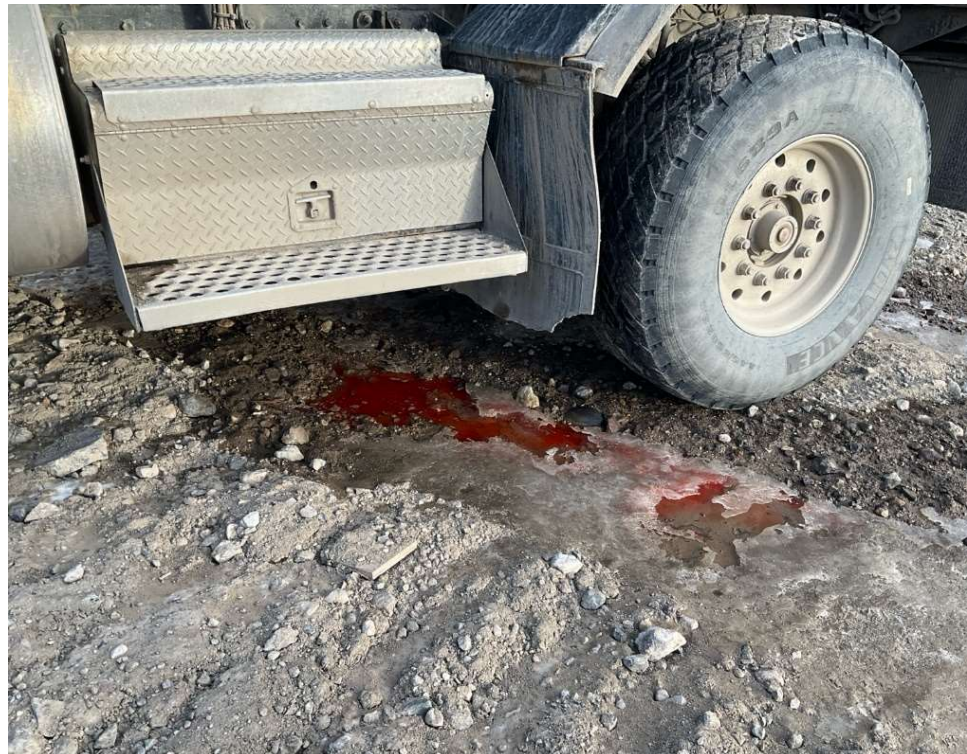
Photo 112948-4. Spill to ground observed beneath a low-bed truck staged at the 'Andrew's Hill' laydown.

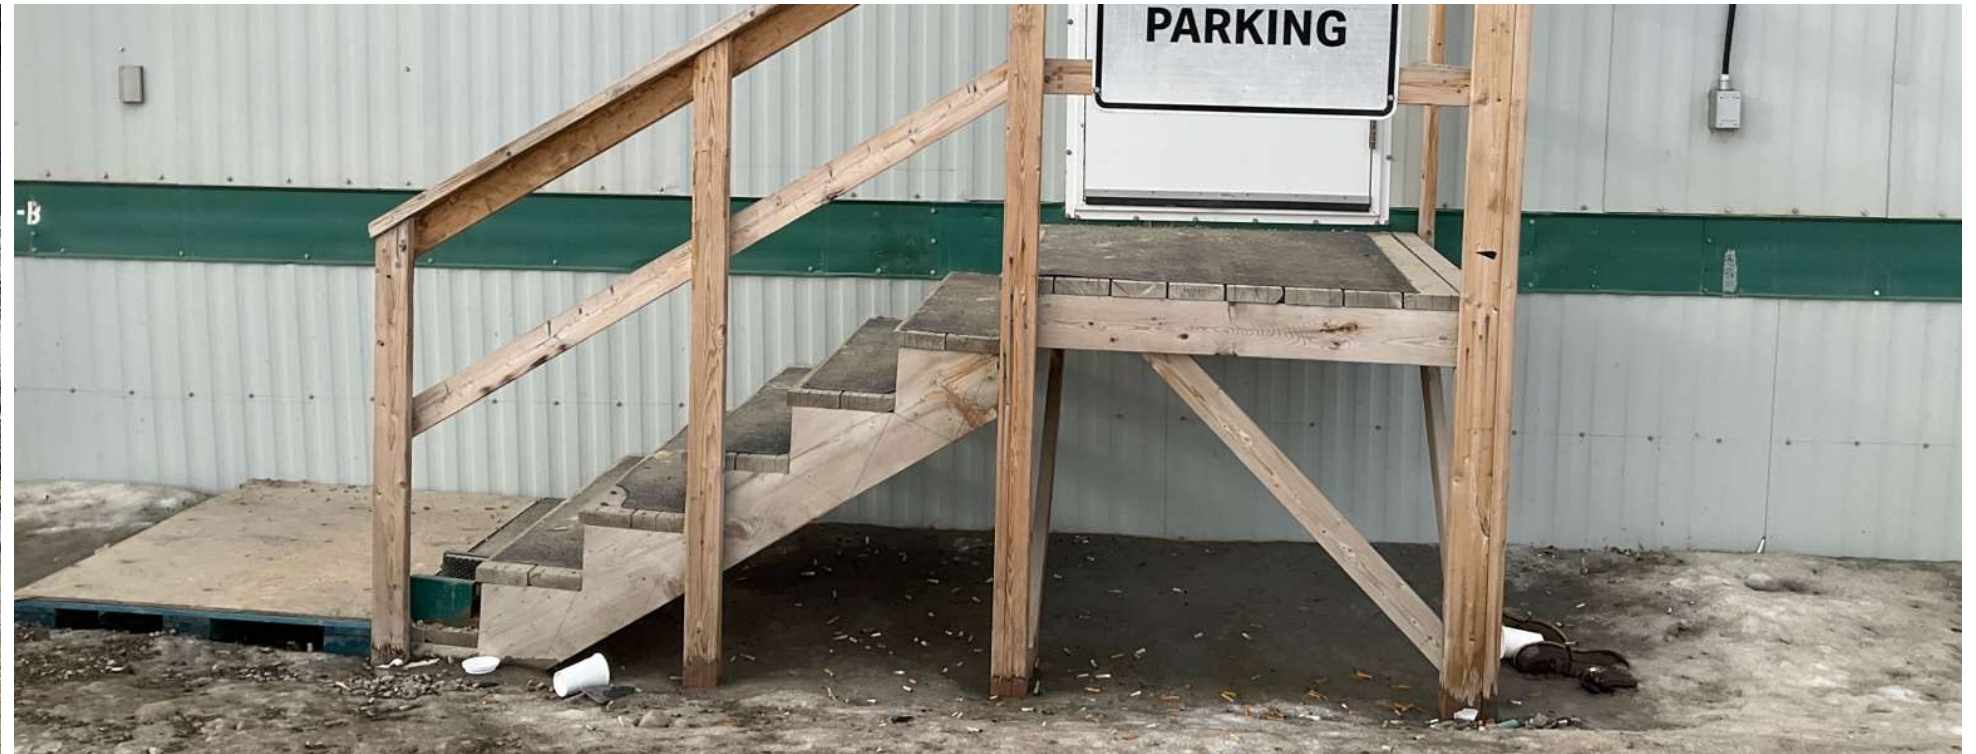
Domestic waste (food and numerous cigarette butts) were observed on the ground around and beneath the exterior steps leading into Bunks 2 through 4 at the construction camp (Record ID-112960). Confirmation that waste had been cleaned up was provided on February 5, 2025.	Closed

Photo 112960-2. Example of domestic waste (food/cigarette butts) observed outside of entrance to bunk at the Construction Camp. BWG has confirmed the area was cleaned up.

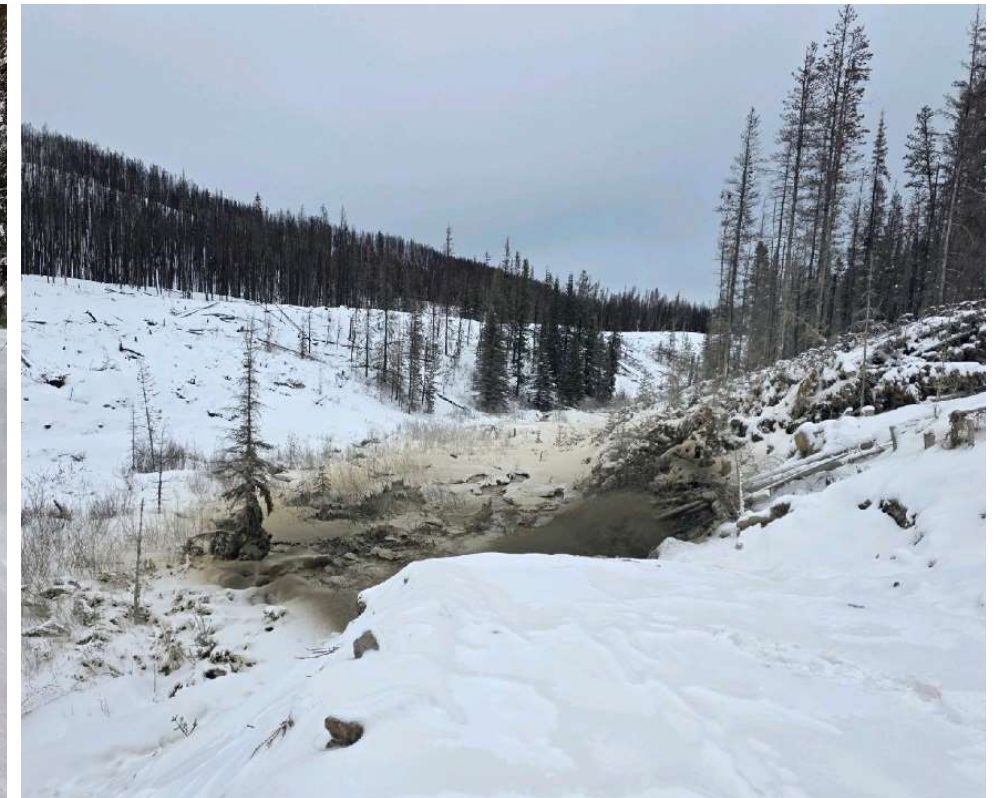
Photo 113127-1. WMP outfall structure (which discharges to Davidson Creek). Observed to not be operating at time of visit due to frozen pumps.

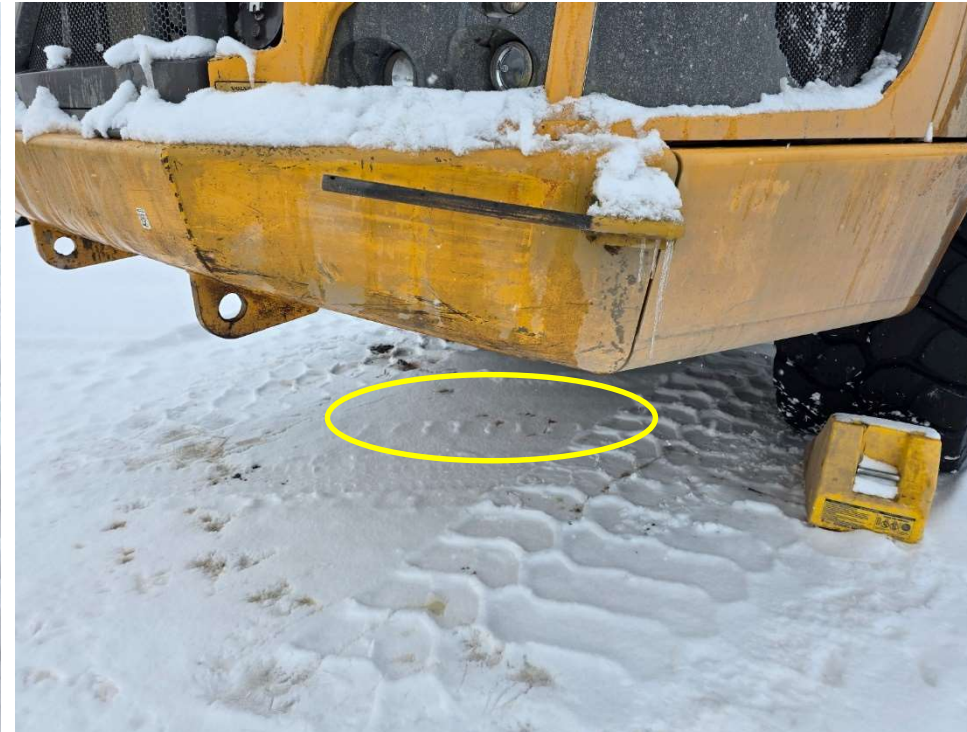
General Mine Site	
During the visit to an equipment laydown known locally as ‘Andrew’s Hill’, an open top bag containing used (hydrocarbon contaminated) spill pads was observed (Photo 113122-4; Record ID-113122). The bag containing used spill pads was removed at the time of the visit by BWG staff. This matter was issued as an open/close non-compliance.	Closed
Coolant spills to ground were observed beneath a haul truck (Photo 113120-5) and a flat deck truck staged within the Mobile Maintenance Yard (Record ID-113120). Photograph confirmation showing that both spills had been cleaned up was provided on February 21, 2025 (Photo 12).	Closed
Workers Accommodation	
A bag containing recyclable waste (cans/juice boxes) was observed within a domestic waste bin at the operation camp (Record ID-113117). The bag containing recyclables was removed from the bin and placed into an appropriate receptacle by BWG staff at the time of the visit. This matter was issued as an open/closed non-compliance.	Closed

Photo 113122-4. Used spill clean up materials (hydrocarbon contaminated) in open top bag at equipment laydown known locally as 'Andrews Hill.' Bag removed and disposed of by BWG staff during site visit.

113122	20/02/2025	Bag containing used (hydrocarbon contaminated) spill pads found at Andrew's Hill laydown.	Clean up and dispose of contaminated material in accordance with Section 9.2 of the Fuel Management and Spill Control Plan	01/03/2025	Used spill clean up materials removed and disposed of by BWG staff during visit. This matter was issued as an open/close non-compliance.	20/02/2025

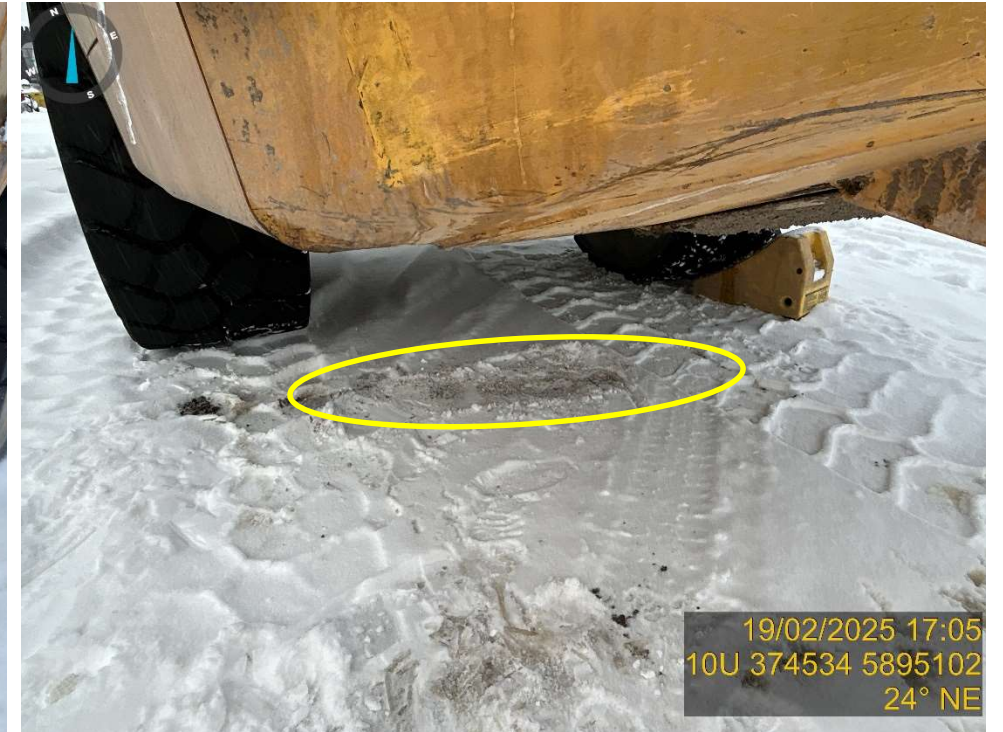
Photo 113120-5. Coolant spills observed beneath a haul truck staged at the Mobile Maintenance Yard.

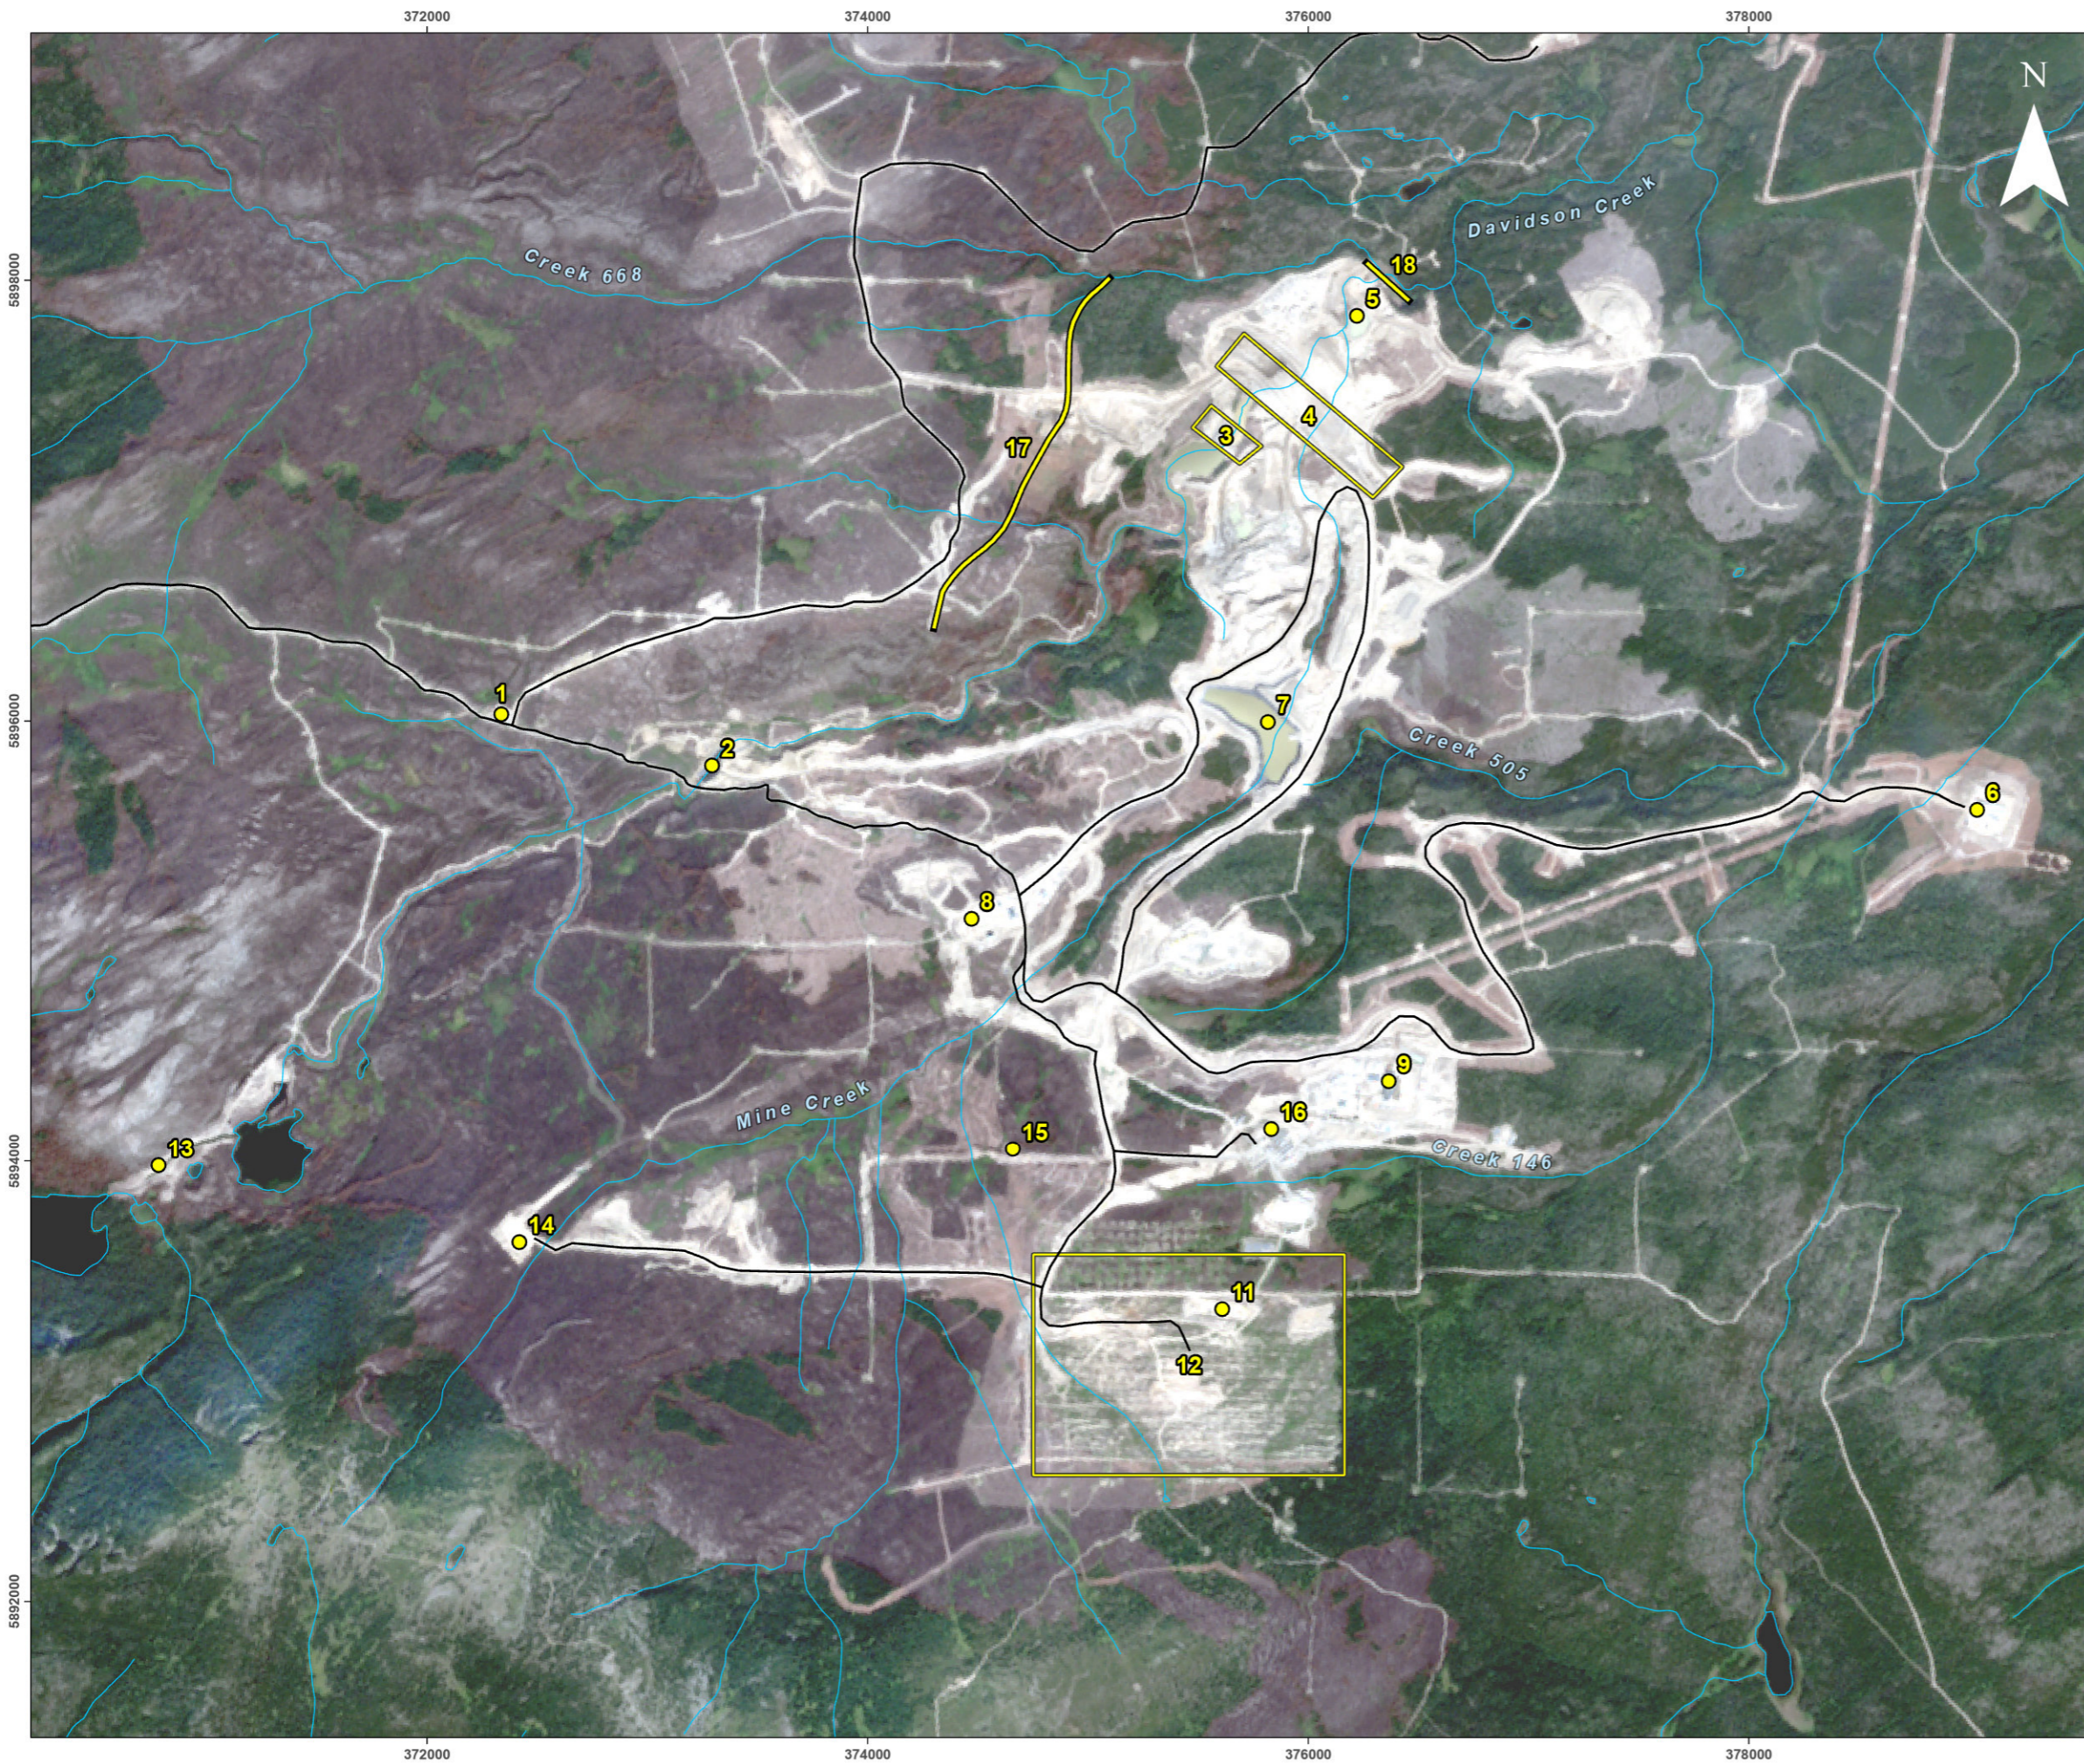
Photo 12. Photo showing coolant spill clean up beneath haul truck at Mobile Maintenance Yard (provided by BWG on February 21, 2025). Note a photo was also provided by BWG confirming clean up of spill beneath flat deck truck referenced in Record ID-113120.

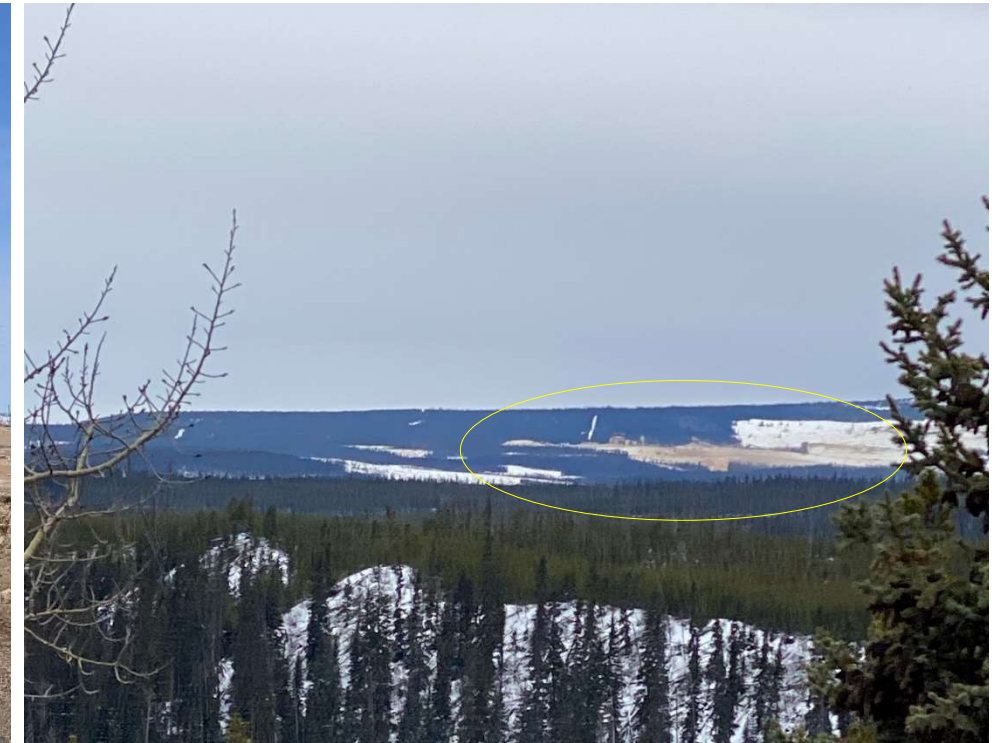
Photo 113340-6. Example of high-grade ore dust accumulation on top of snow northeast of plant along roadway towards operations camp on March 18, 2025. Plant Site location on top of hill in photo.

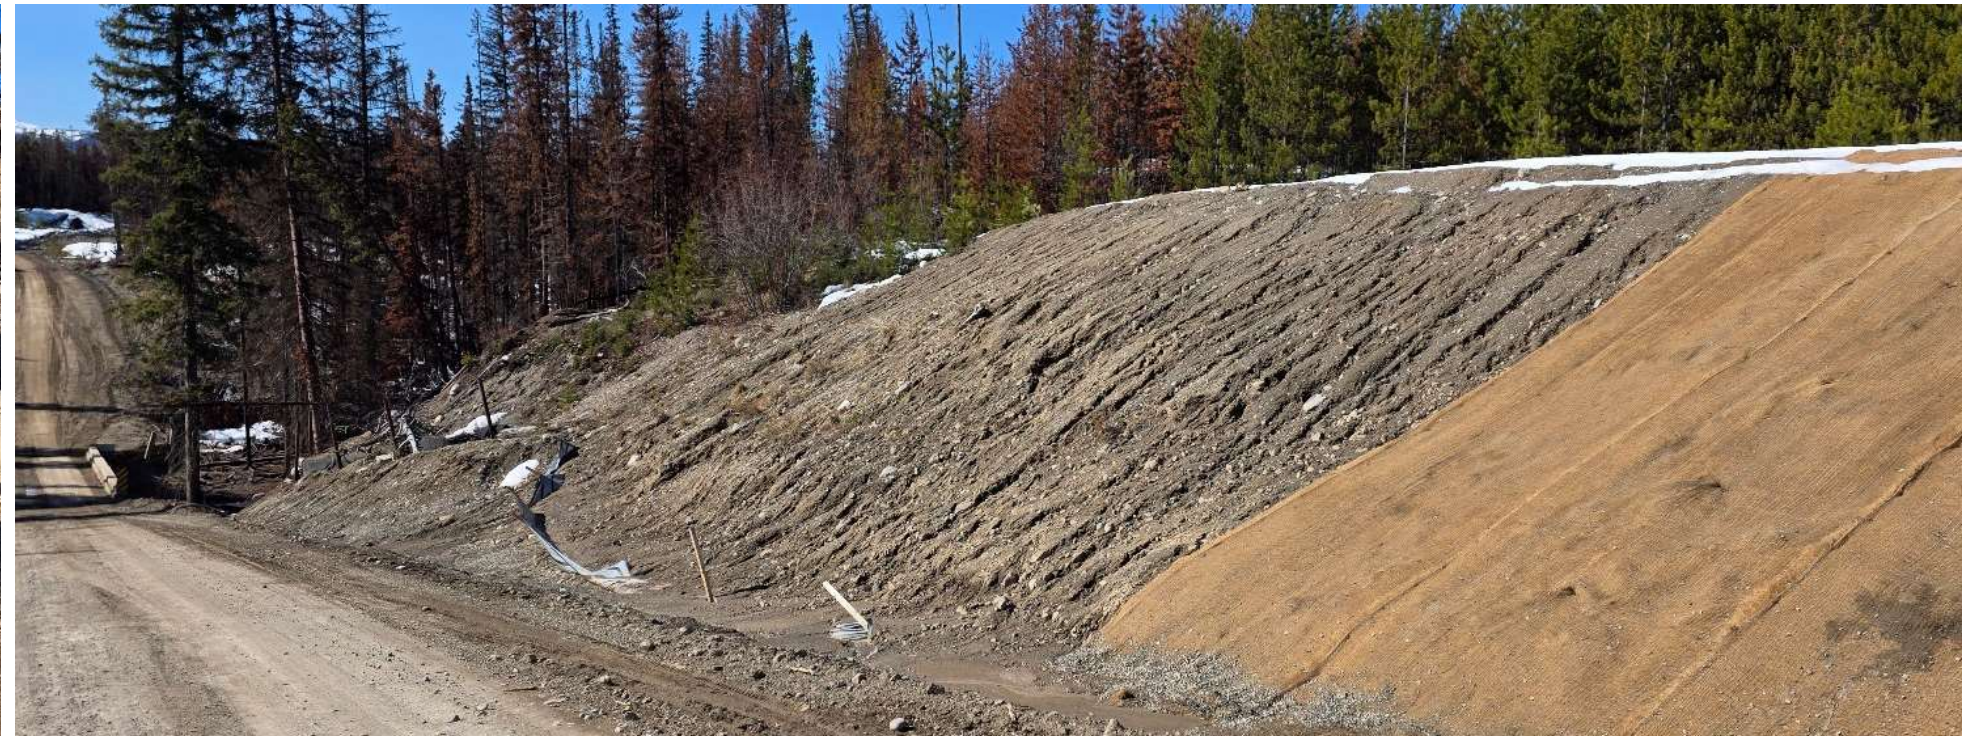
Photo 113555-10. Overview of base of C-trail access road drainage ditch adjacent to Watercourse 636 after spring melt period. Sediment transport into watercourse observed to be minor at time of visit.

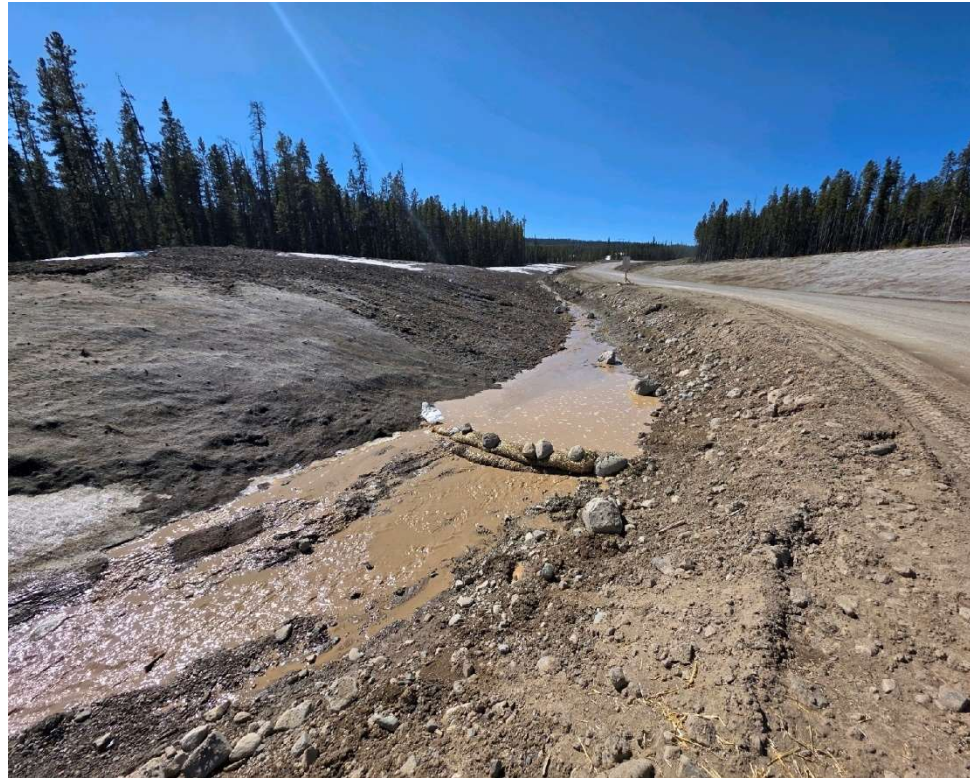
Photo 113555-9. Overview of slope above Watercourse 636 crossing where ESC measures will likely soon require maintenance/repair in order to minimize sediment transport to Watercourse 636. IEM will complete a follow up visit to this location to observe area in a future visit.

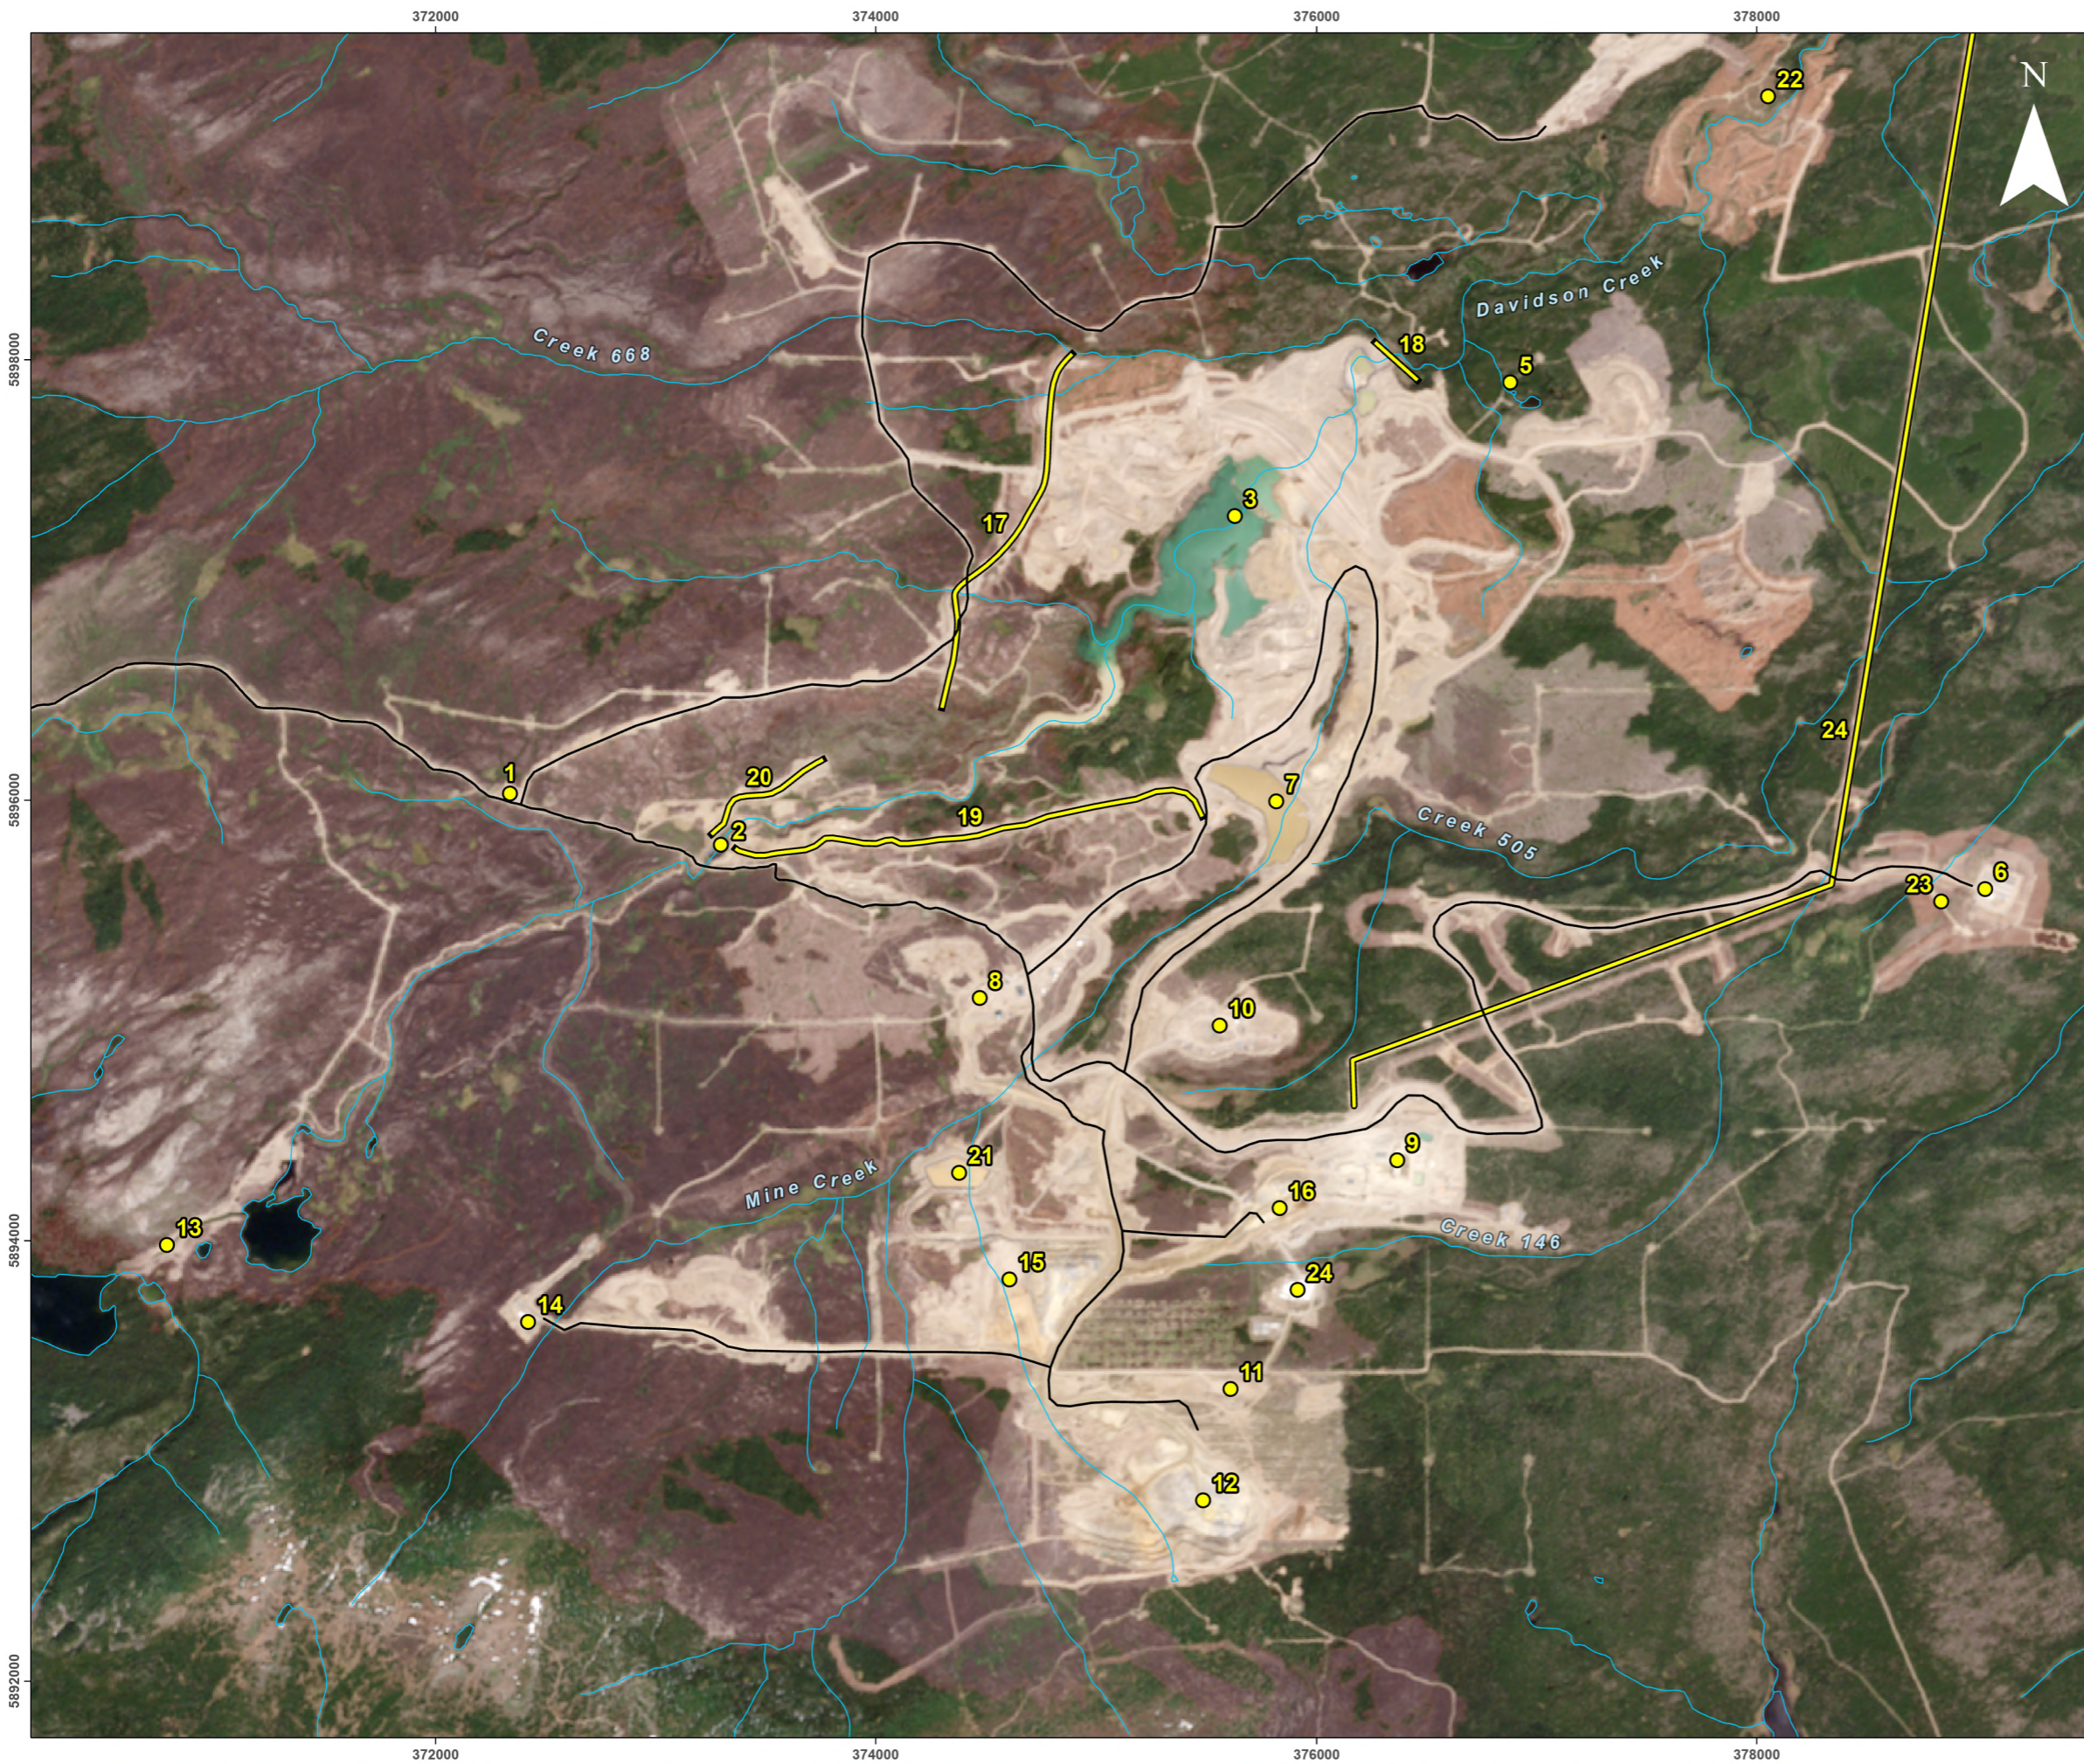
Photo 19. Slide into Davidson Creek (above the DC-05 compliance sampling point) within the Fresh Water Reservoir clearing worksite. Photograph provided by BWG on July 27, 2025.

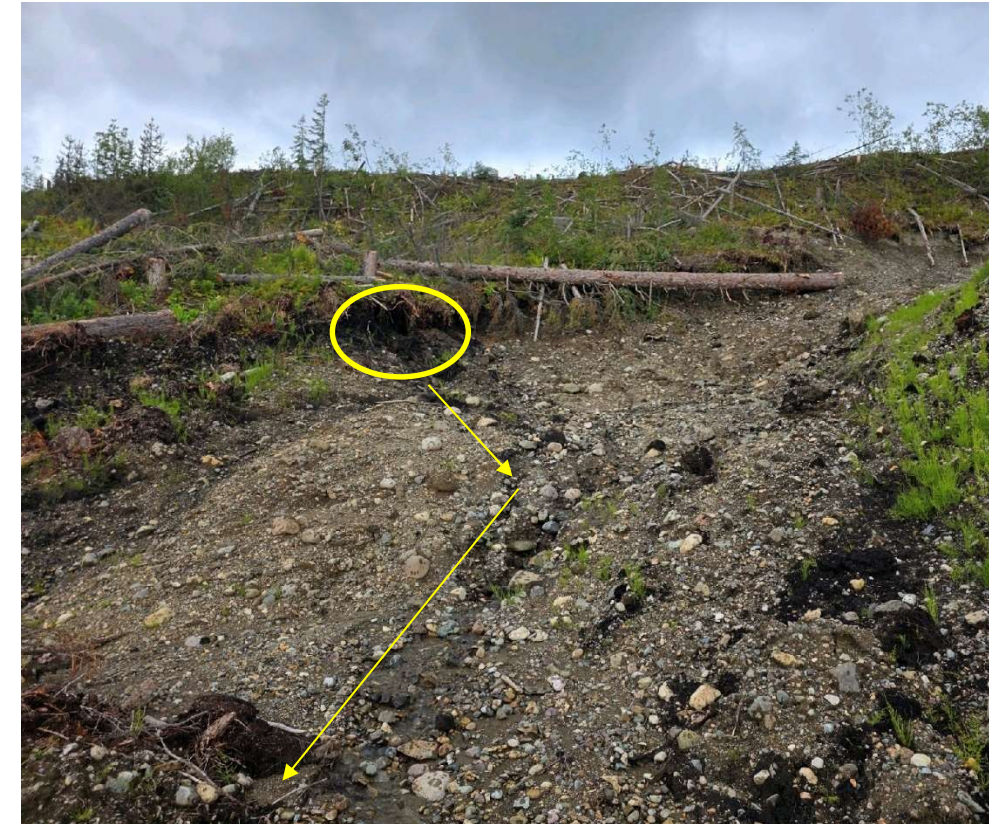
Photo 114201-7. Current state of Davidson Creek following slope failure within the Fresh Water Reservoir footprint that occurred on June 24, 2025. Current channel can be seen on high side of slide.

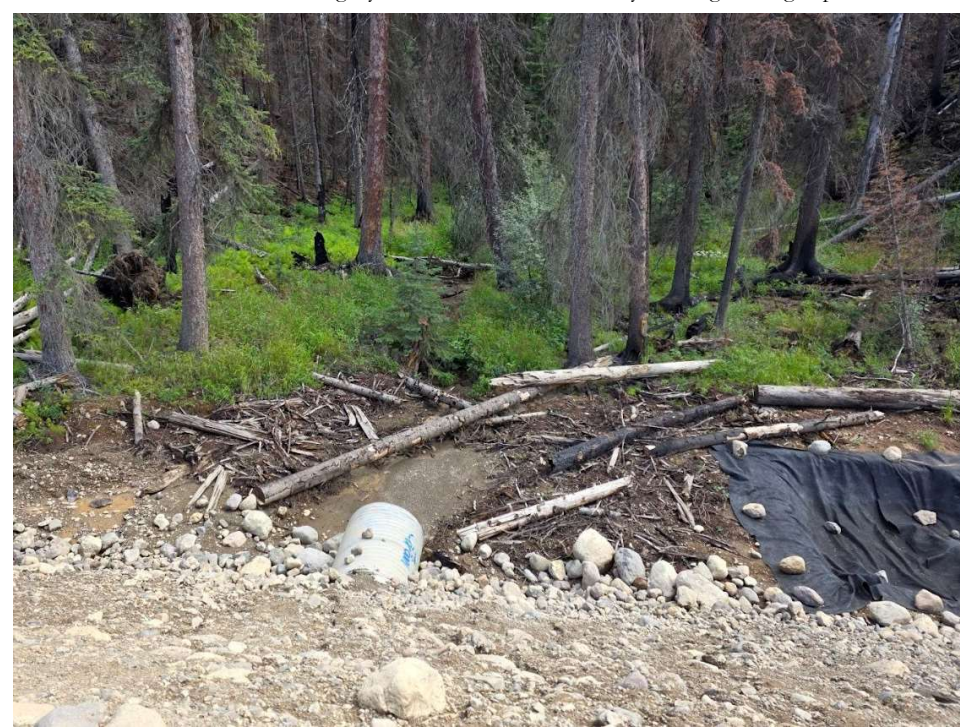
Photo 114199-2. Lack of energy dissipation on downstream side of Watercourse 636 culvert crossing at 9.5 km on the C-trail access road.

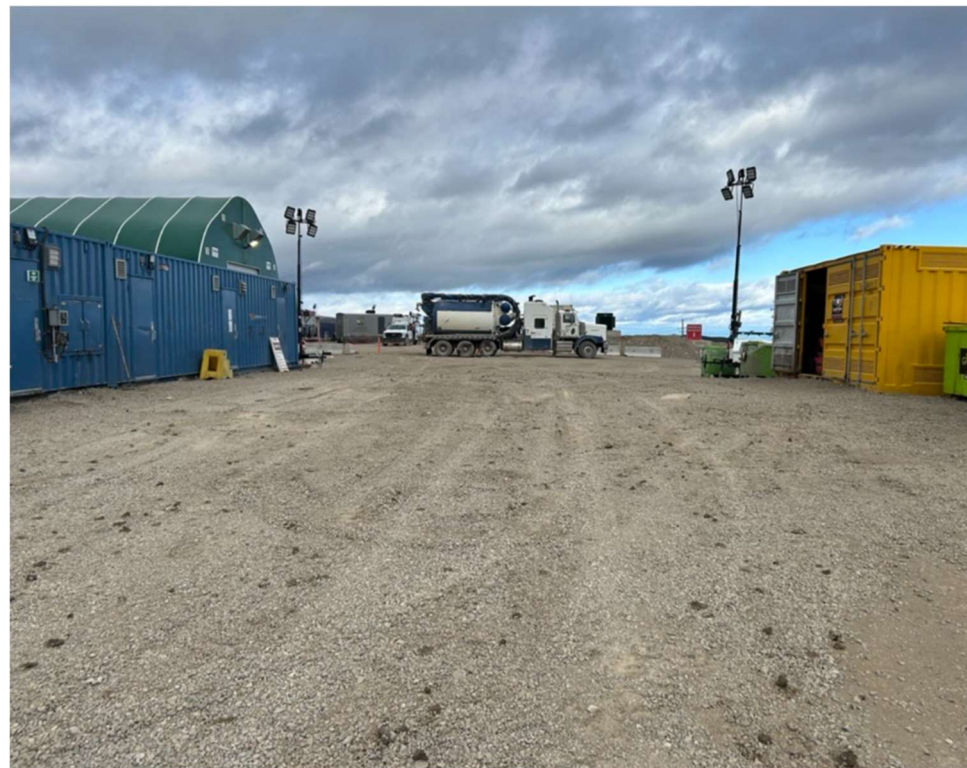
Photo 114471-1. Several spills to ground observed within a lined area at the Mobile Maintenance Yard. Opportunity for improvement issued to prevent tracking of hydrocarbon contamination out of lined area.

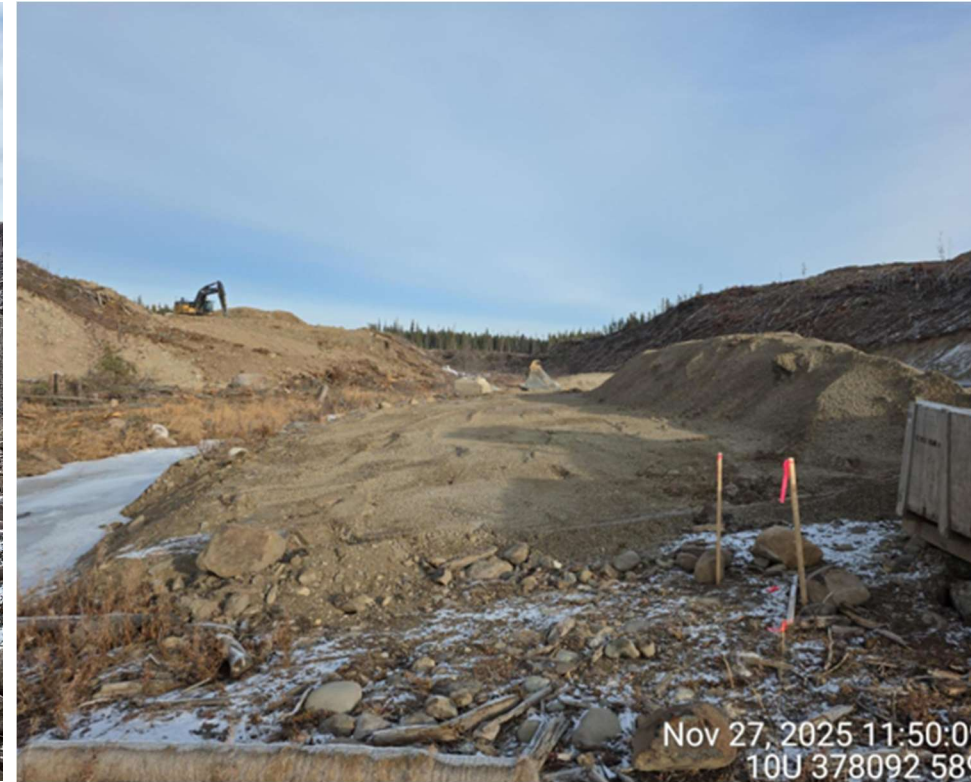
Photo 114706-1. Stockpile of aggregate (with some fines) located adjacent to Davidson Creek. IEM recommended this pile be removed to prevent sediment transport into Davidson Creek.
