**Blackwater Gold Mine
IEM Site Visit Report 026
January 27 – 28, 2025**

Prepared By
EDI Environmental Dynamics Inc.
3810 18th Ave
Prince George BC V2N 4V5

EDI Project
21P0403
January 2025

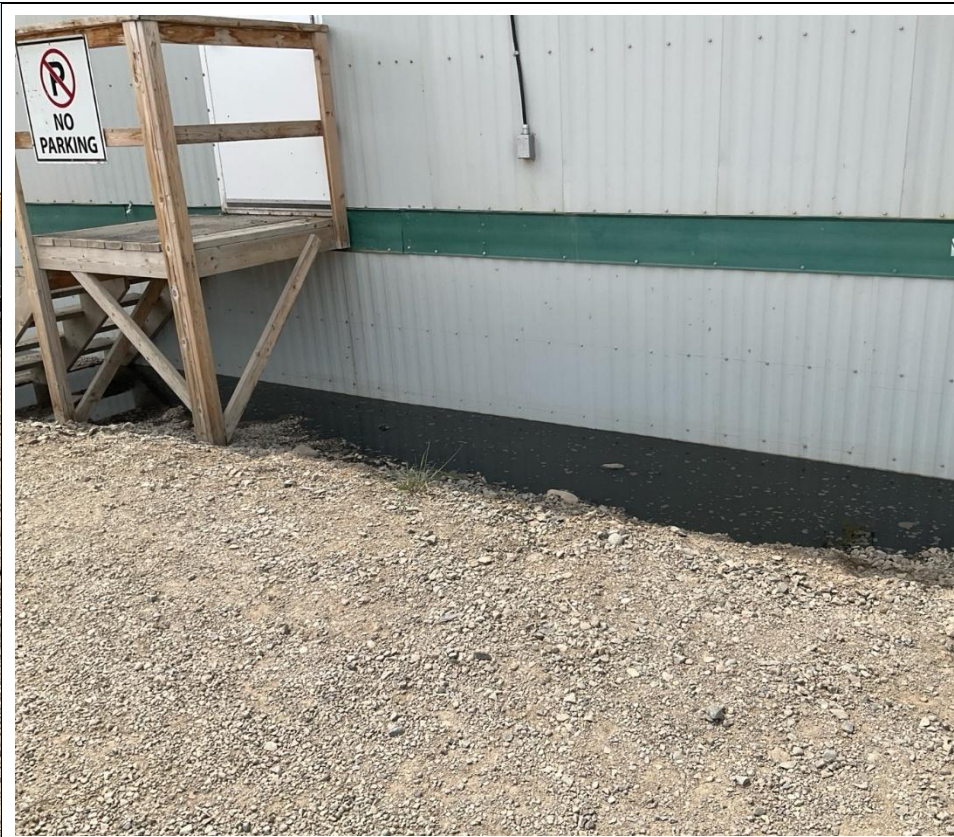
Photo 113868-1 Sewage leak below the bunk house at the Construction Camp.

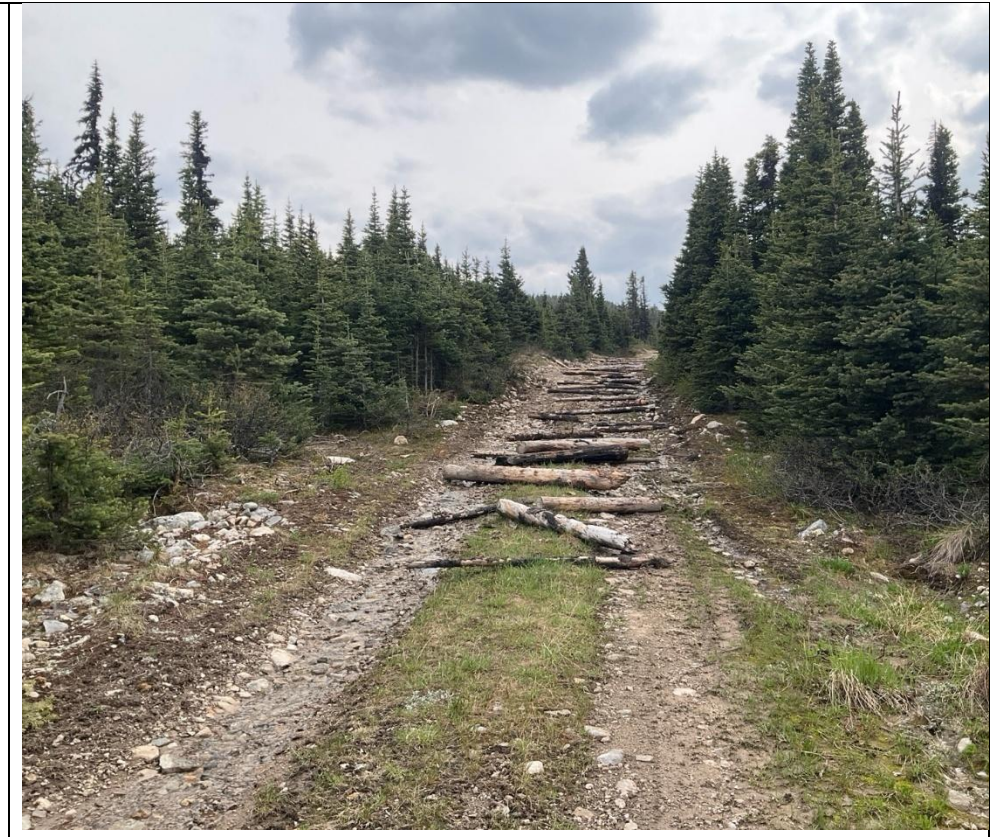
Photo113872-1 Large woody debris placed on Mt Davidson Exploration Road.
