Subject: 30 Day Follow Up Report – Tailings Pipeline Failure – January 30, 2026

Blackwater
Mine

Incident Report

Appendix B – DGIR260410 Attachments

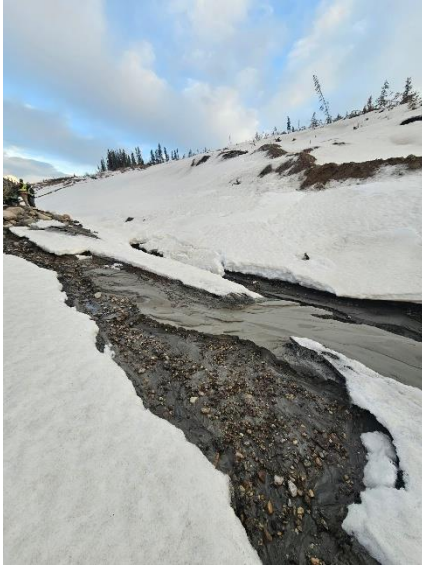
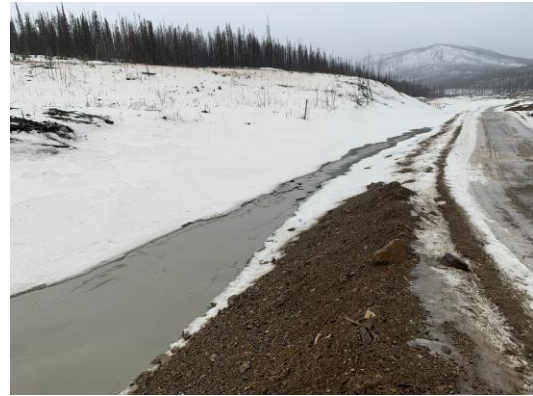
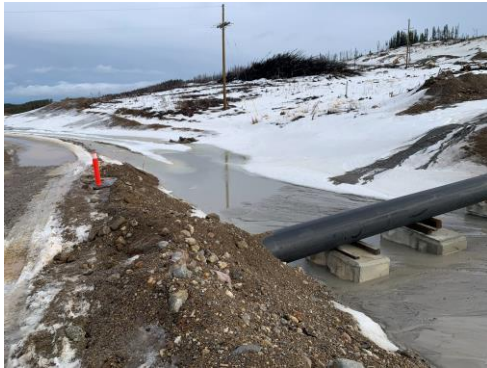
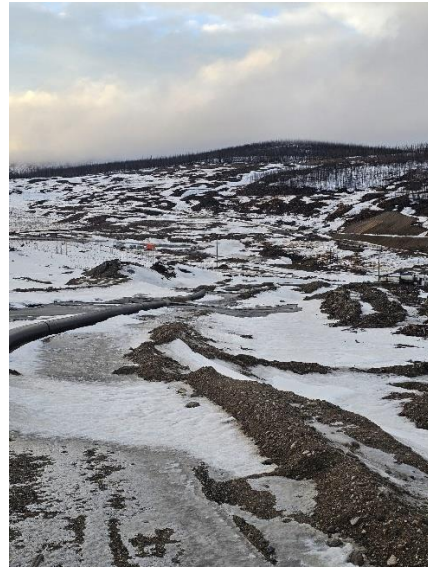
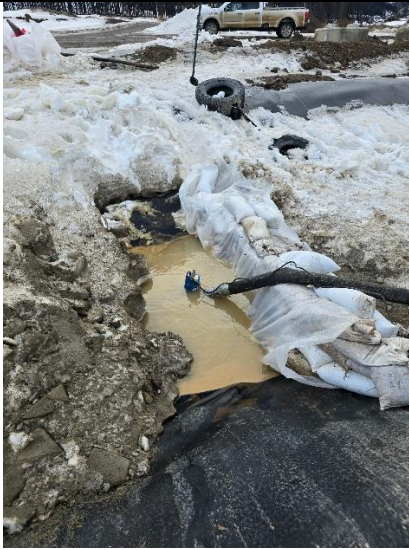
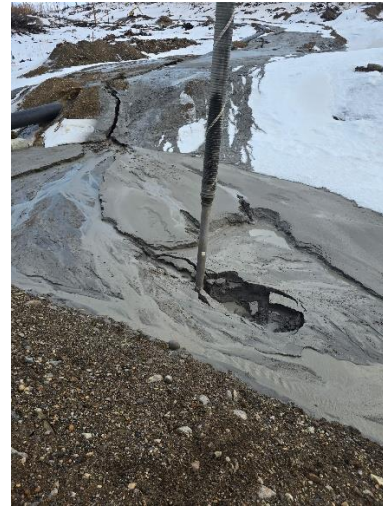
Figure 1. Initial spill photograph (Jan 30)

Figure 2. Initial spill photograph (Jan 30)

Figure 3. Initial spill photograph (Jan 30)

Figure 4. Initial spill photograph (Jan 30)

Figure 5. Initial spill photograph (Jan 30)

Figure 6. Initial spill photograph (Jan 30)

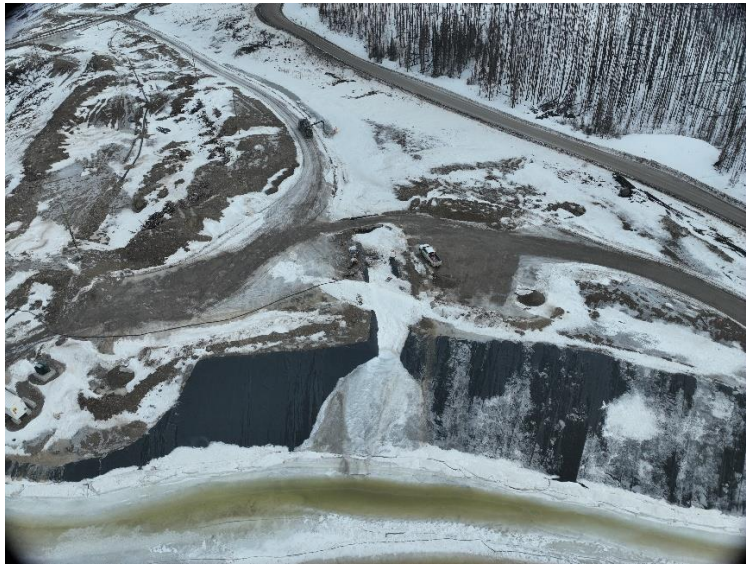
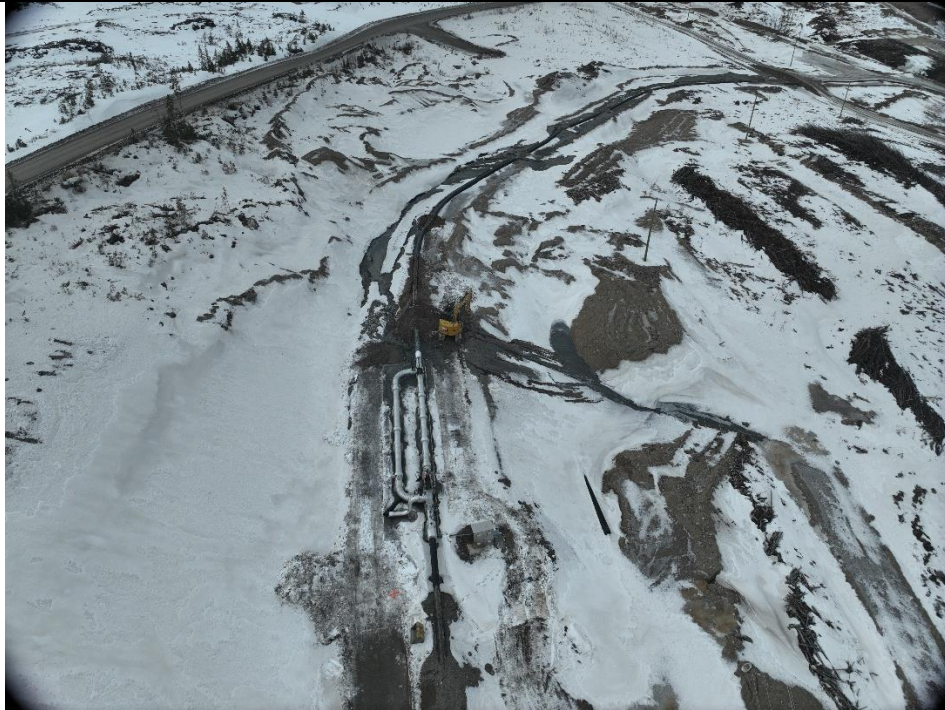
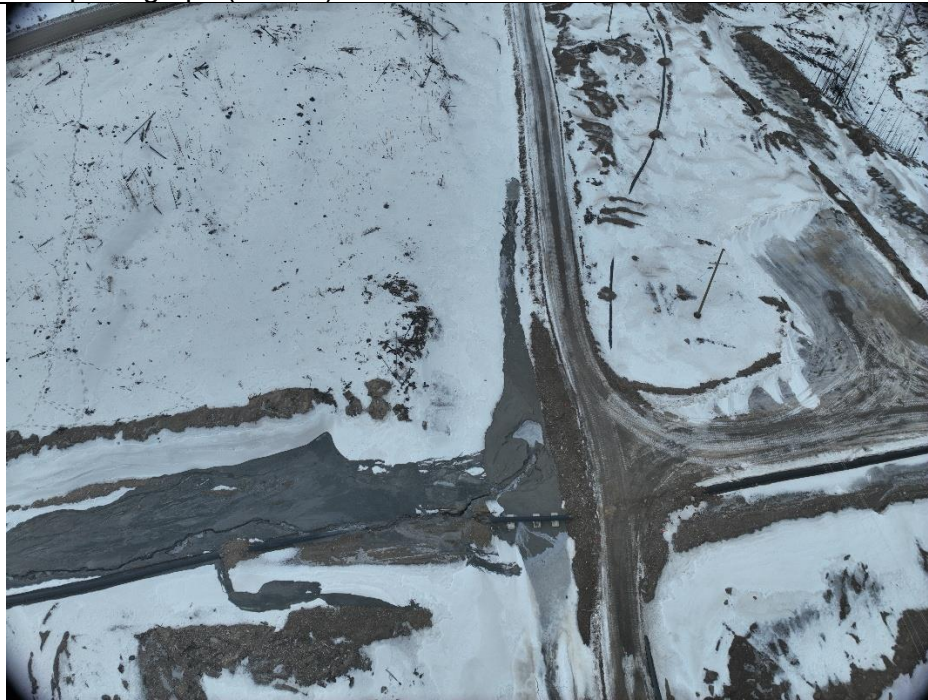
Figure 7. Aerial Photograph (Jan 31)

Figure 8. Aerial photograph (Jan 31)

Figure 9. Aerial photograph (Jan 31)

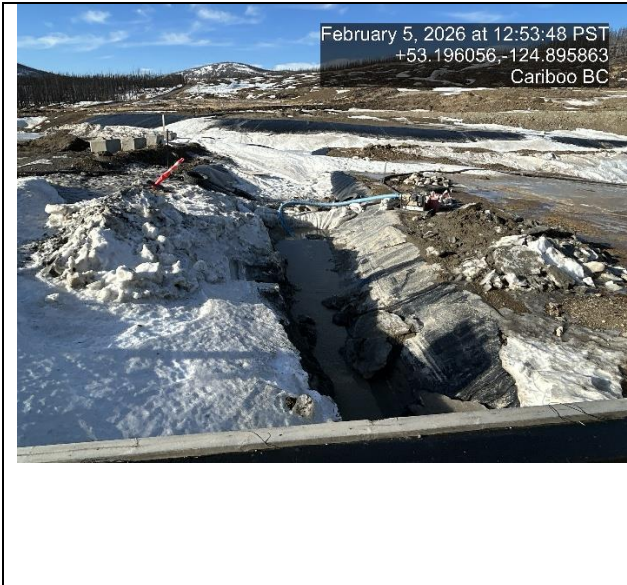
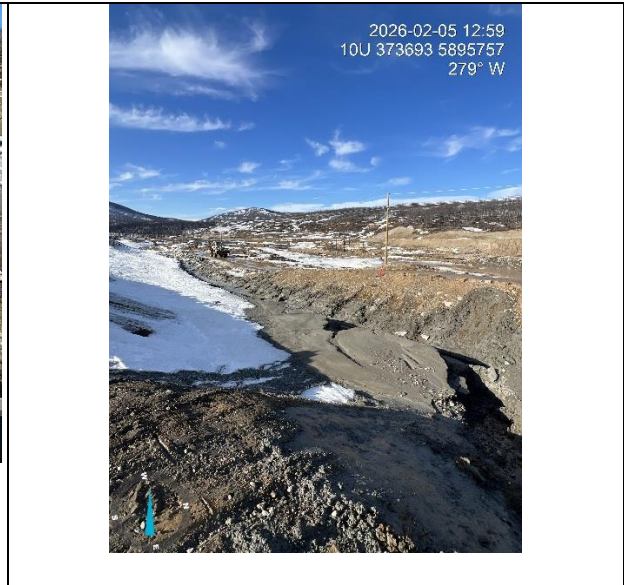
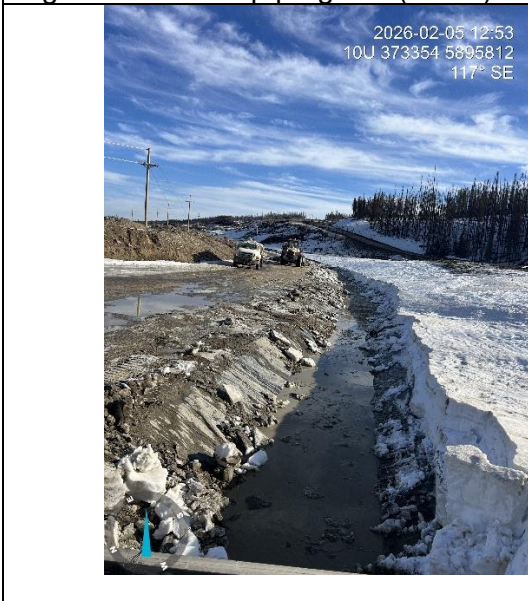
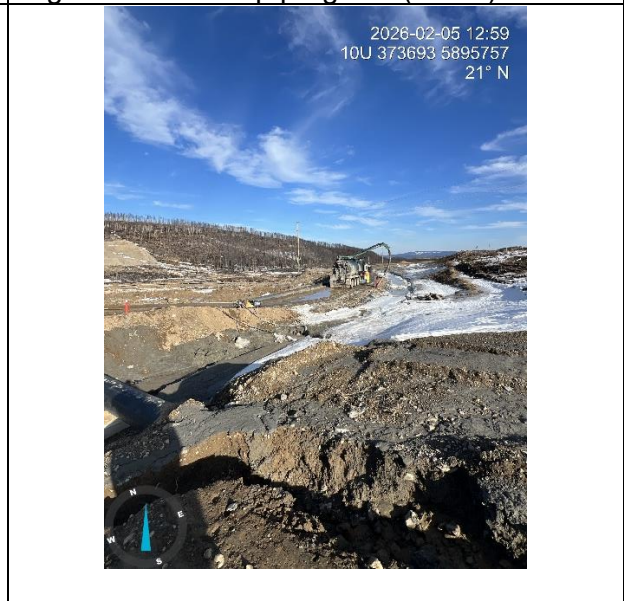
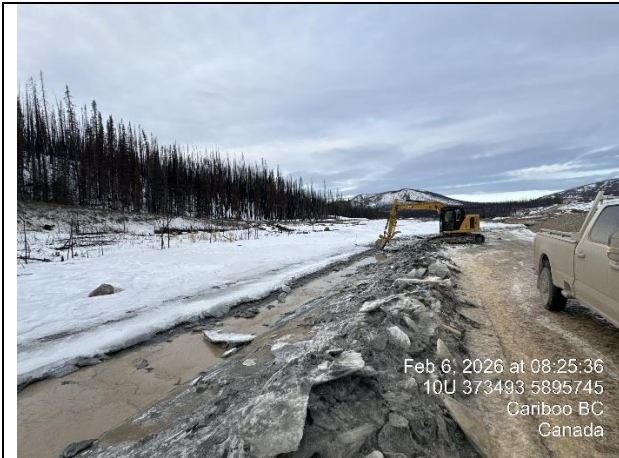
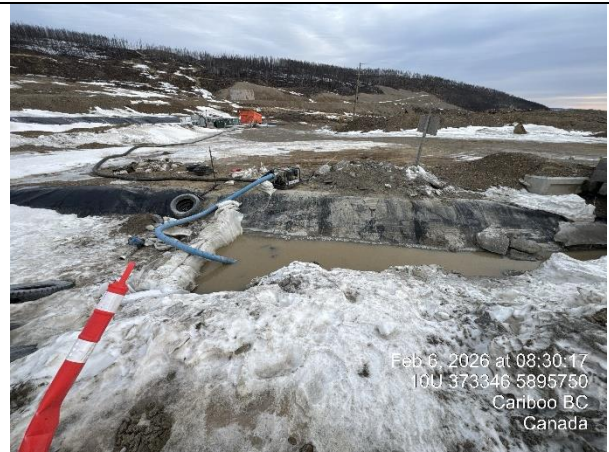
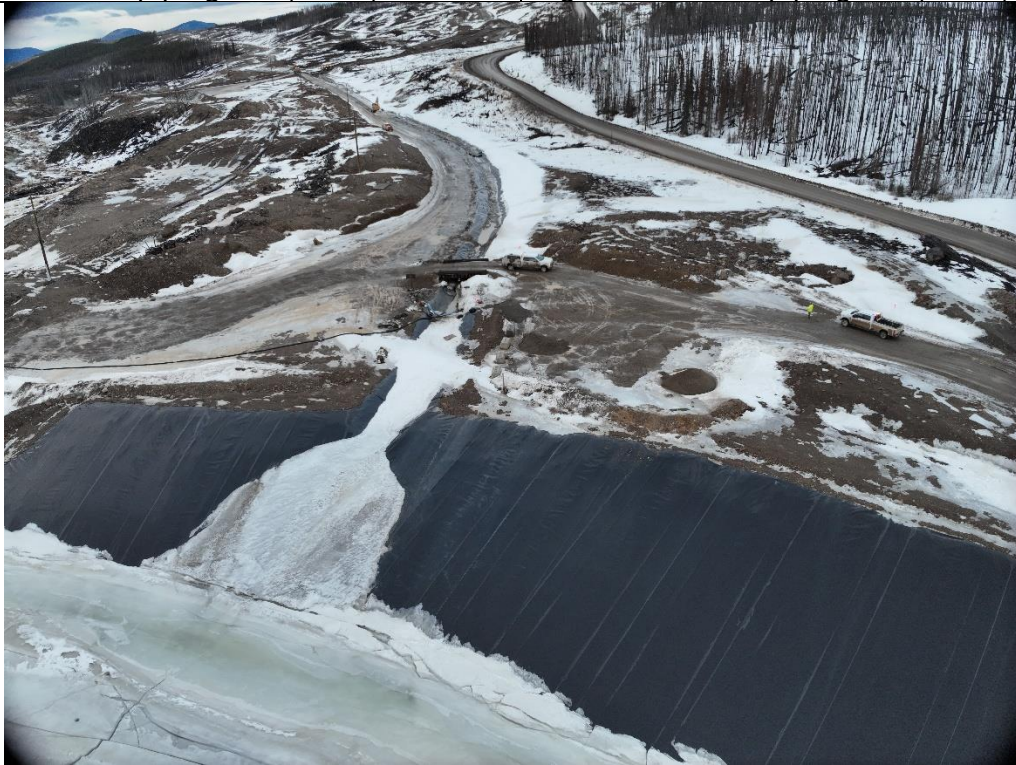
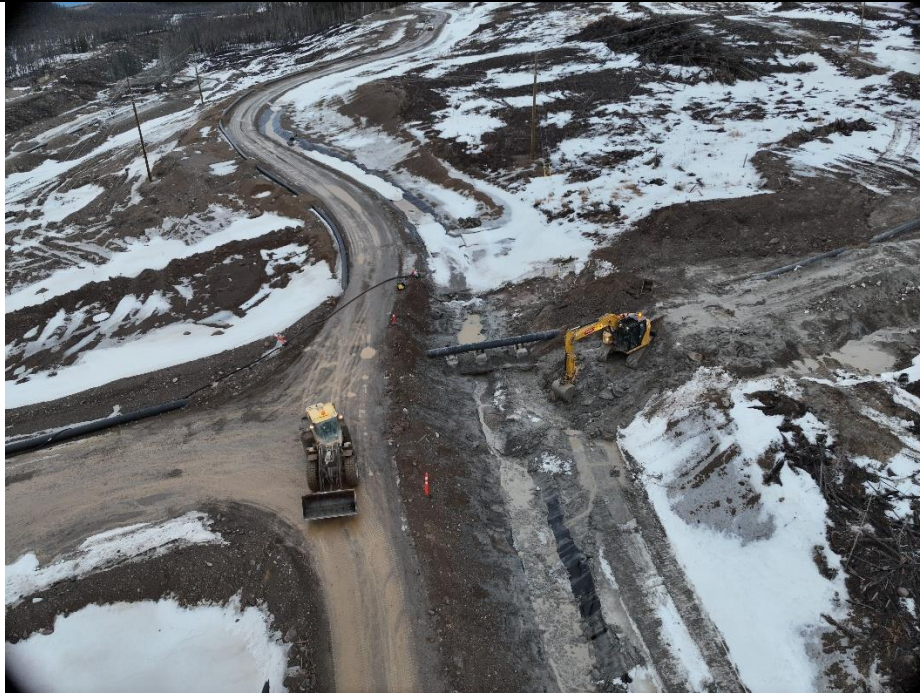
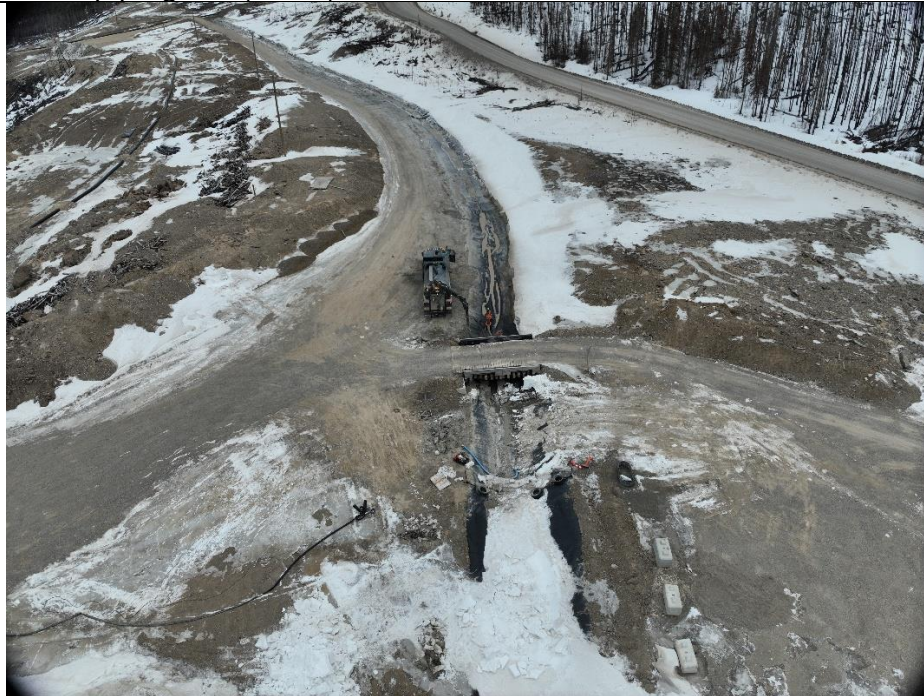
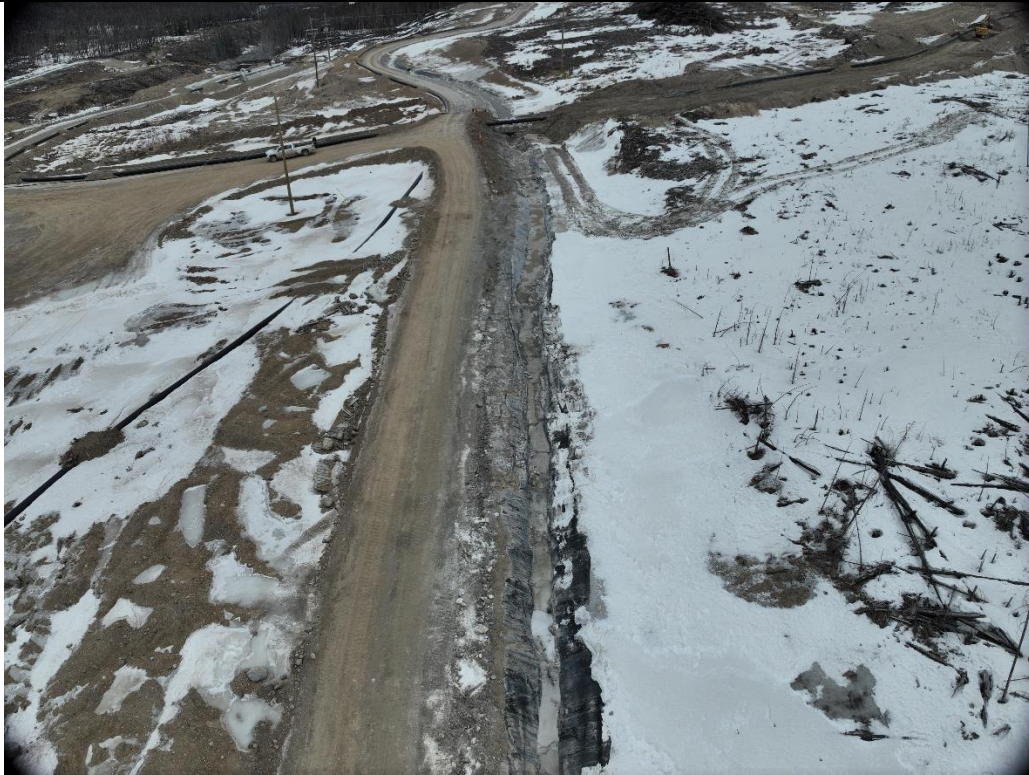
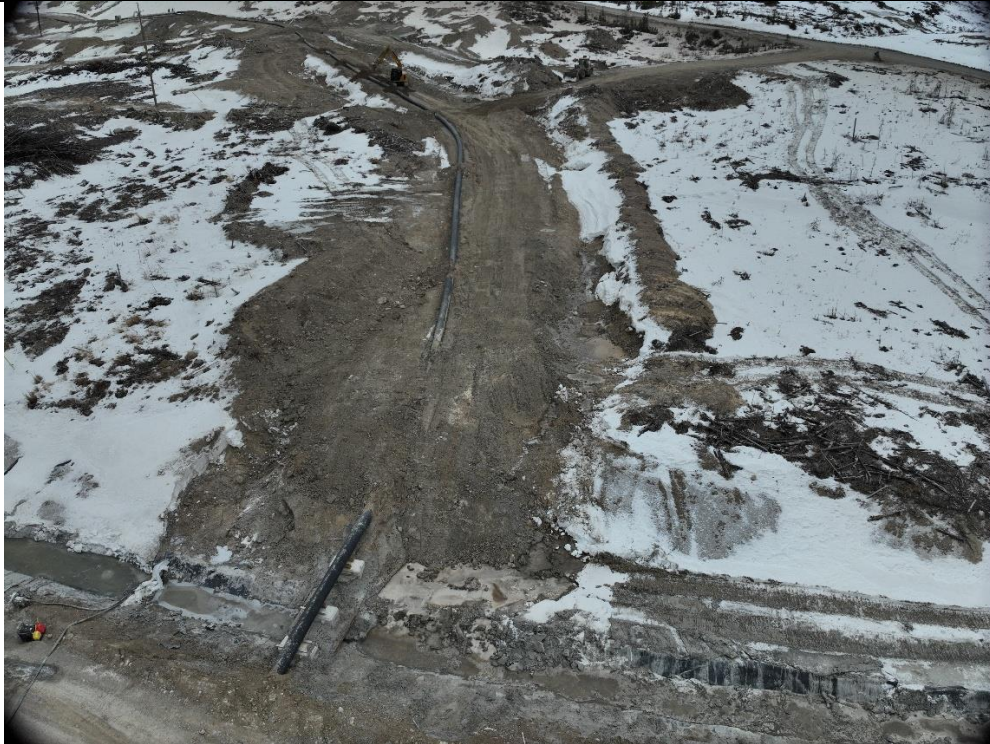
Figure 10. Cleanup progress (Feb 5)

Figure 11. Cleanup progress (Feb 5)

Figure 12. Cleanup progress (Feb 5)

Figure 13. Cleanup progress (Feb 5)

Figure 14. Cleanup progress (Feb 6)

Figure 15. Cleanup progress (Feb 6)

Figure 16. Cleanup progress (Feb 7)

Figure 17. Cleanup progress (Feb 7)

Figure 18. Cleanup progress (Feb 11)

Figure 19. Cleanup progress (Feb 11)

Figure 20. Cleanup progress (Feb 11)

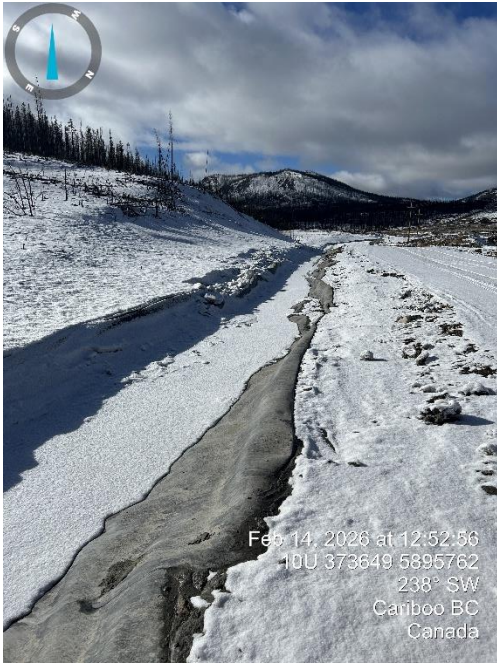
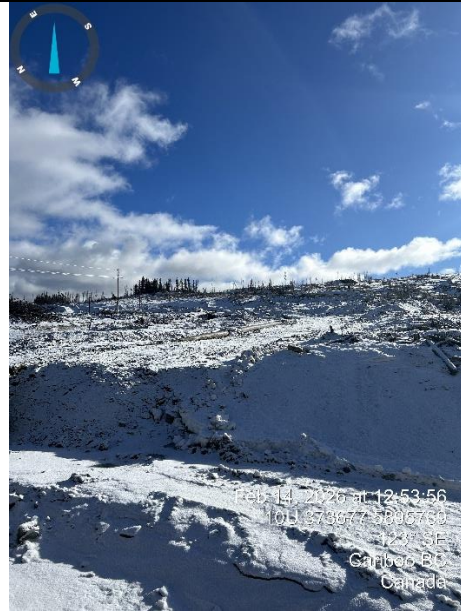
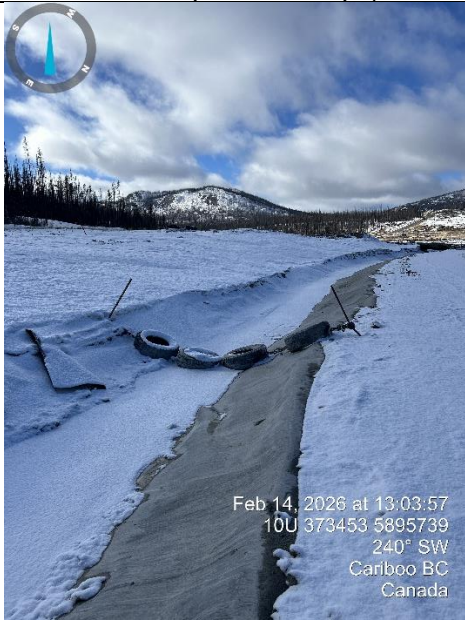
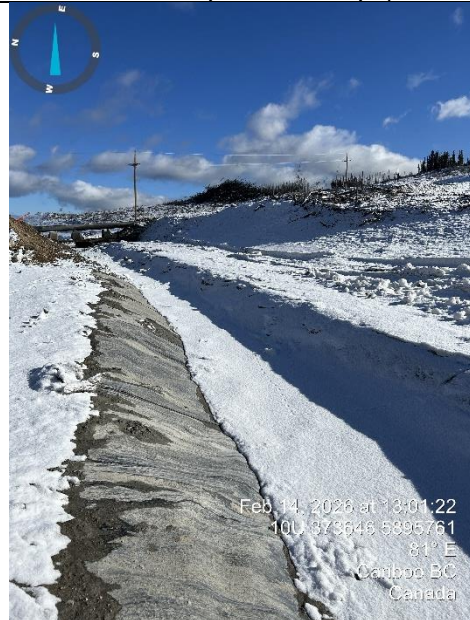
Figure 21. Channel post cleanup (Feb 14)

Figure 22. Channel post cleanup (Feb 14)

Figure 23. Channel post cleanup (Feb 14)

Figure 24. Channel post cleanup (Feb 14)
