As per Blackwater Gold's Accidents and Malfunctions Management Plan, the information below acts as the 30 follow up report to the "Initial Notification - CIL Slurry Release - January 31, 2026" submitted on February 1, 2026.

On January 31<sup>st</sup> at approximately 10:45 am, CIL tank 4 at the processing plant was being drained for maintenance when the drain valve malfunctioned. This malfunction caused a buildup of solids around the tank base and led to a breach causing 200 L of CIL slurry to be spilled to the ground (DGIR #260427). The spill was contained within the plant site perimeter ditching.

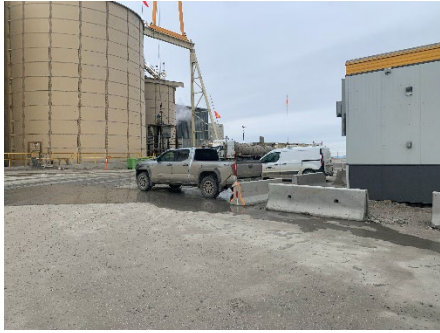
Figure 1. Initial spill photograph (Jan 31)

At the time of the incident, the tank valve was closed as much as possible to slow the leak. Once the leak was stopped, the area was blocked off with barricades, a vac truck and skid steer were dispatched to conduct cleanup of the ground affected area. All contaminated material was disposed of via the processing mill.

Incident investigation resulted in adding an inspection of the CIL Tank discharge valves after draining each tank as a corrective action, which was implemented immediately.

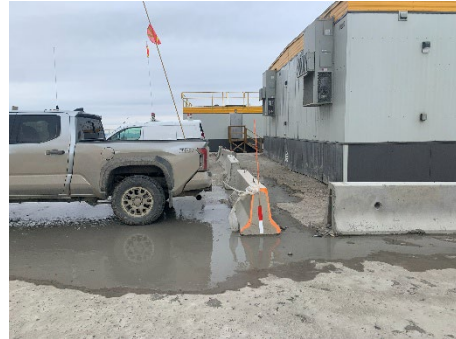
Figure 2. Initial spill photograph (Jan 31)

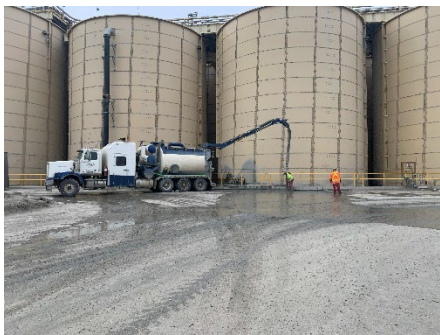
Figure 3. Spill clean up photograph (Jan 31)

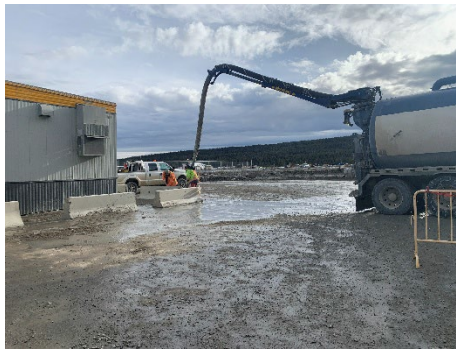
Figure 4. Spill clean up photograph (Jan 31)

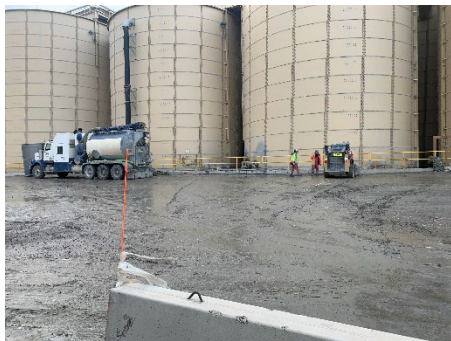
Figure 5. Spill clean up photograph (Jan 31)

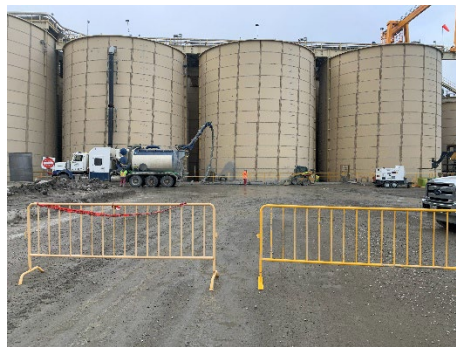
Figure 6. Spill clean up photograph (Jan 31)

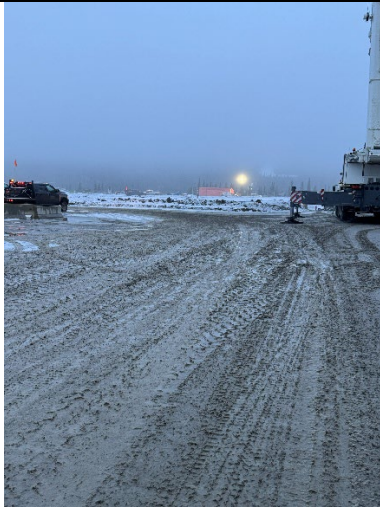
Figure 7. Post clean up photograph (Jan 31)

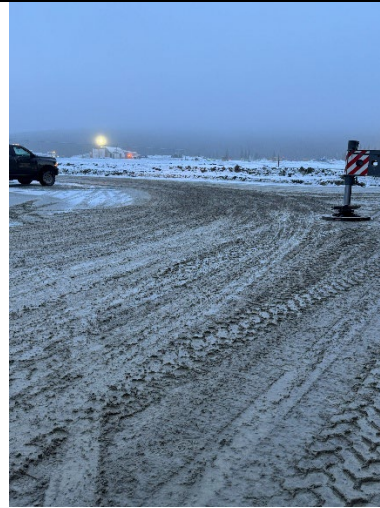
Figure 8. Post clean up photograph (Jan 31)

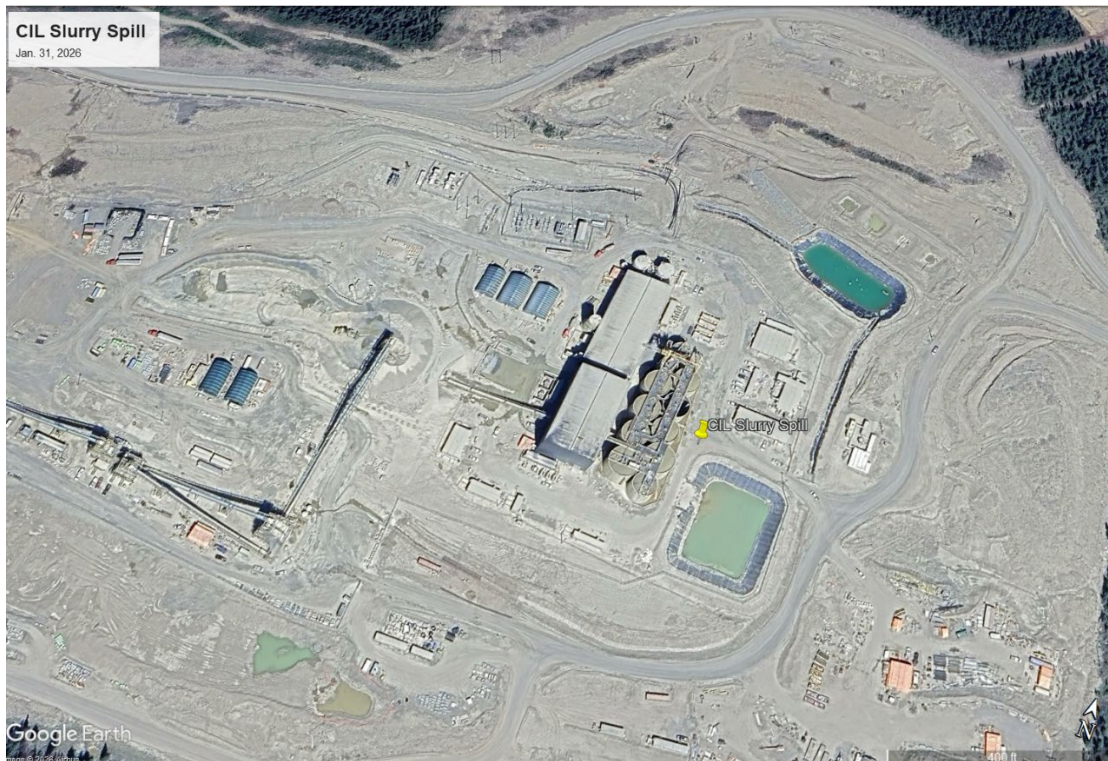
Figure 9. Map of spill location
