ARTEMIS GOLD INC | Blackwater Mine

30 Day Follow-up Report

Subject: 30 Day Follow-up Report – IECD Pipeline Leak

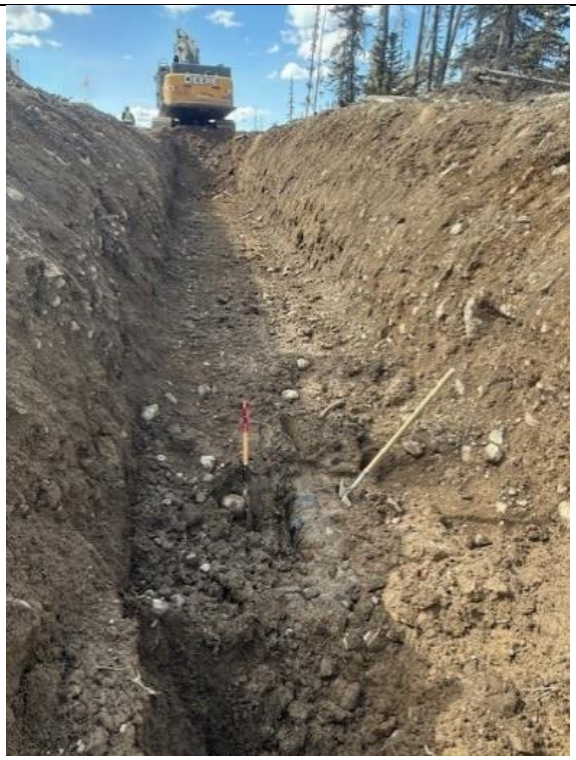
At approximately 17:00 on April 26, 2026, a leak was discovered from a subsurface pipeline running from the Interim Environmental Control Dam (IECD) to the Blackwater Mill, at 10U 376088 5895477. The IECD collects process water seepage from the Tailings Storage Facility (DGIR #261570). Upon discovery, pumping through the line was terminated; the pipeline has since been repaired.

Photo 1. Initial spill photograph (April 26)
