**Blackwater Gold Mine
IEM Site Visit Report 026
January 27 – 28, 2025**

Prepared By
EDI Environmental Dynamics Inc.
3810 18th Ave
Prince George BC V2N 4V5

EDI Project
21P0403
January 2025

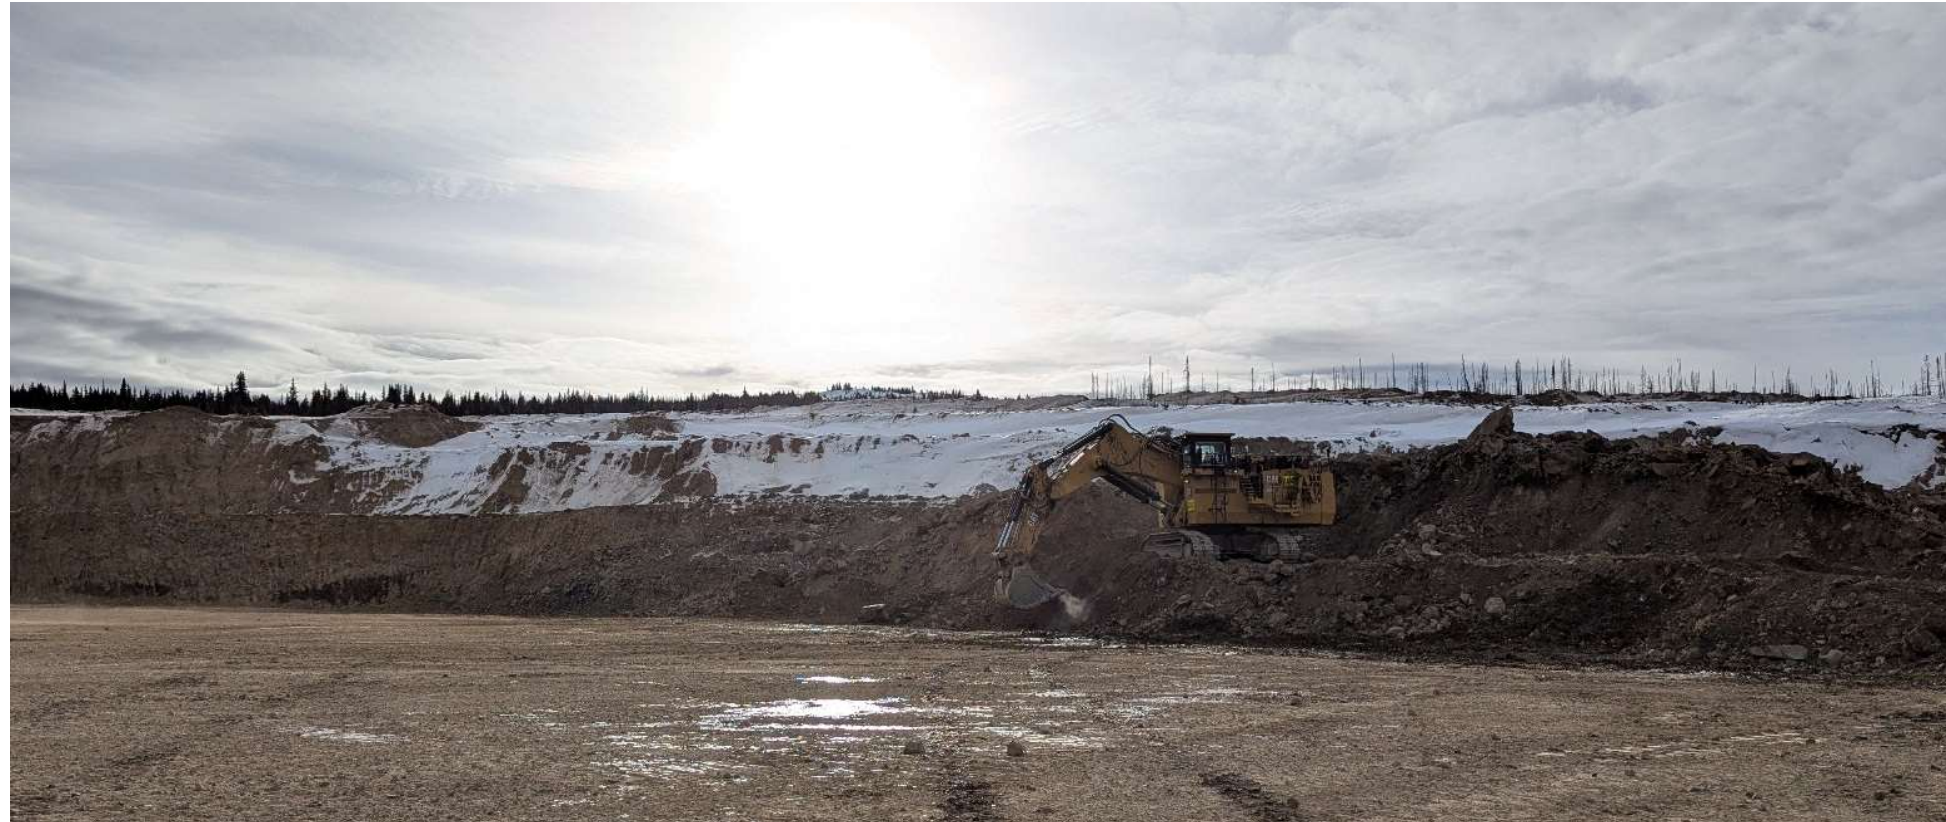
Photo 112957-2. Ongoing excavation within the open pit/ore body.

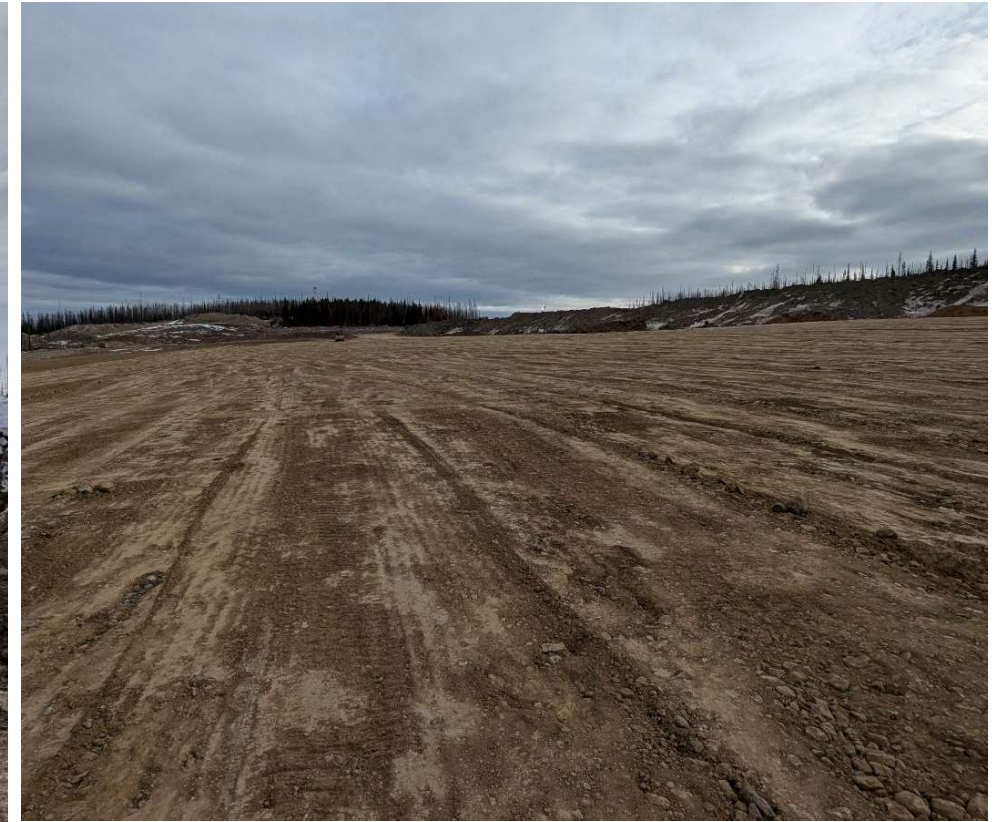
<p>Construction of the LGO stockpile pad continues. During the site visit, crews were observed placing and compacting the 'Zone S' till material that forms the base of the LGO stockpile pad (Photo 112953-7). Crews have also recently commenced with the excavation of the future drainage channels to be installed within the base of the pad that will collect water and send it to the LGO stockpile pond (Photo 112953-5).</p>	No
<p>Lining of the LGO stockpile pond was observed to be nearing completion (Photo 112954-4).</p>	No
Plant Site	
<p>Crews continue with commissioning of the plant site (Photo 112941-4), and leach circuit (Photo 112941-9). Both components have been operating (as part of commissioning activities) in the past few weeks and BWG announced it had completed its first pours of gold and silver in a media release on January 29, 2025.</p>	No
<p>Stockpiles of high-grade ore have begun to be stored on the run of mine (ROM) pad near the hopper for the crusher (conveyor) circuit (Photo 112951-2). Material that has been passed through the crusher circuit and is ready to be brought into the plant site was also observed at the terminus of the conveyor/crusher circuit (Photo 112941-3).</p>	No

Photo 112953-7. Overview of preparation of the compacted till liner under construction at the LGO stockpile pad.

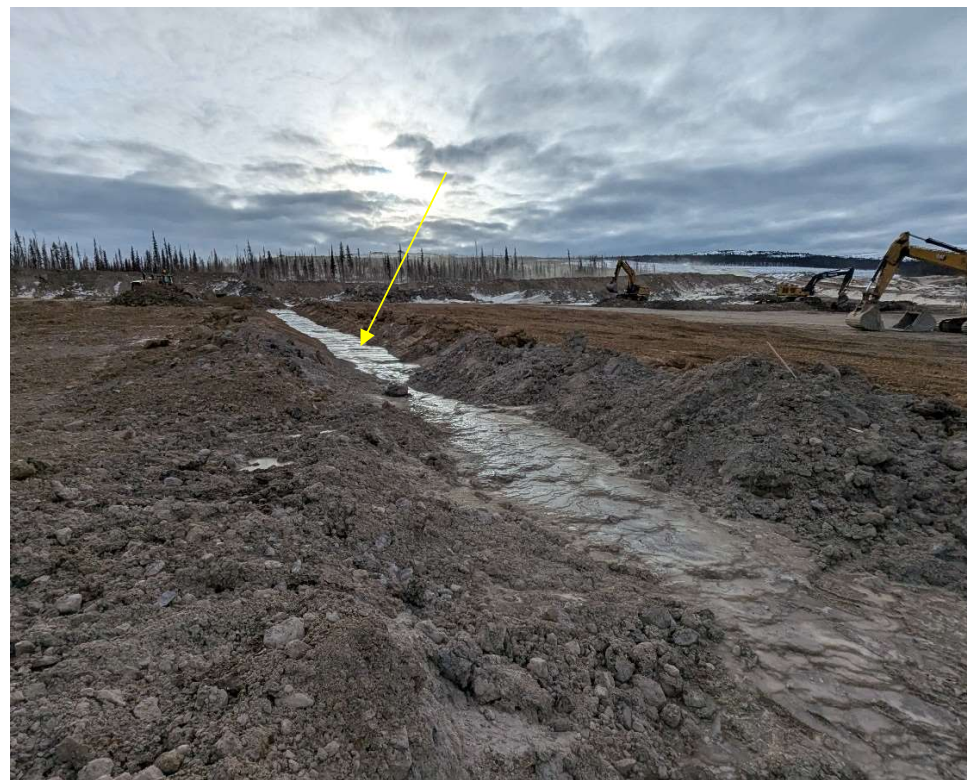
Photo 112953-5. Ongoing construction of the drainage channels beneath the future LGO stockpile pad.

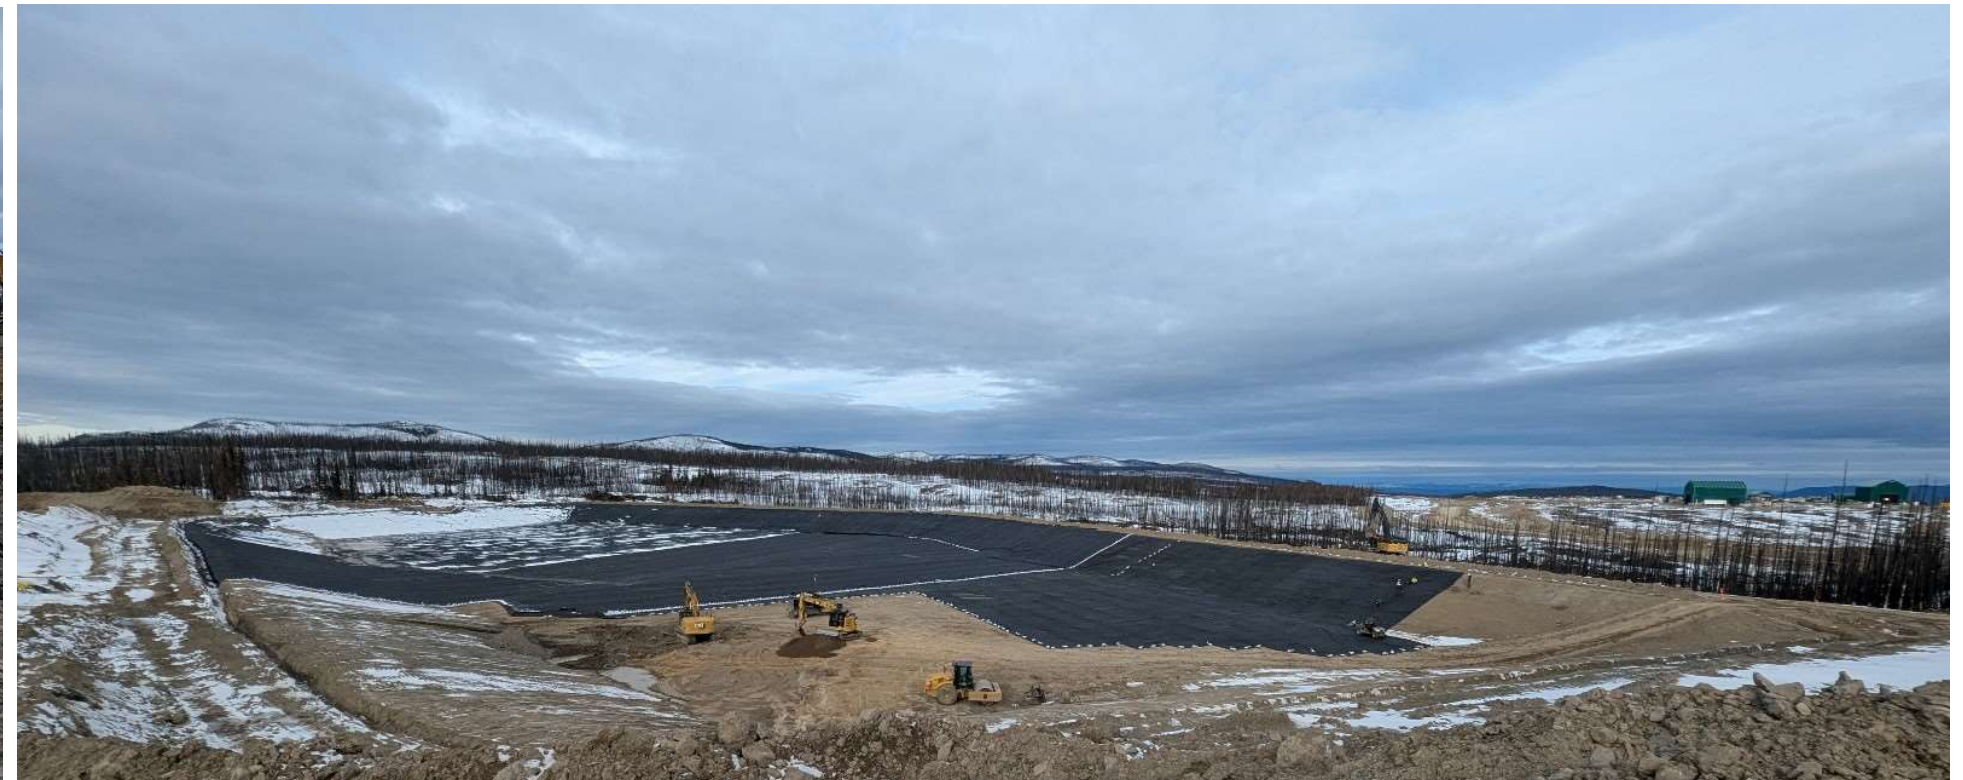
Photo 112954-4. Crews nearing completion of liner placement within the LGO stockpile pond.

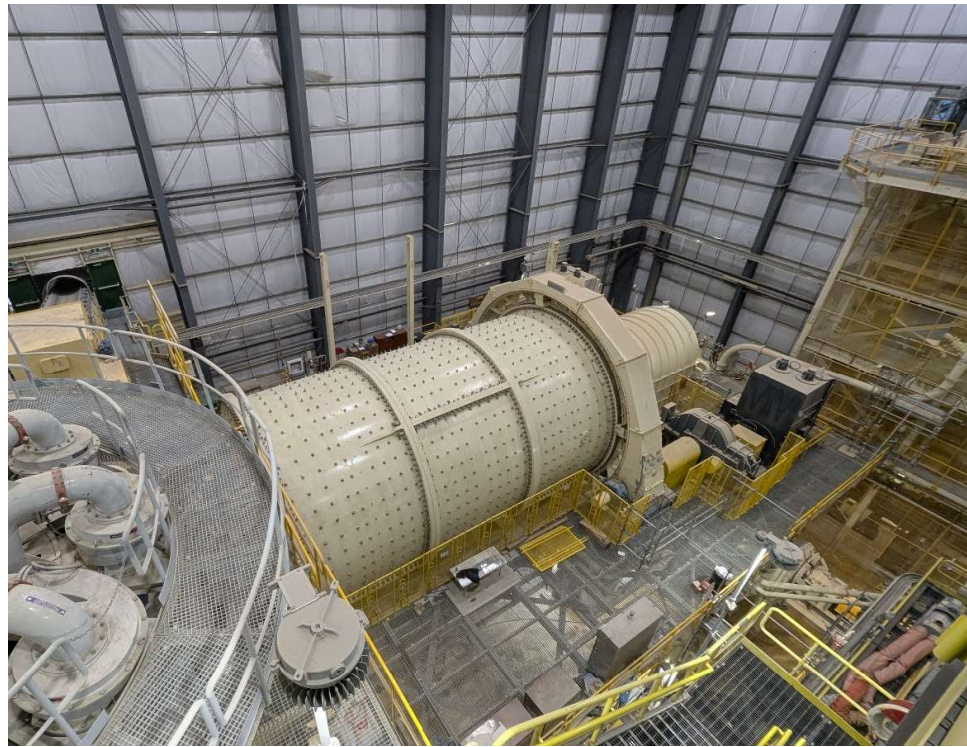
Photo 112941-4. Overview of components inside of plant site building currently undergoing commissioning.

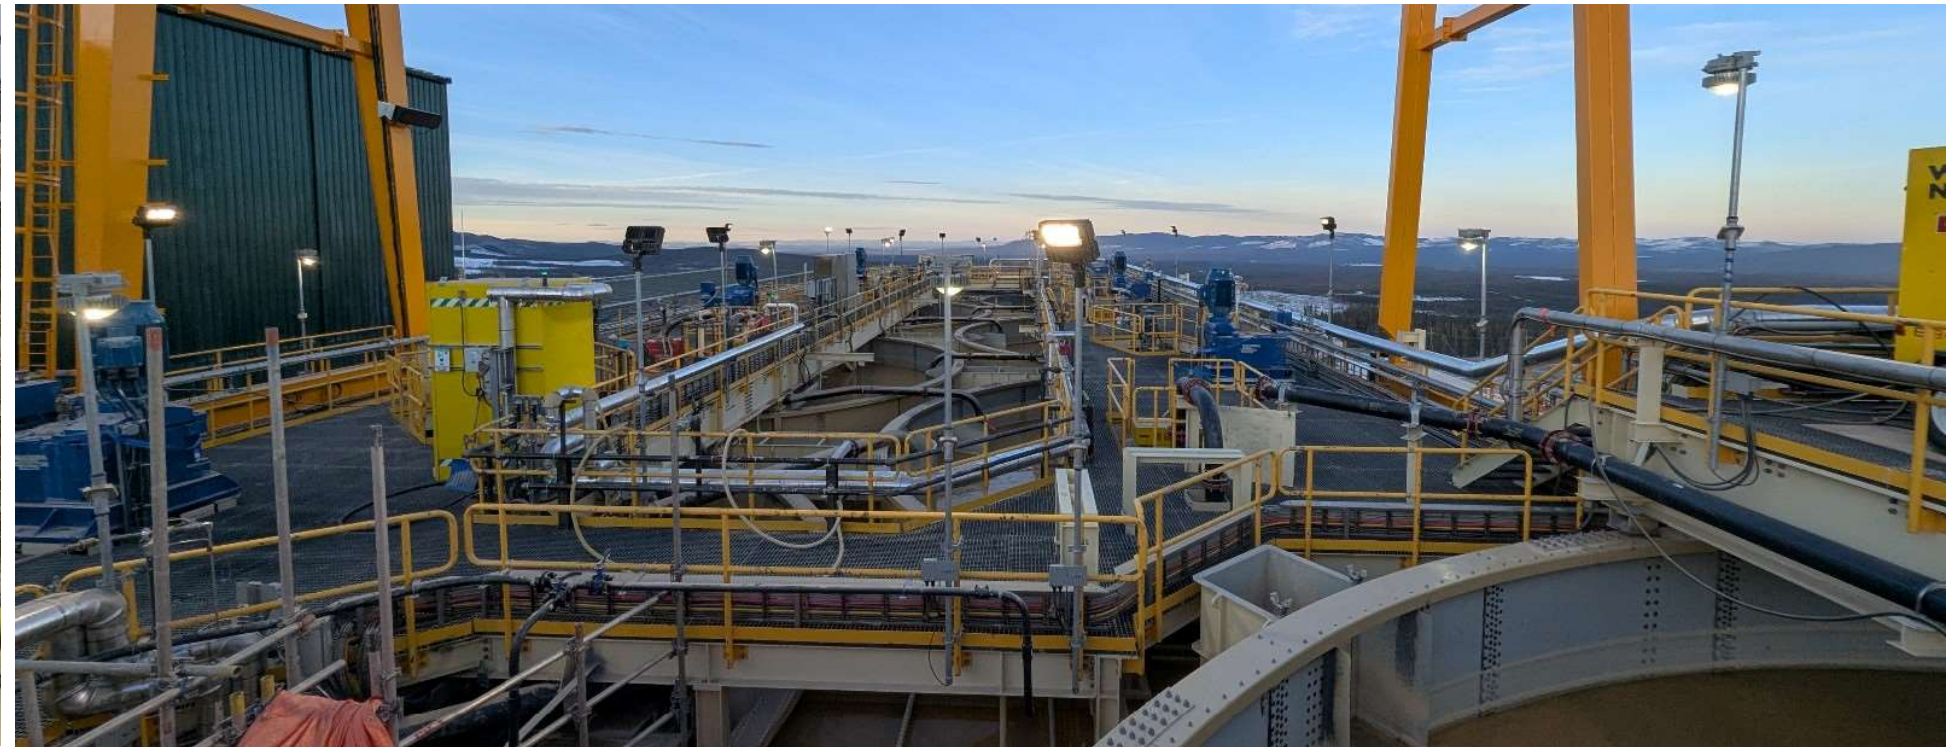
Photo 112941-9. Overview of leach circuit components currently undergoing commissioning.

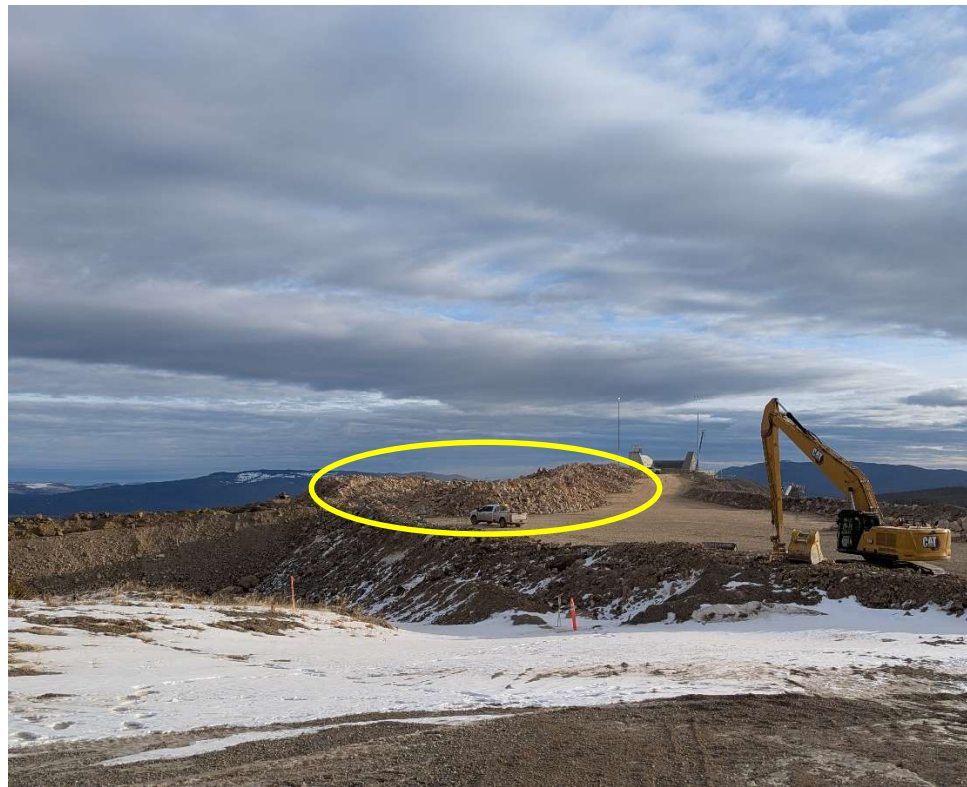
Photo 112951-2. High-grade ore stockpiled on the ROM pad adjacent to the hopper for the conveyor/crusher circuit.

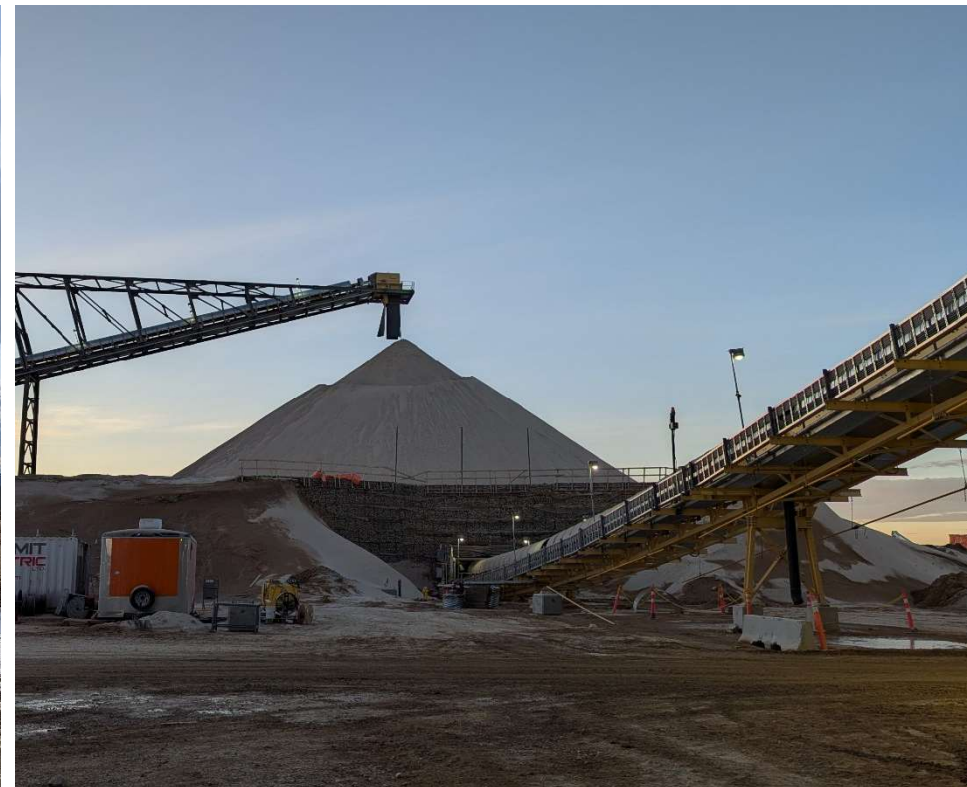
Photo 112941-3. Stockpile of high-grade ore at terminus of crusher/conveyor ready to be brought into plant site.

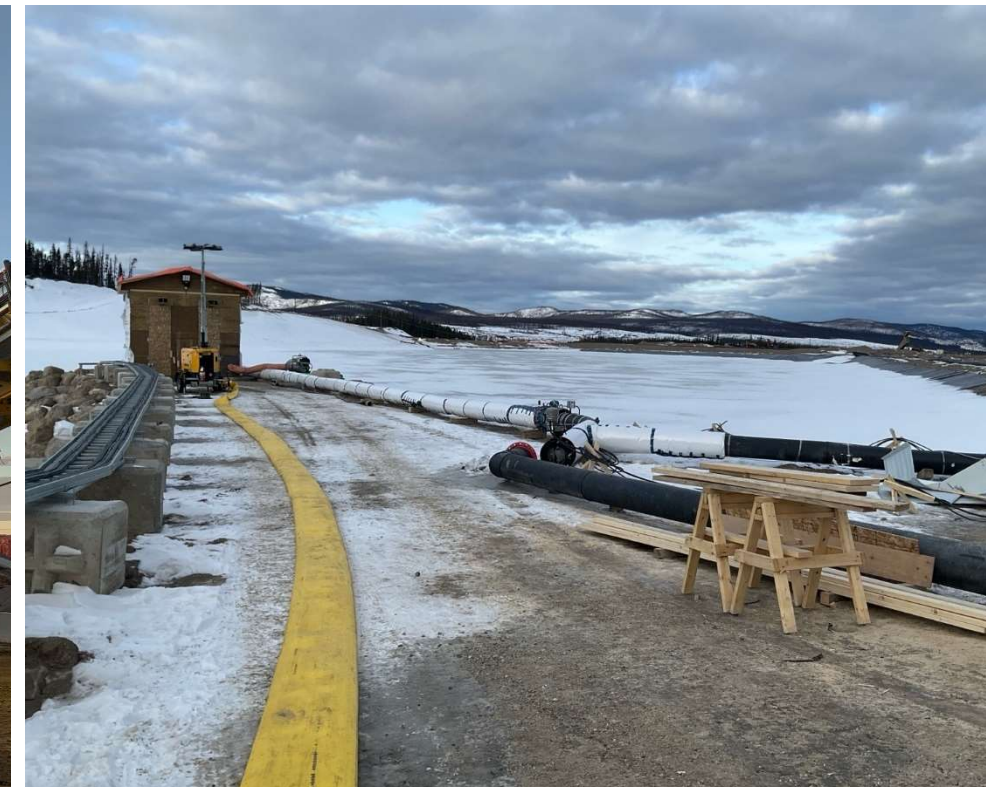
Following onsite discussions, it is understood remaining portions of the former exploration camp will be required to be removed to accommodate the eventual expansion of the ROM pad/road at the plant site. A request for information was submitted inquiring whether BWG planned to demolish buildings on site, and if so, whether the buildings would be subject to hazardous material testing (asbestos, lead, etc.).	No
A response was provided on February 5, 2025 which indicated the buildings would be removed from site (as opposed to being demolished).	
Mine Site Water Management	
Construction of the decant tower (and accompanying buildings) at the Water Management Pond (WMP) is nearing completion. As water is currently required from the WMP for plant commissioning, crews have laid out a temporary 12” hose between the pond and the plant to deliver water until the permanent water pipeline can be put into operation (Photo 112947-4).	No

Photo 112947-4. Status of decant tower at the water management pond. Water temporarily being pumped to plant site via hose until permanent pipelines can be implemented.

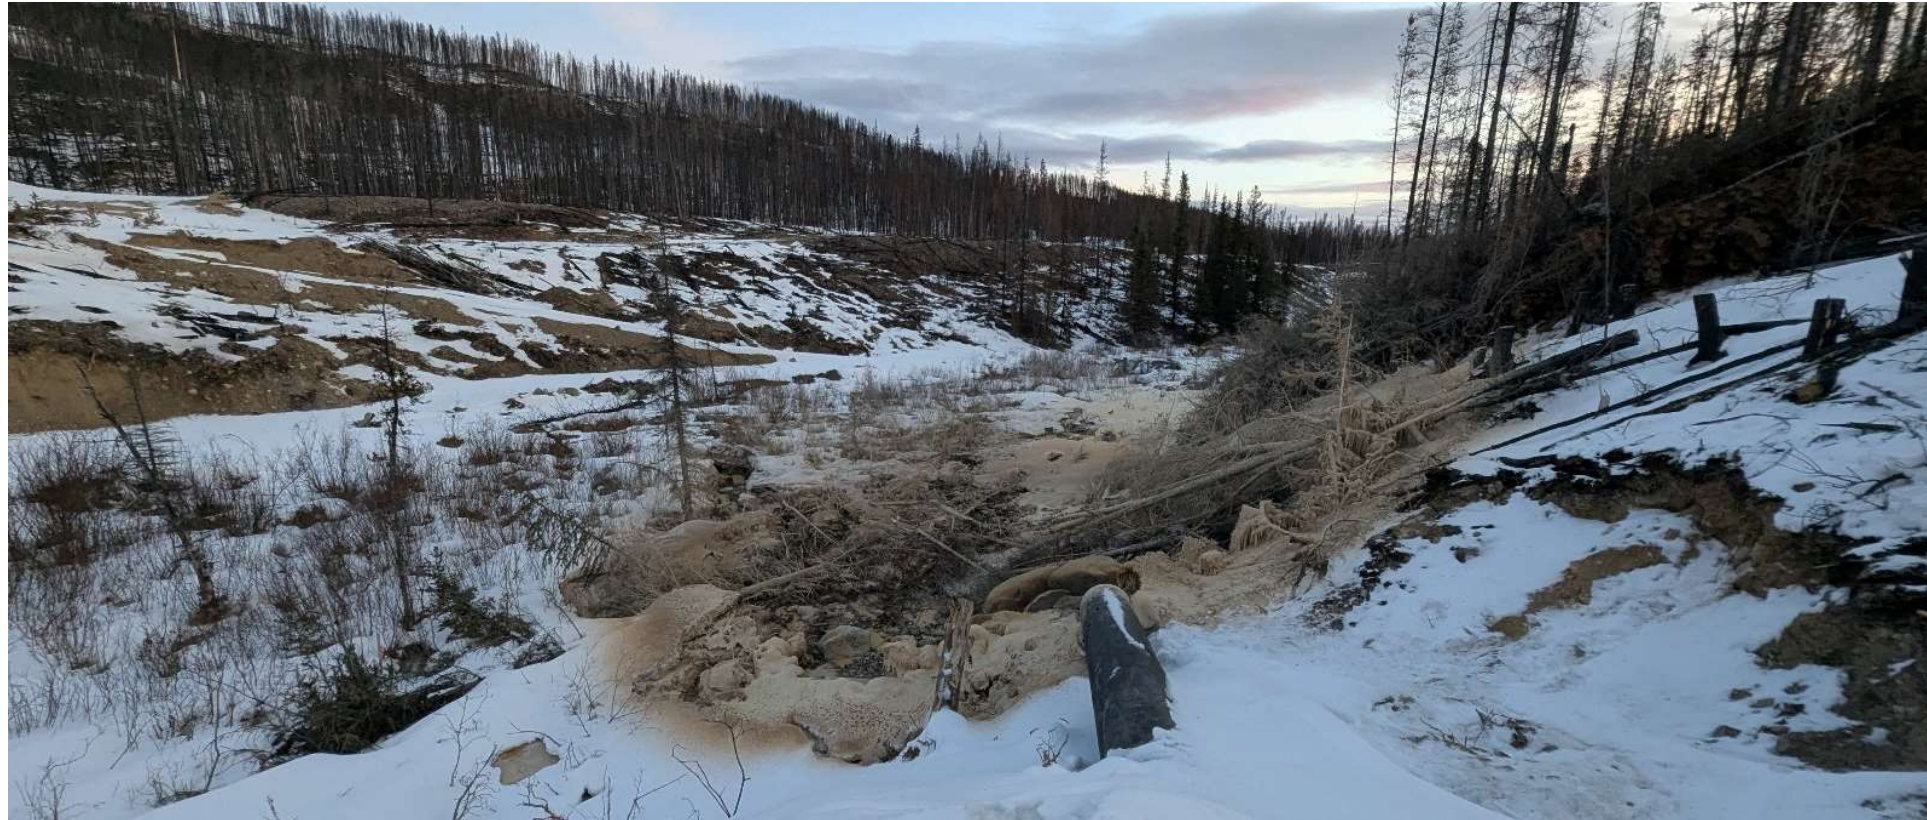
During the site visit, the discharge point at the terminus of the pipeline (currently located downstream of the CWTP) was observed (Photo 112943-1).	
Placement of ‘waste’ PAG material generated from the ore body/open pit excavation has begun in the area located immediately upstream of the TSF dam known locally as the ‘PAG dump’ (Photo 112944-4). This material will eventually become submerged beneath water (as a mitigation against the acid generation process) as the tailings and water volumes upstream of the TSF dam accumulate over time.	No
Interim Environmental Control Dam	
Crews have recently installed pumps and pipelines to enable the periodic movement of water pooling on the upstream side of the Interim Environmental Control Dam (IECD) to the area upstream of the TSF dam (Photo 112946-6).	No
The water collection point (foundation drain) located immediately downstream of the IECD that was installed to help manage and capture groundwater during construction of the structure, remains in place and continues to capture seepage water that travels beneath the IECD (Photo 112946-1). Following onsite discussions with BWG staff, with construction of the IECD (and associated upstream structures that manage water) now complete, the IEM understands this water is now classified as Project related ‘contact water’ and as a result, will no longer be pumped and discharged to Davidson Creek (as was previously being carried out when it was classified as non-project related groundwater). Water from this foundation drain is now being managed by pumping it back to the upstream side of the IECD.	No

Photo 112943-1. Discharge point from pipeline delivering tailings from the Plant site into the Tailings Storage Facility (located downstream of the Central Water Transfer Pond).

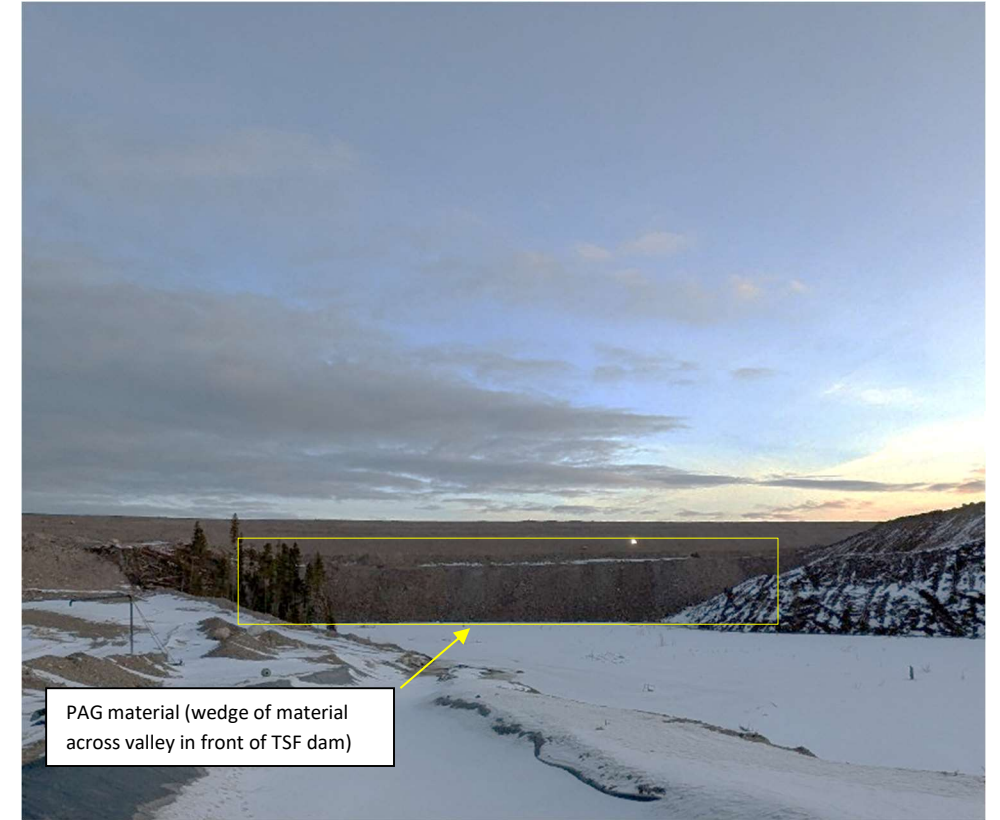
Photo 112944-4. Overview of 'PAG dump' immediately upstream of the TSF dam.

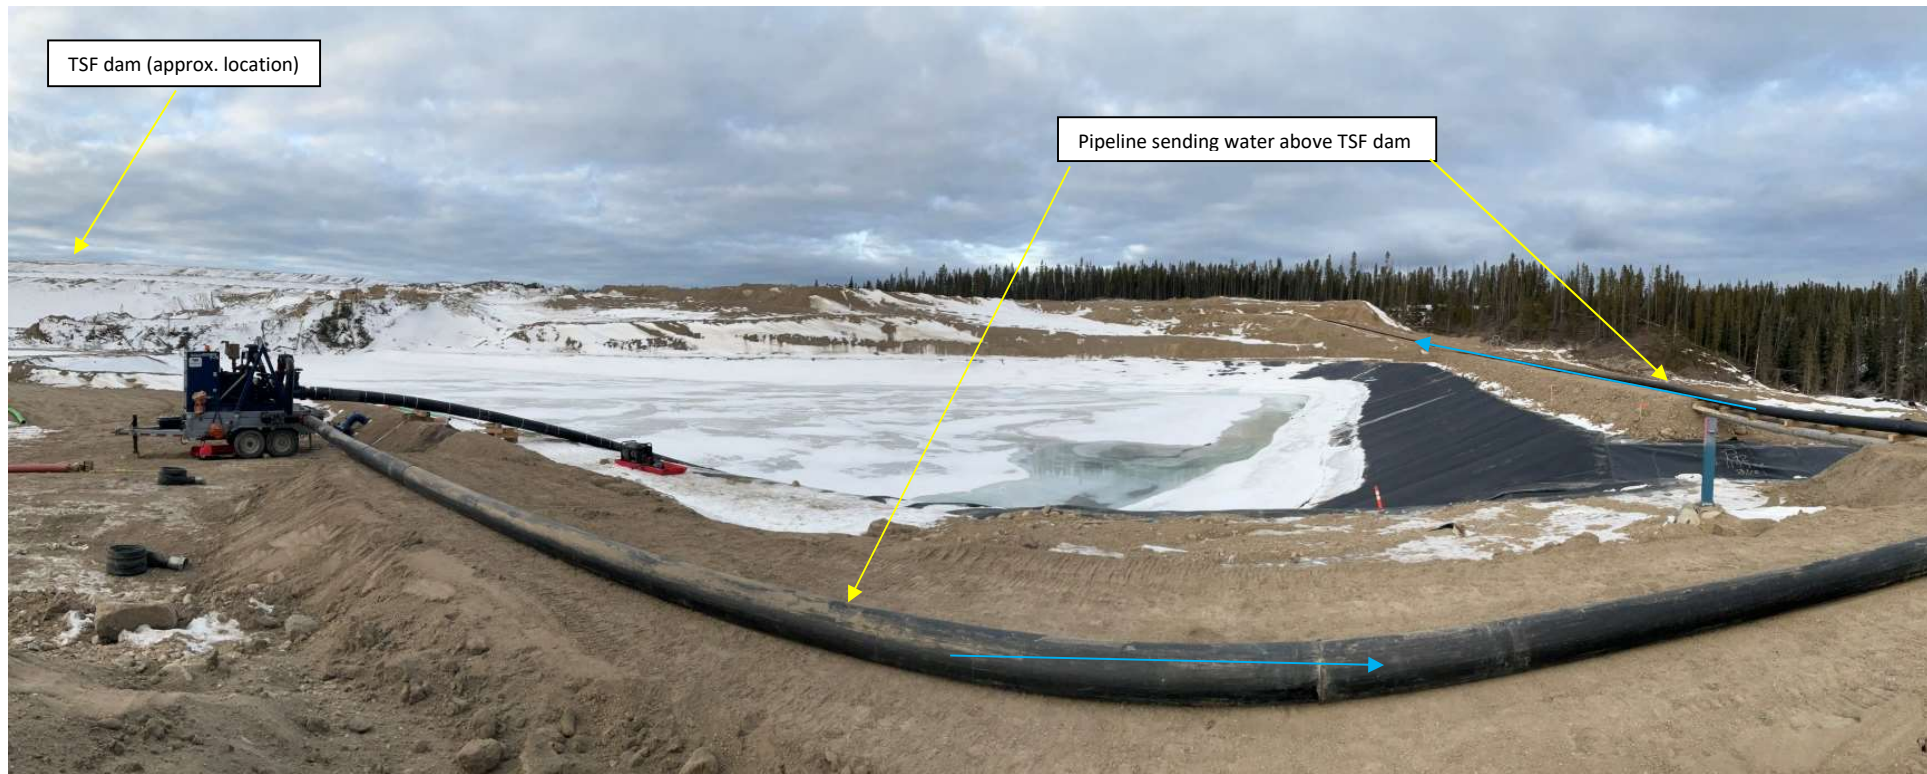
Photo 112946-4. Overview of water pooling on the upstream side of the Interim Environmental Control Dam (IECD). Water is being pumped (via pipeline) to the area upstream of the TSF dam.

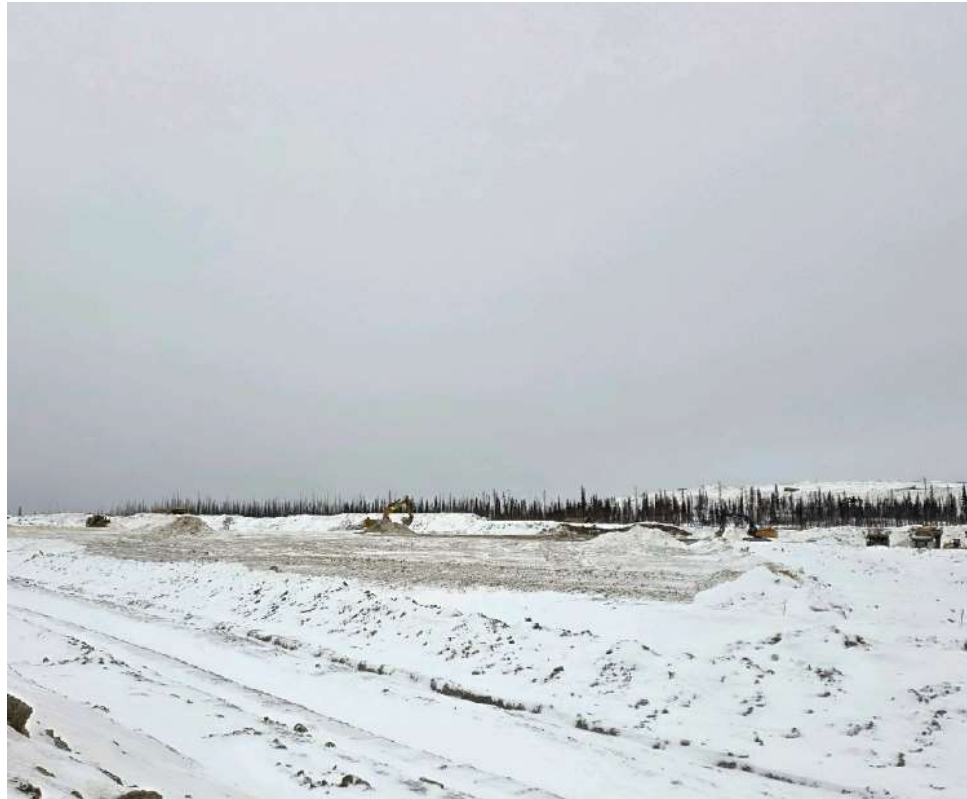
Photo 113125-2. Crews continue placement of 'zone s' till liner along the base of the LGO stockpile pad.

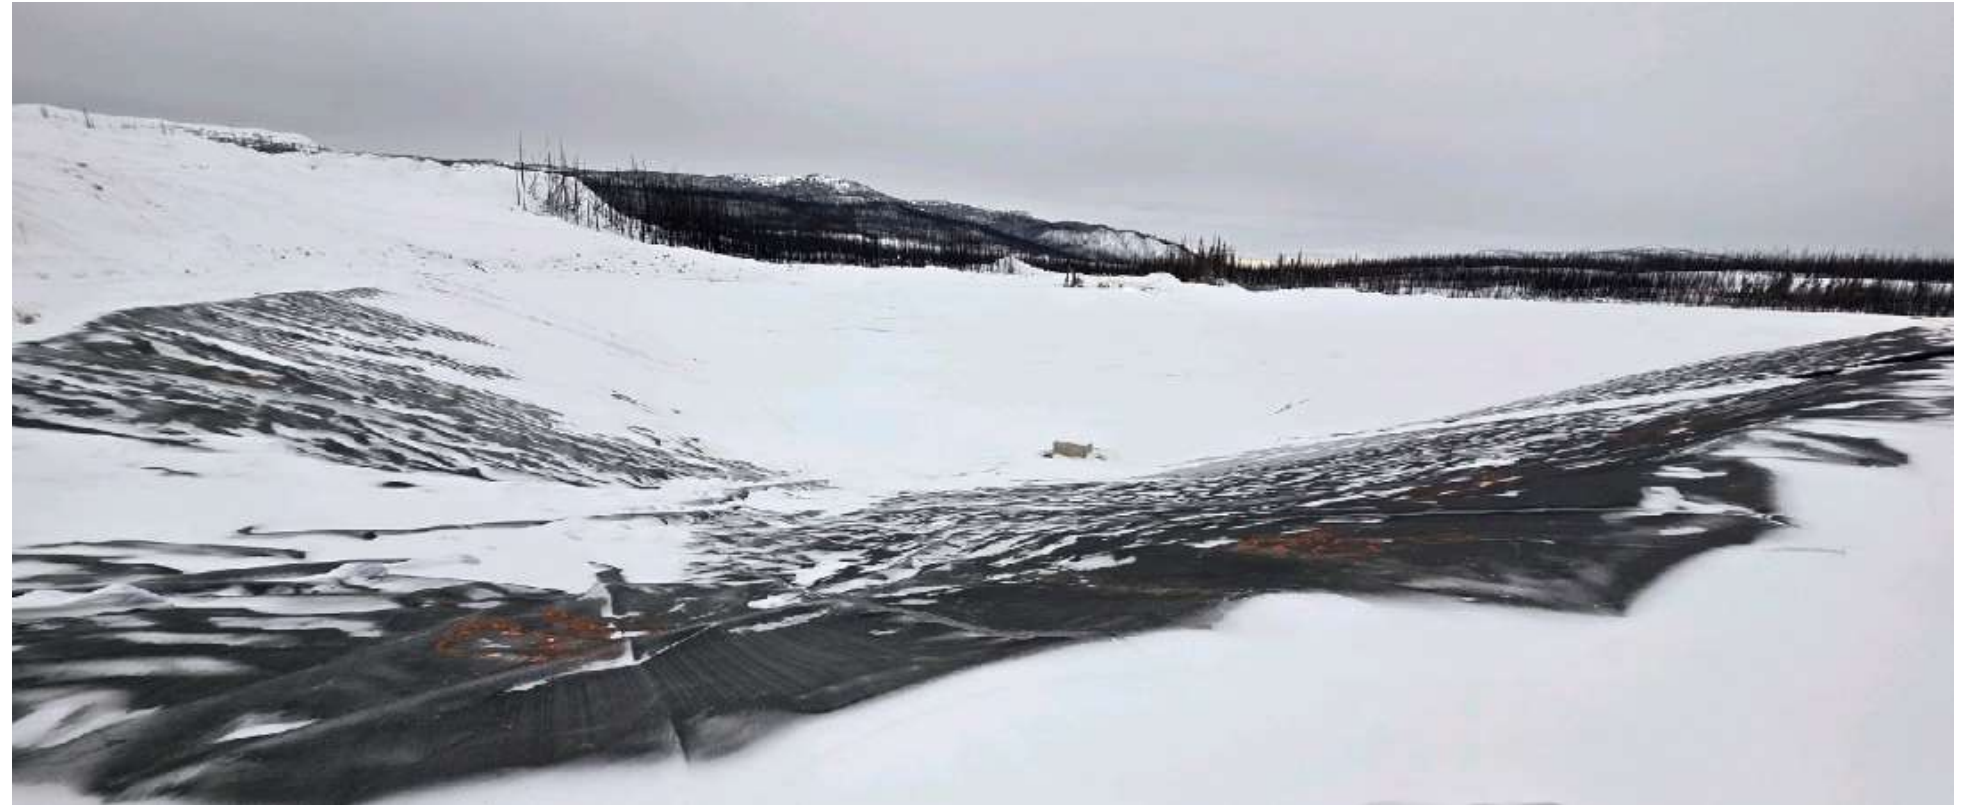
The installation of the geotextile liner within the base of the LGO stockpile pond has recently been completed (Photo 113124-2). Crews have now begun to install liner within the base of the western drainage ditch from the LGO stockpile pad to the LGO pond. The liner that has been installed within the pond and drainage ditch was noted to be the ‘textured liner’ that BWG has begun to utilize on site to provide grip for wildlife escape from water collection features (Photo 113124-3).	No
Plant Site	
Commissioning of the crusher circuit, plant site and leach circuit continues. Crews were observed feeding the plant site with material that had been passed through the crusher circuit during the recent site visit (Photo 113115-1).	No
Mine Site Water Management	
Construction of the decant tower (and accompanying buildings) at the Water Management Pond (WMP) continues and is nearing completion. The IEM team understands one of the pumps has recently been commissioned and is being used to send water between the WMP and the plant site through a water pipeline (Photo 113126-3).	No

Photo 113124-2. Overview of the LGO stockpile pond following completion of liner installation.

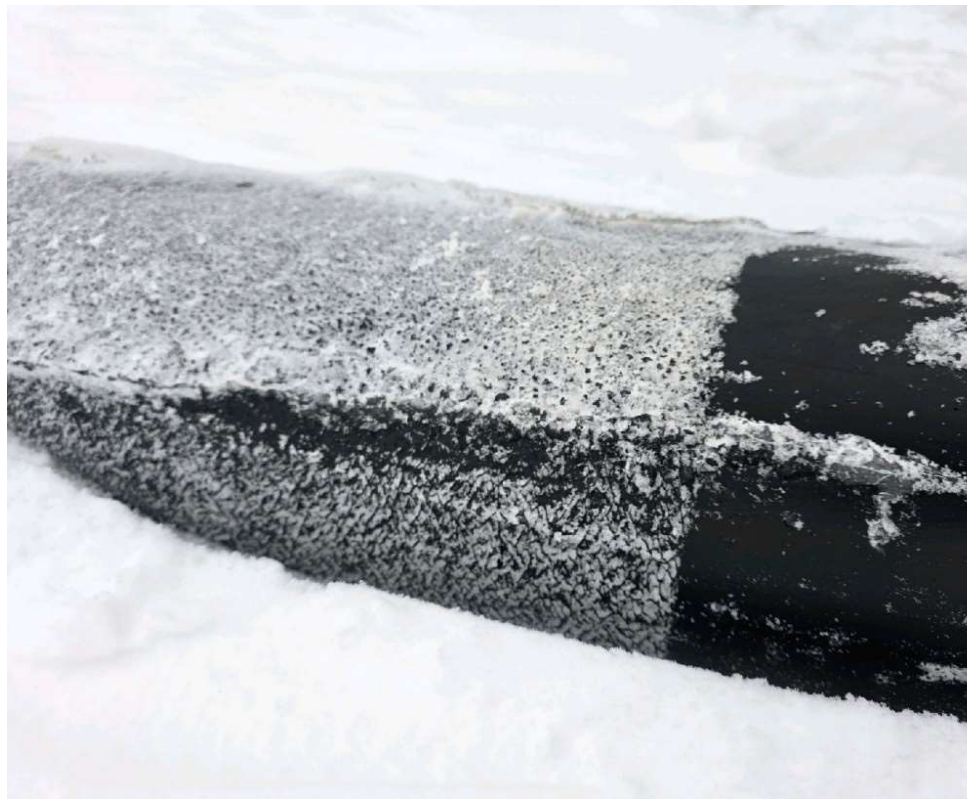
Photo 113124-3. Textured liner installed within the LGO stockpile pond.

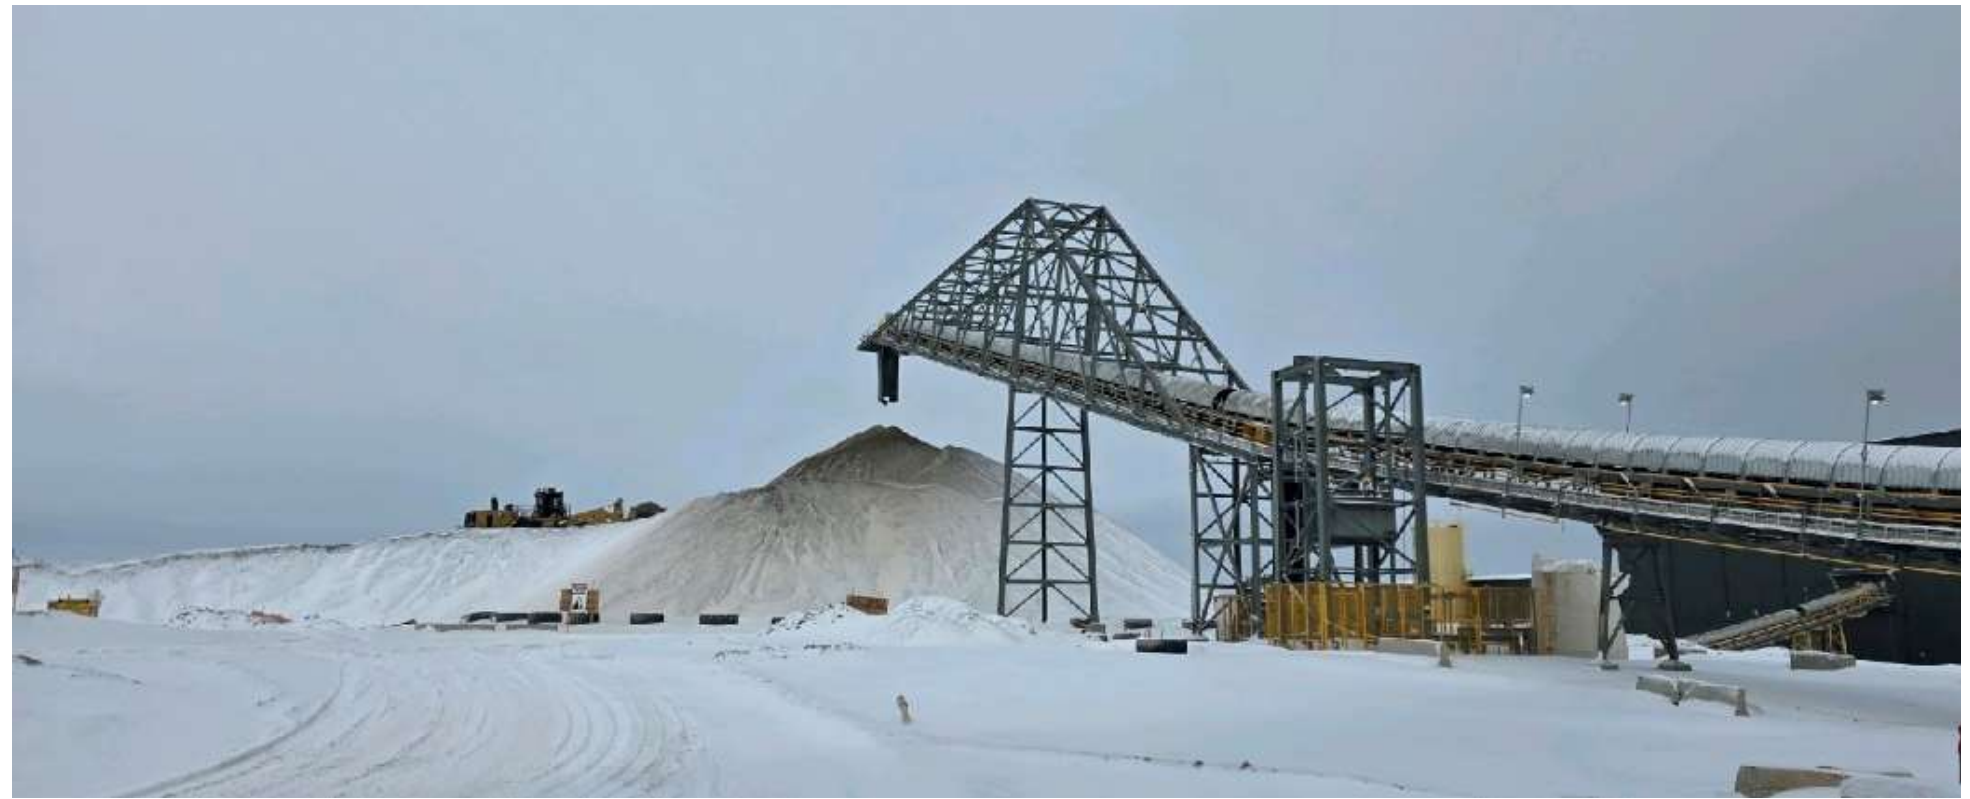
Photo 113115-1. High grade ore stockpile being worked and fed to plant site at the terminus of the crusher circuit.

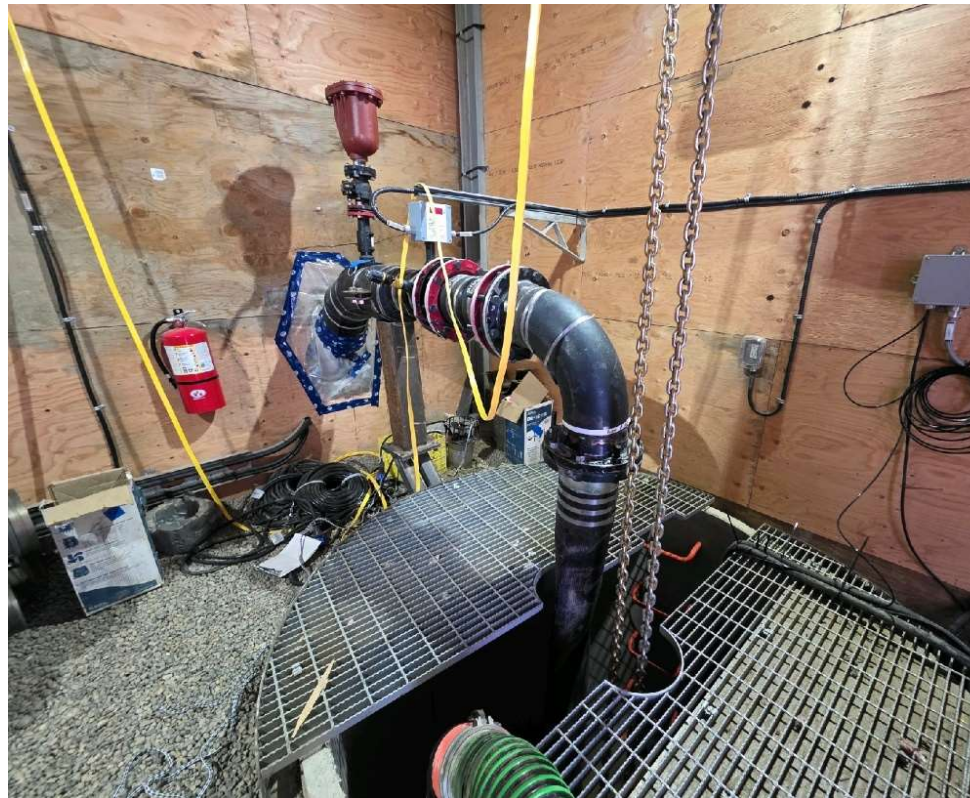
Photo 113126-3. Pump within the WMP decant tower, in operation and pumping water to the plant site.

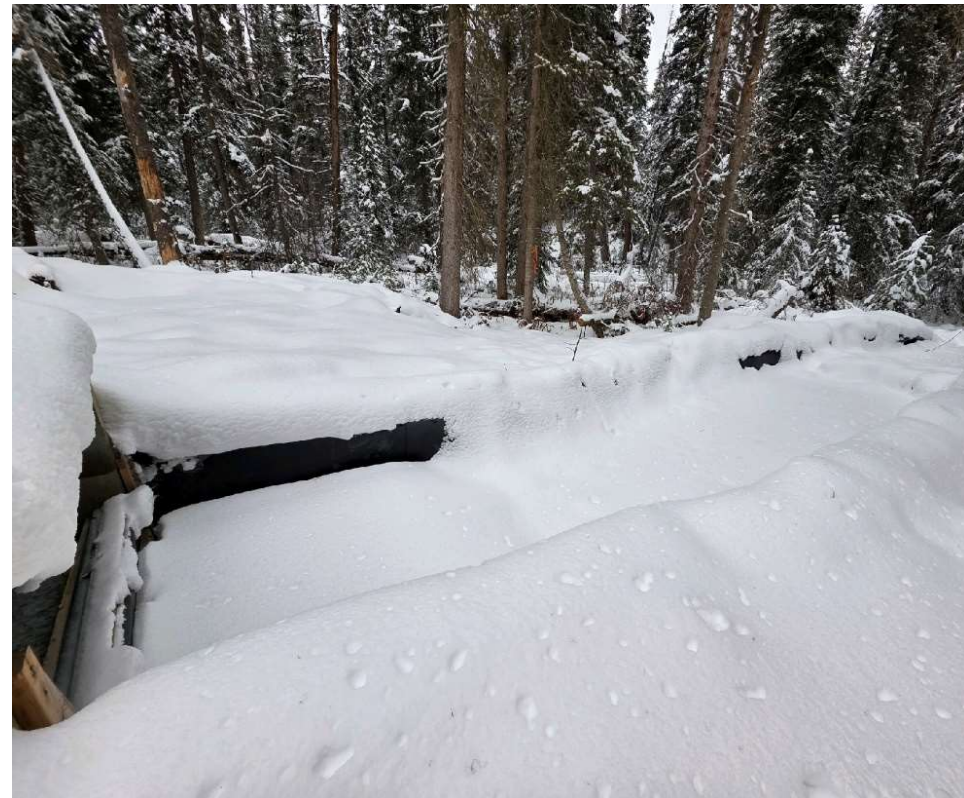
During the IEM team’s visit to site, the WMP outfall structure (which discharges to Davidson Creek) was visited. At the time of the visit, the IEM team did not observe flows from the structure into Davidson Creek which BWG indicated was due to freezing temperatures impacting the ability to utilize pumps (Photo 113127-1). Following onsite discussions, despite the WMP outfall not discharging water to the Davidson Creek system, BWG indicated downstream flows to Davidson Creek continued to be fed from Watercourse 668 and ground infiltration. BWG indicated they were working towards getting the pumps back online and anticipated this would be completed shortly.	No
Originally, it was planned that during the site visit, the IEM and First Nations representatives would join BWG’s environmental staff during the collection of one of the monthly surface water collection points located near the operations camp (known as sample location 661-04). However, due to weather conditions present during the time of the visit (heavy snowfall), the site was not able to be visited. As sample collection point 661-04 is a sample location that is to be collected monthly, the IEM submitted a request for information (RFI) inquiring whether the sample would be collected prior to months end.	No

Photo 113127-1. WMP outfall structure (which discharges to Davidson Creek). Observed to not be operating at time of visit due to frozen pumps.

BWG provided a response on February 21, 2025 which confirmed the sample would be collected and submitted to the lab for analysis prior to months end.	
Tailings Storage Facility	
During the site visit, the discharge point at the terminus of the tailings discharge pipeline (currently located downstream of the Central Water Transfer Pond) was observed to be operational and discharging tailings into the Tailings Storage Facility (TSF) (Photo 113133-1).	No
Water levels continue to rise upstream of the Davidson Creek Diversion Structure (DCDS) within the TSF (Photo 113132-5). Following onsite discussions with BWG, it is understood water collecting within the TSF area is being pumped back to the plant site (to be utilized as process water) through a barge pump station located upstream of the DCDS.	No
Placement of ‘waste’ potentially acid generating (PAG) material generated from the ore body/open pit excavation continues in the area located immediately upstream of the TSF dam known locally as the ‘PAG dump’ (Photo 113132-1).	No
