**Blackwater Gold Mine
IEM Site Visit Report 026
January 27 – 28, 2025**

Prepared By
EDI Environmental Dynamics Inc.
3810 18th Ave
Prince George BC V2N 4V5

EDI Project
21P0403
January 2025

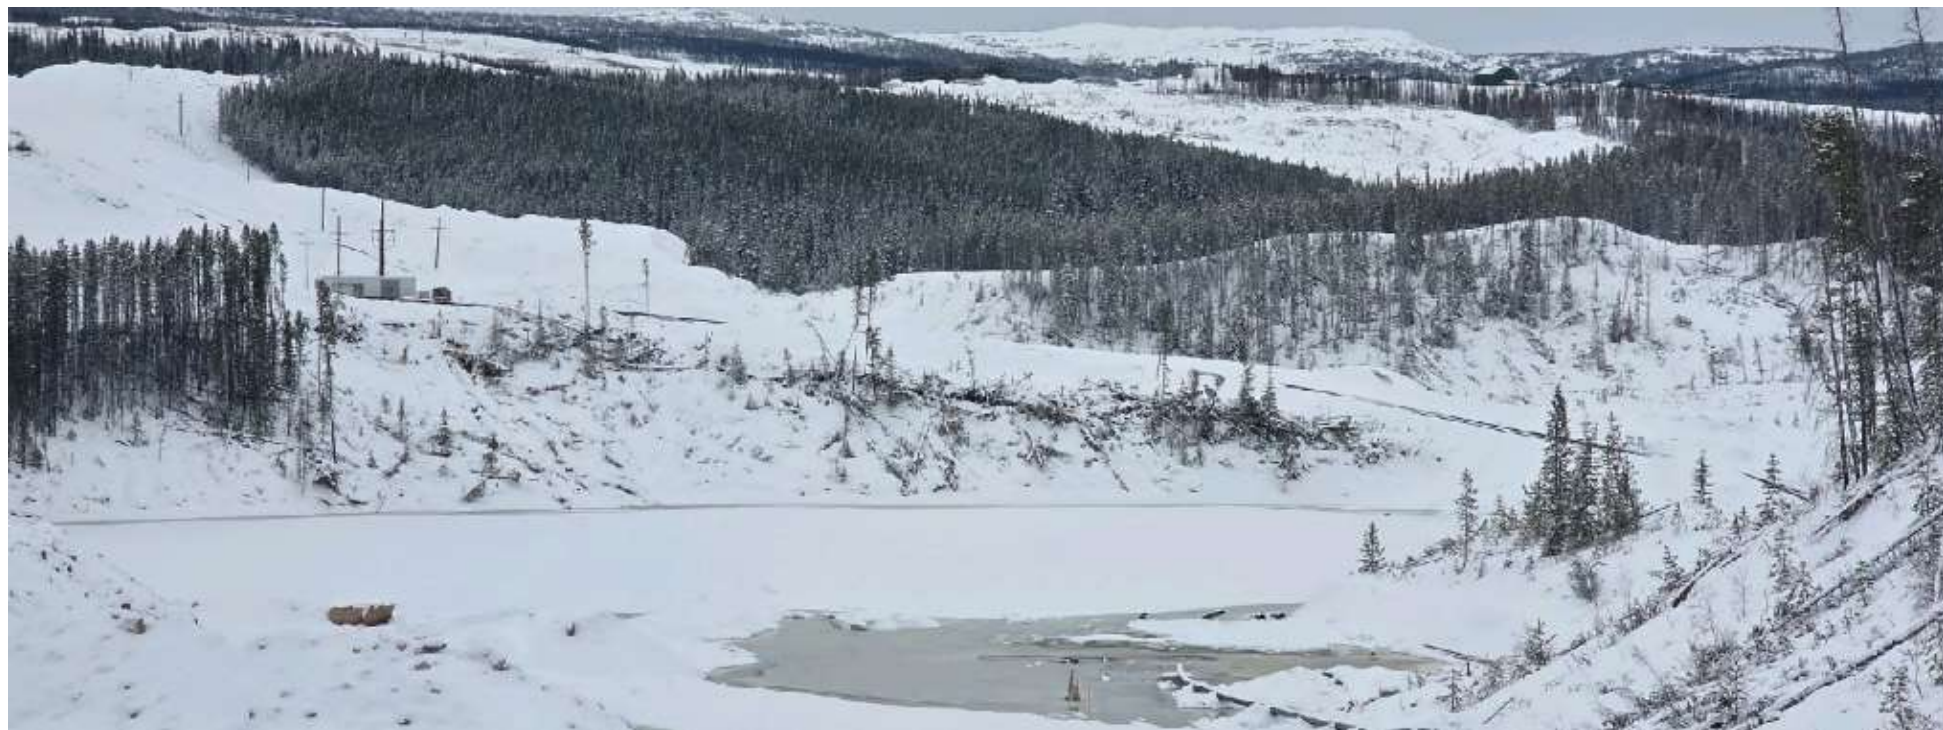
Photo 113132-5. Water accumulation upstream of the DCDS. Barge pump in place sending water to plant site upstream of photo (out of frame and unable to be observed due to access constraints).

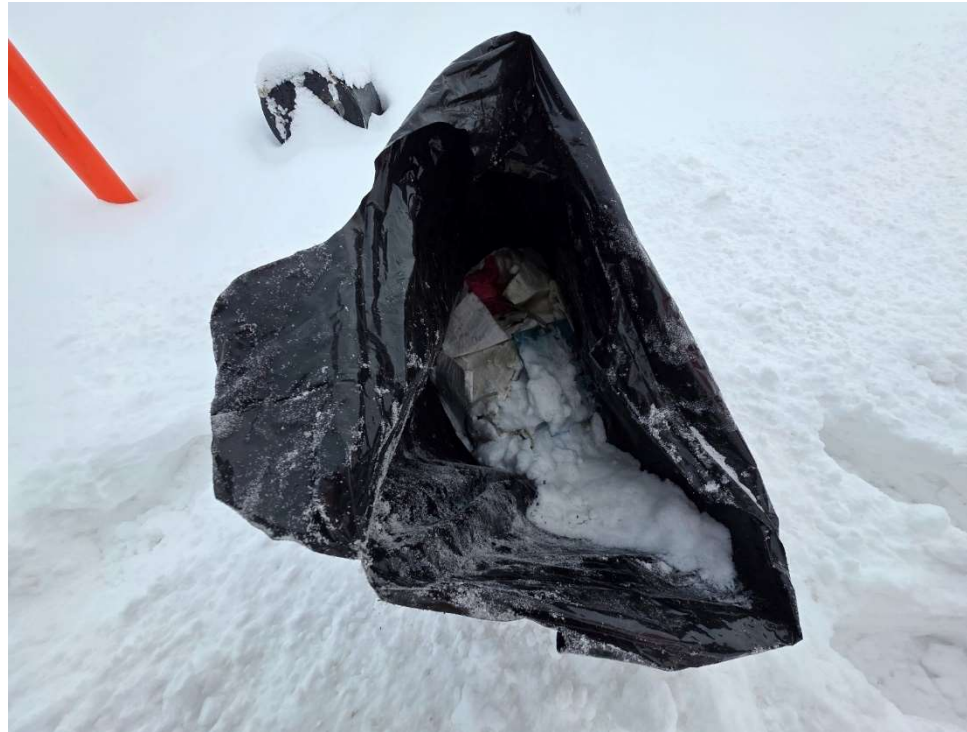
Photo 113122-4. Used spill clean up materials (hydrocarbon contaminated) in open top bag at equipment laydown known locally as 'Andrews Hill.' Bag removed and disposed of by BWG staff during site visit.

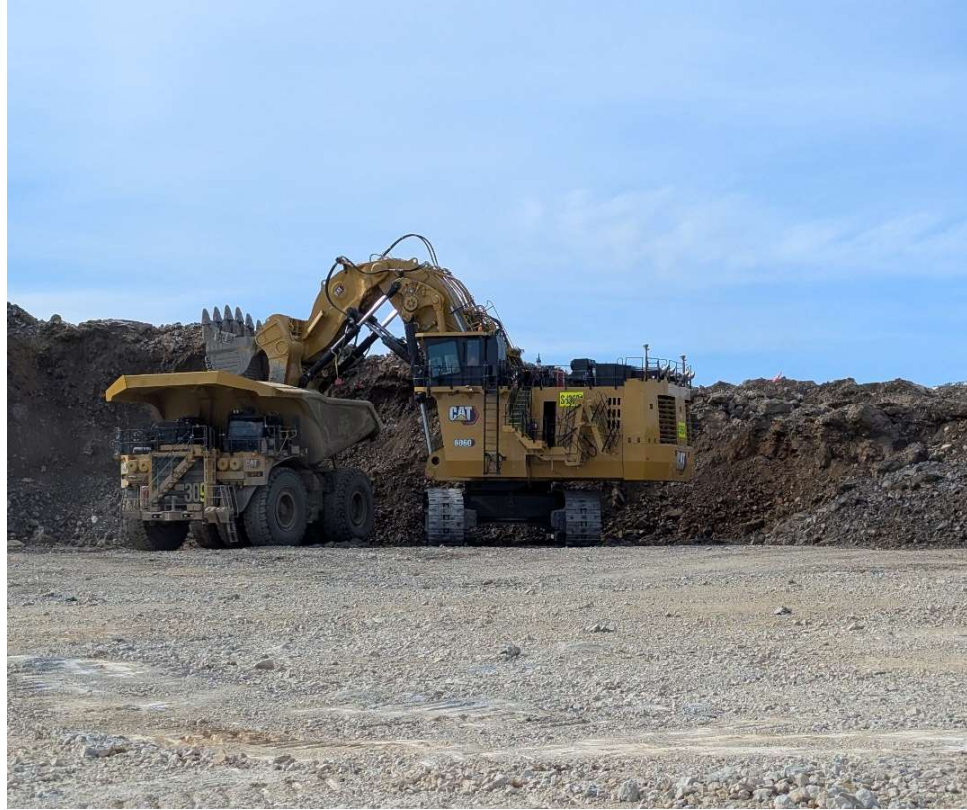
Photo 113325-5. Excavation ongoing within the ore body/open pit.

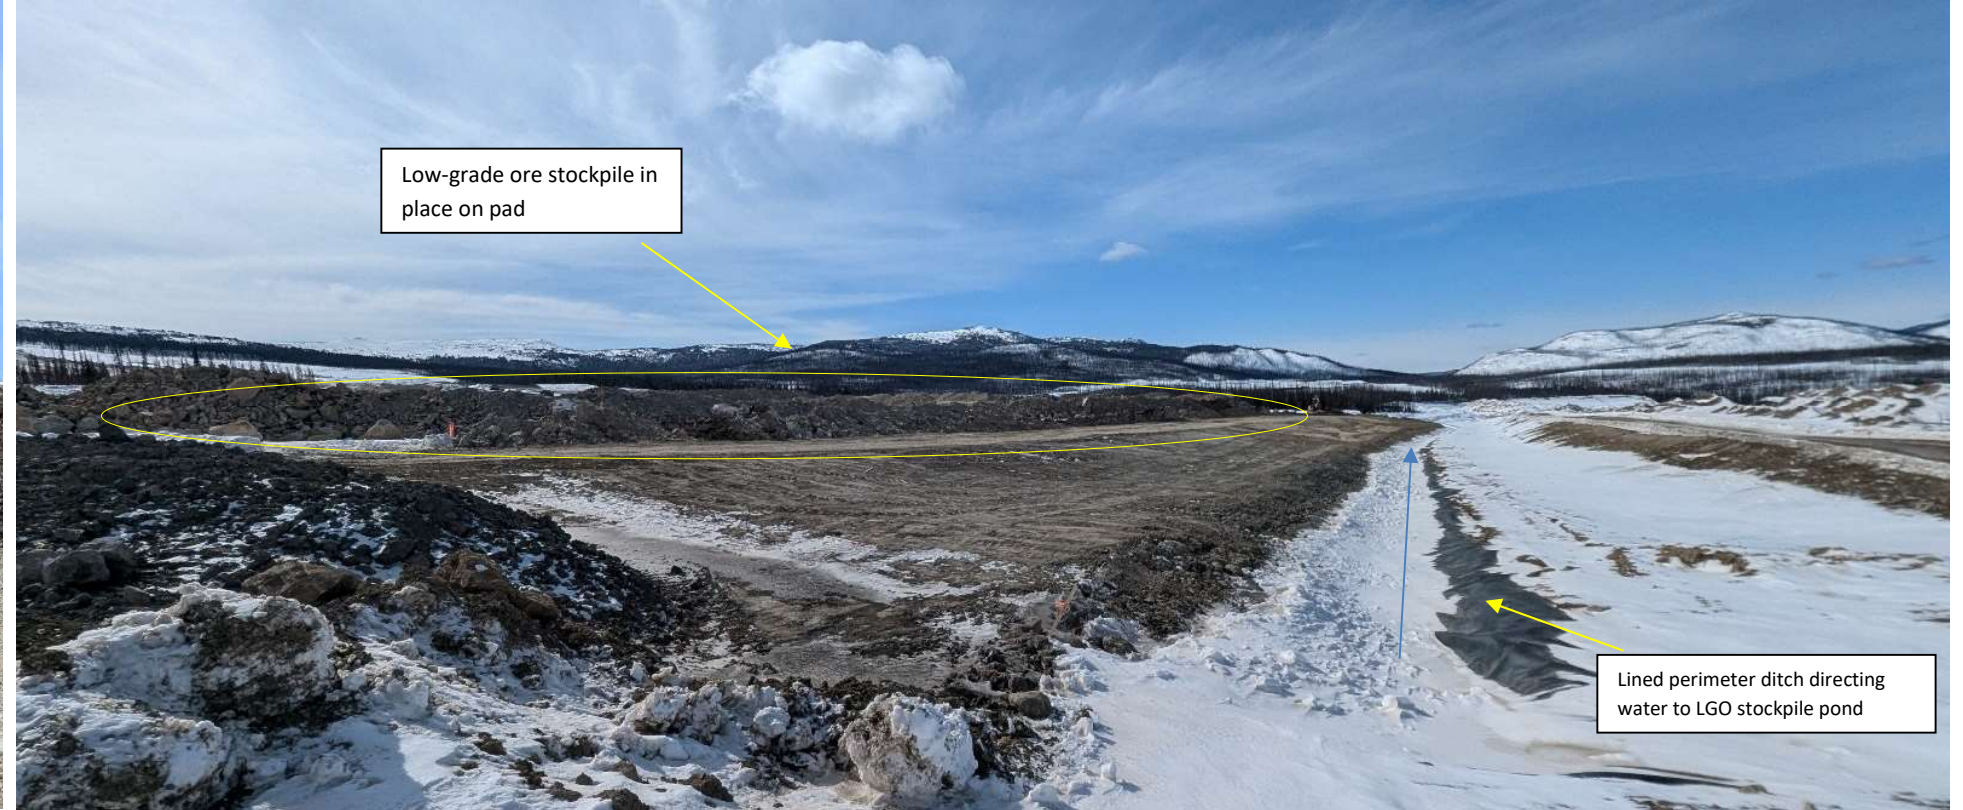
Photo 113327-3. Overview of completed portion of LGO stockpile pad.

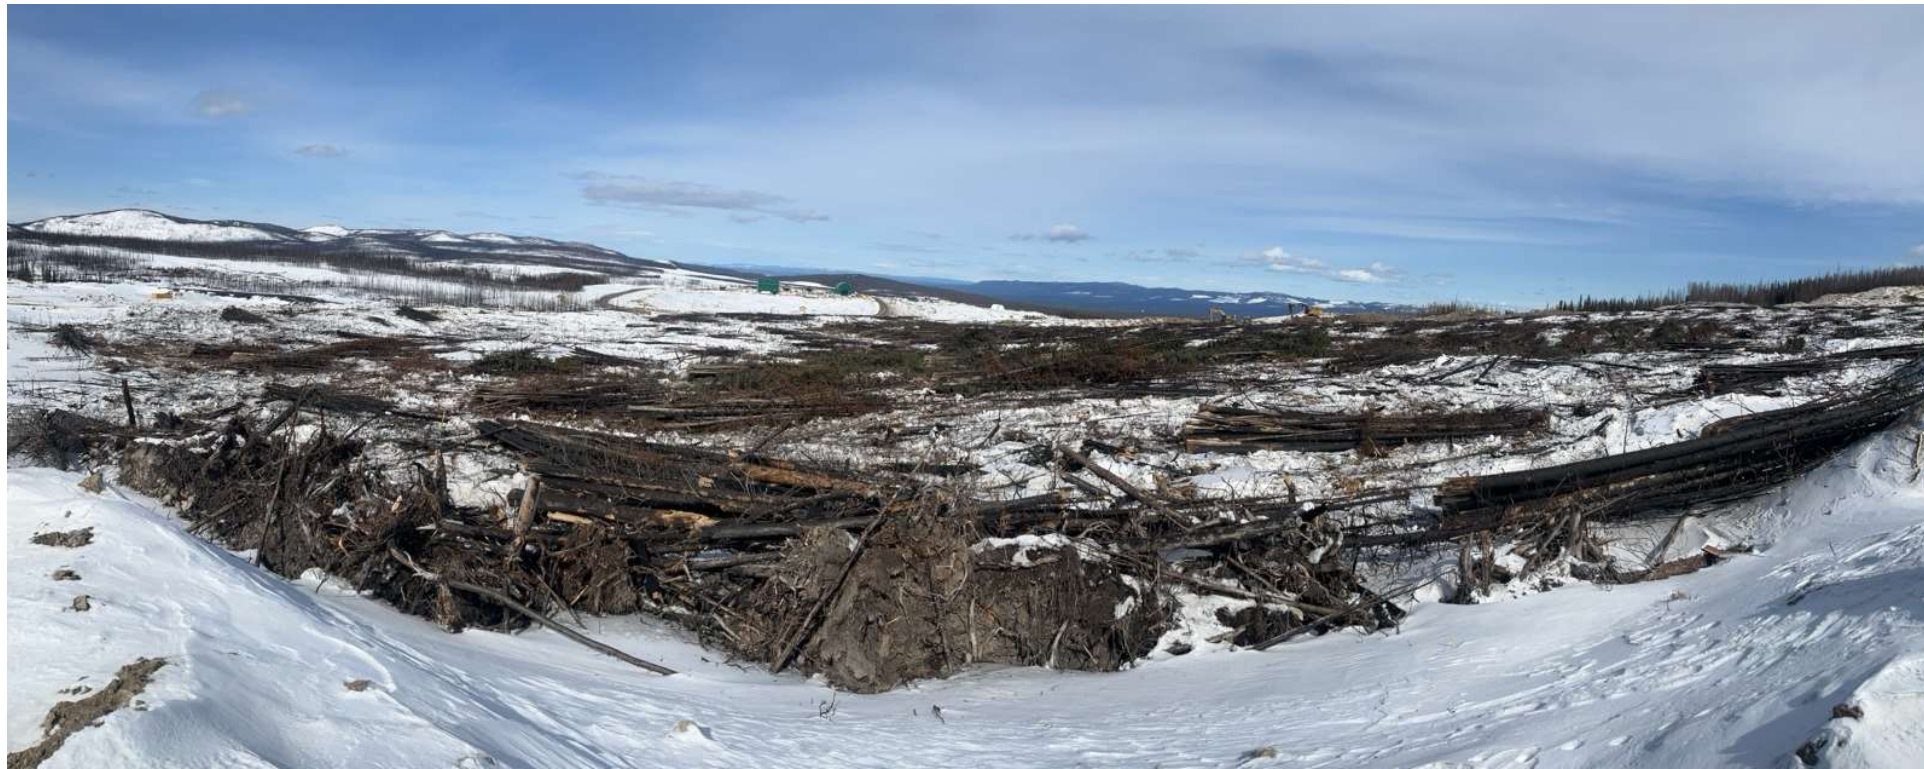
Photo 113324-2. Area recently cleared to accommodate development of Borrow Pit 4 as a source of additional 'zone s' till material to be utilized for further expansion of the LGO stockpile pad.

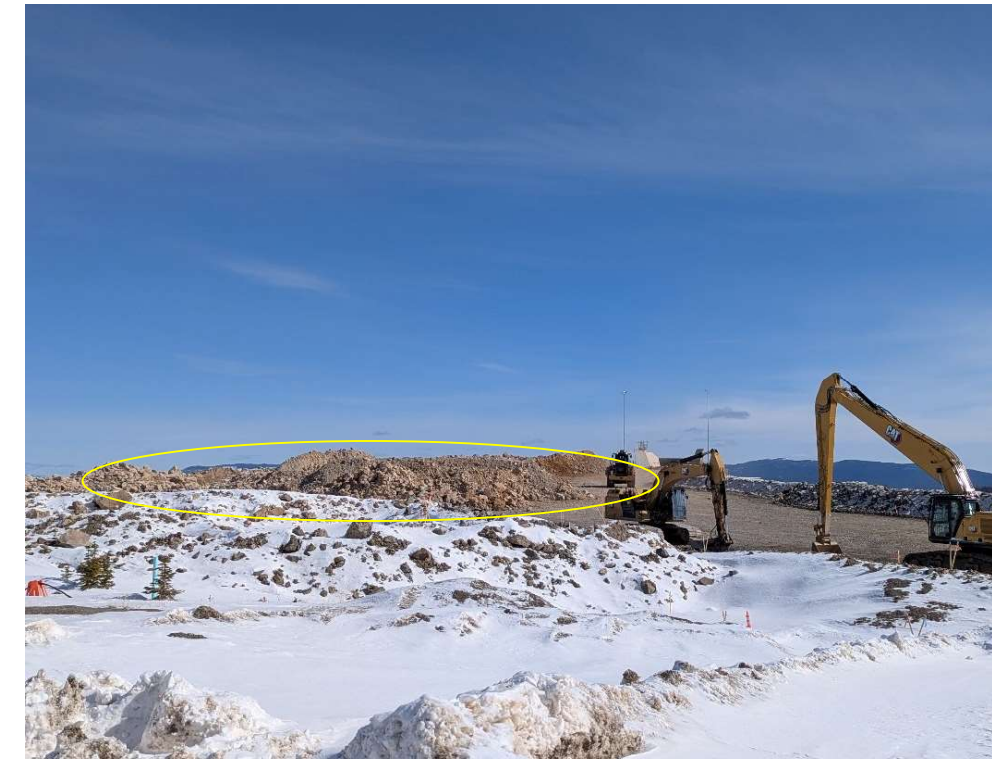
Photo 113344-3. High-grade ore stockpiled on the ROM pad being fed into the conveyor/crusher system.

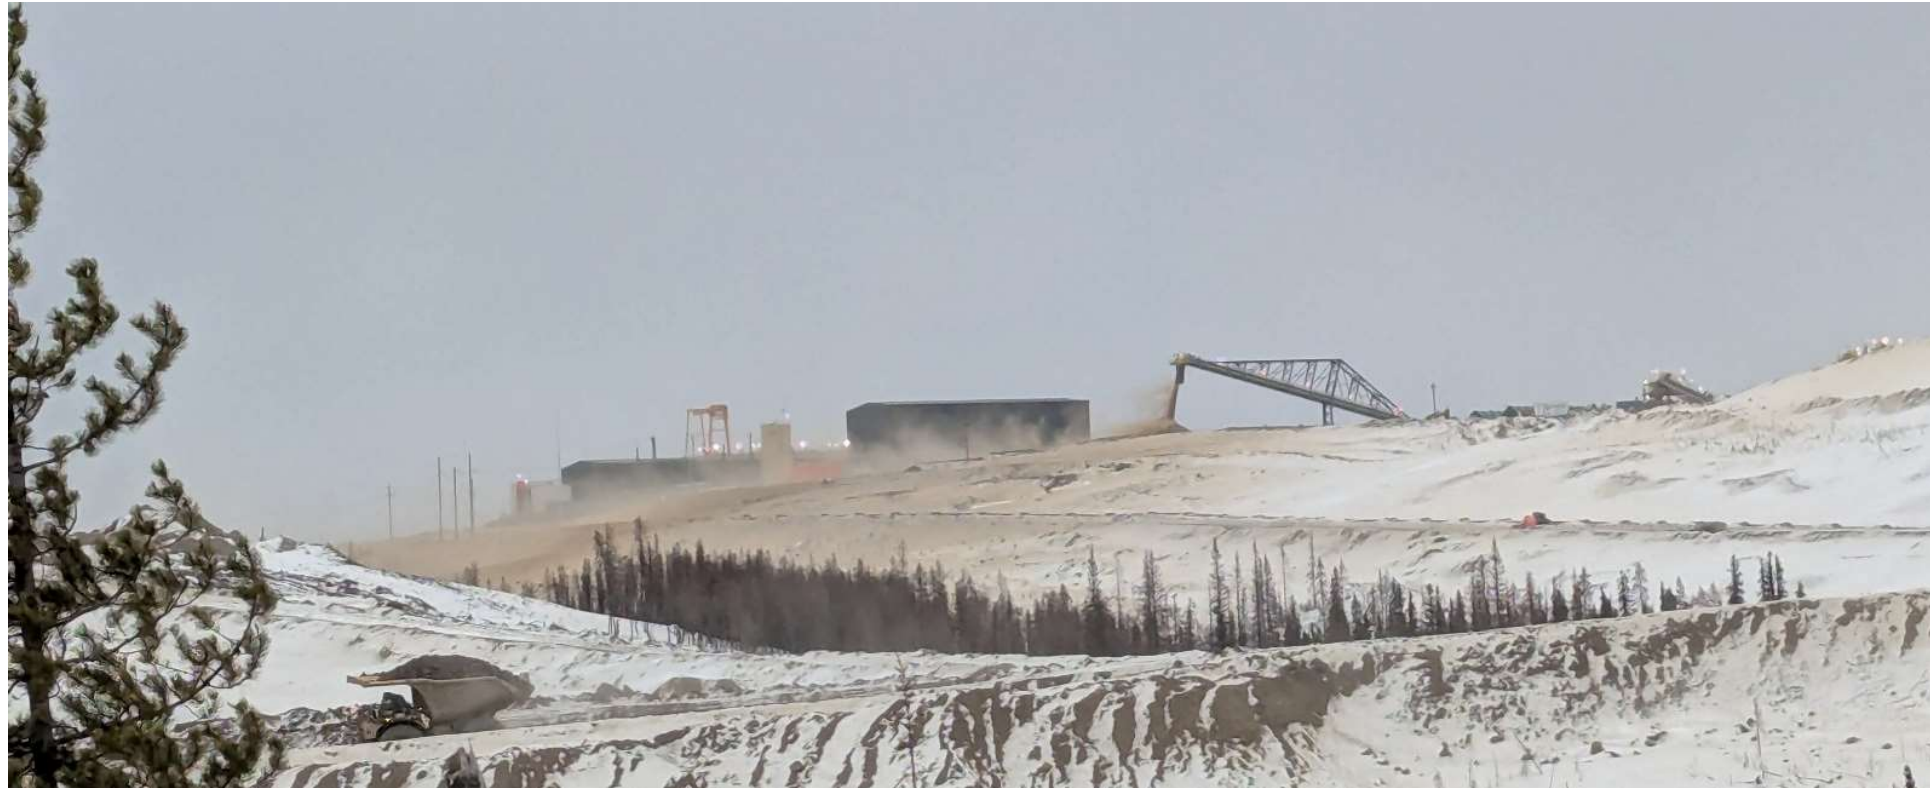
Photo 113363-5. Overview of high-grade ore dust generation from conveyor drop point at the Plant Site on March 19, 2025.

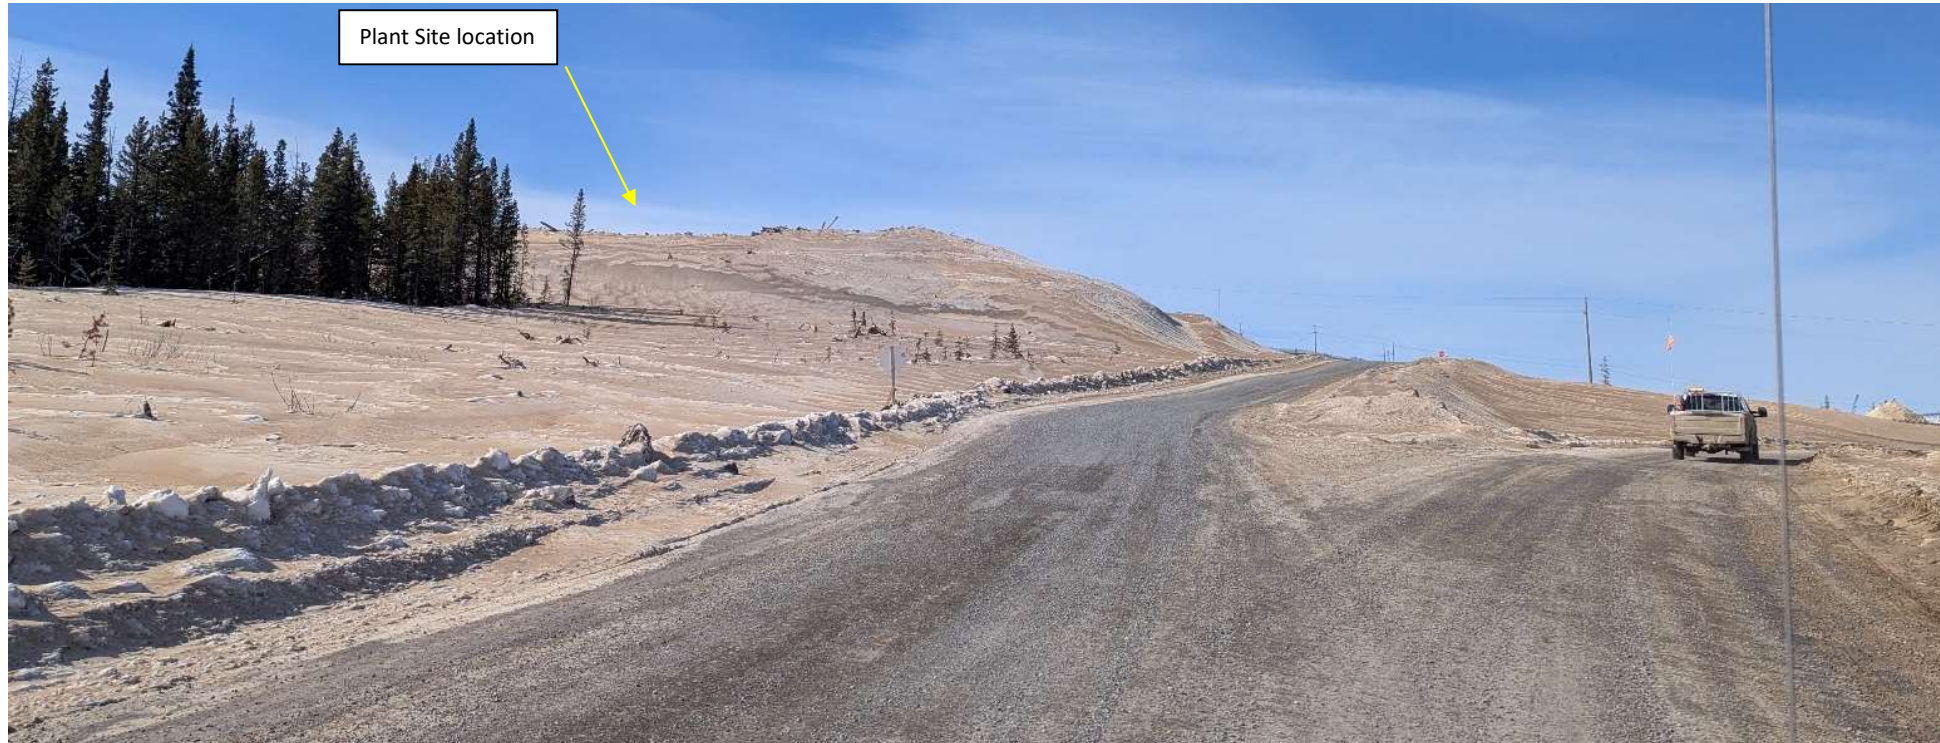
Photo 113340-6. Example of high-grade ore dust accumulation on top of snow northeast of plant along roadway towards operations camp on March 18, 2025. Plant Site location on top of hill in photo.

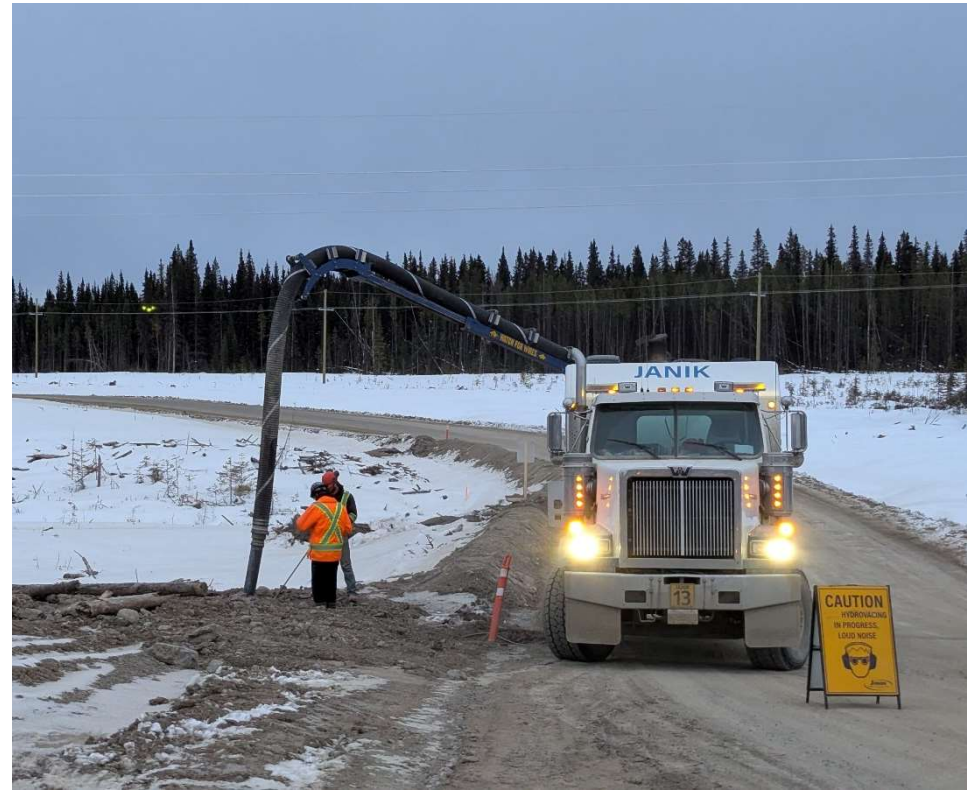
Photo 113345-3. Crews removing turbid water accumulation in sump adjacent to Watercourse 146 (as seen in photo 113343-1) to prevent overtopping.

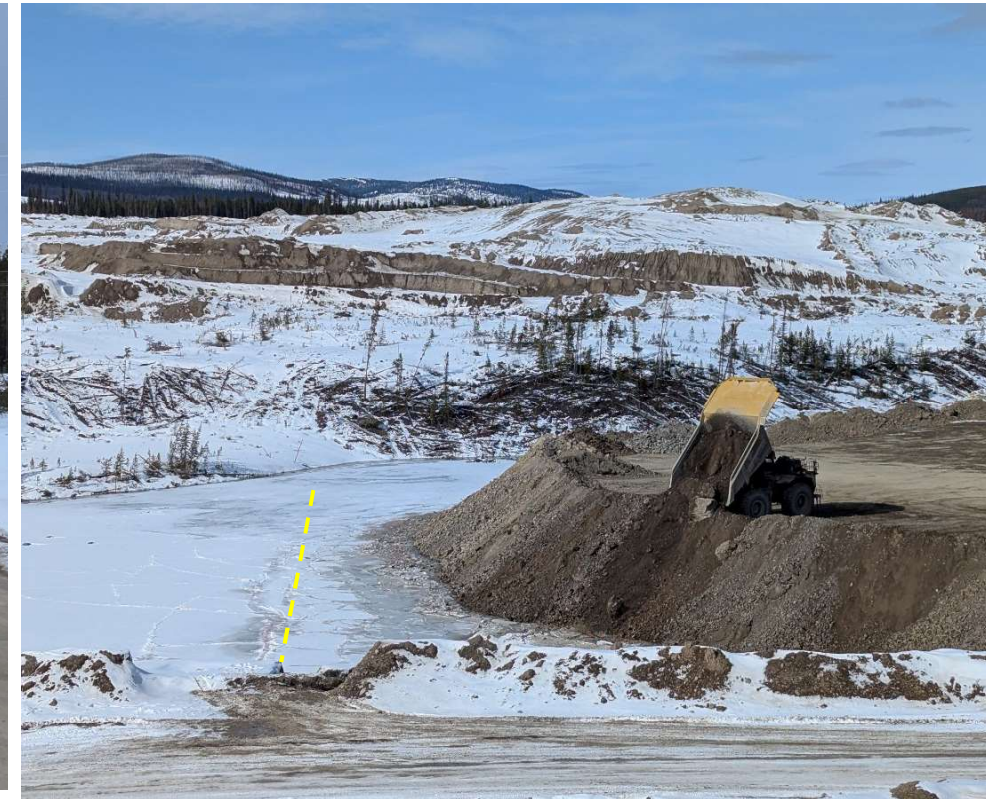
Photo 113330-1. PAG material being placed at the PAG Dump. Approximate centerline of former Davidson Creek Diversion Structure (now under water) indicated on photo.

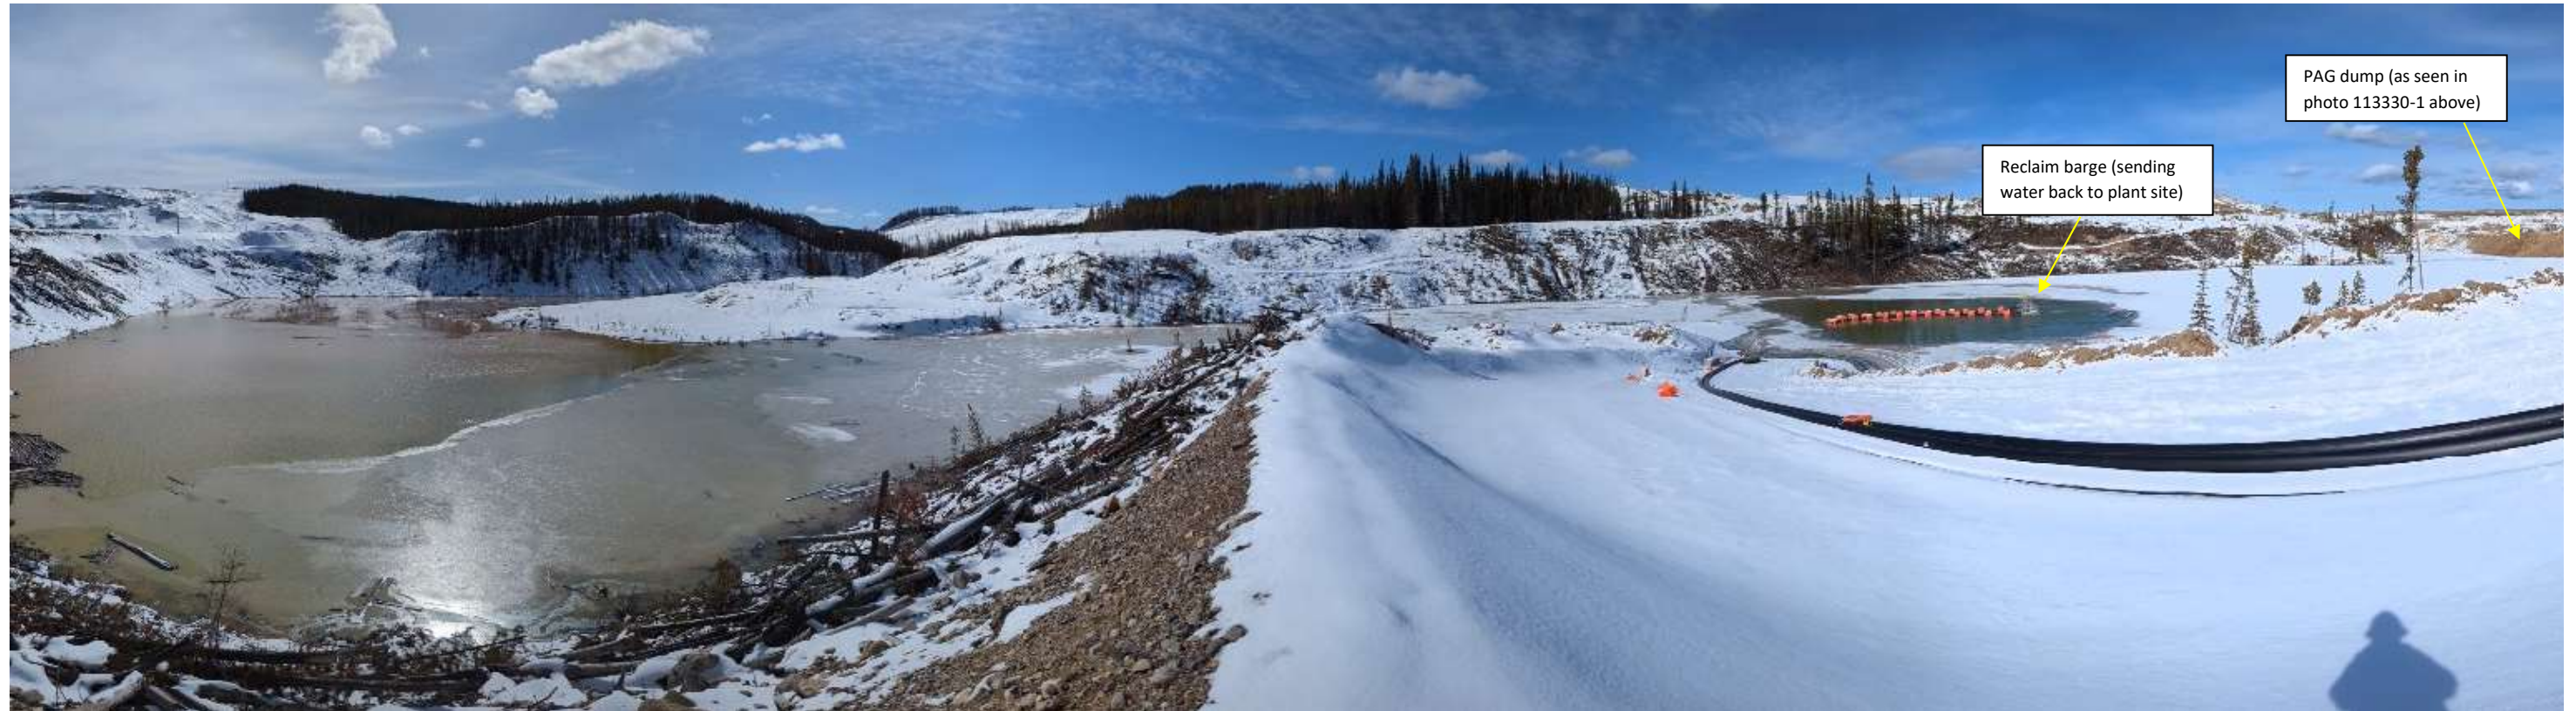
Photo 113323-2. Overview of lower portion of the Tailings Storage Facility. Water levels continue to increase and back up into the former Davidson Creek valley (left side of photo).

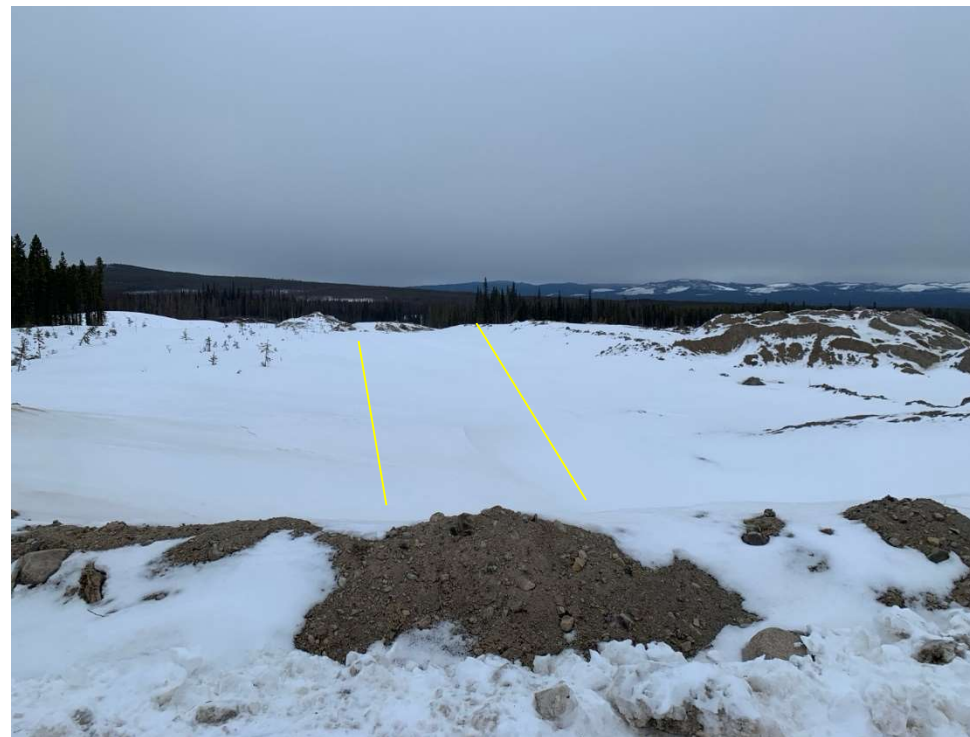
Photo 113351-2. Overview of snow filled north diversion ditch. Plowed access not available at time of visit due to recent snowfall, however BWG plan to re-establish access imminently.

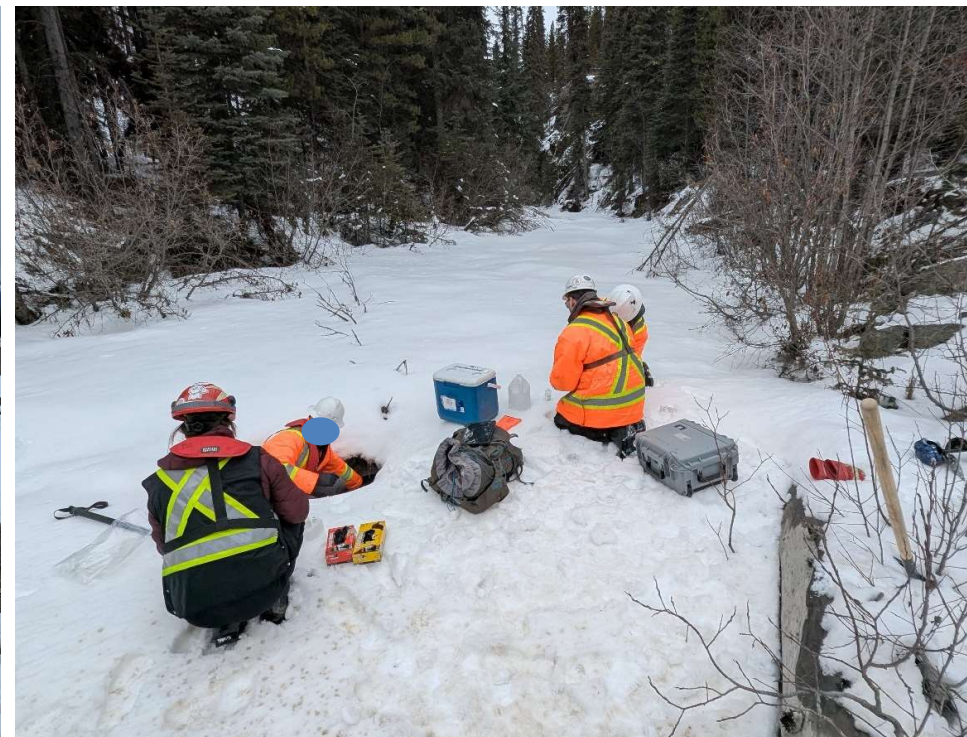
Photo 113364-8. Observing BWG staff collect a surface water sample at Fawnie Creek located at approximately 141.5km on the Kluskus Forest Service Road.

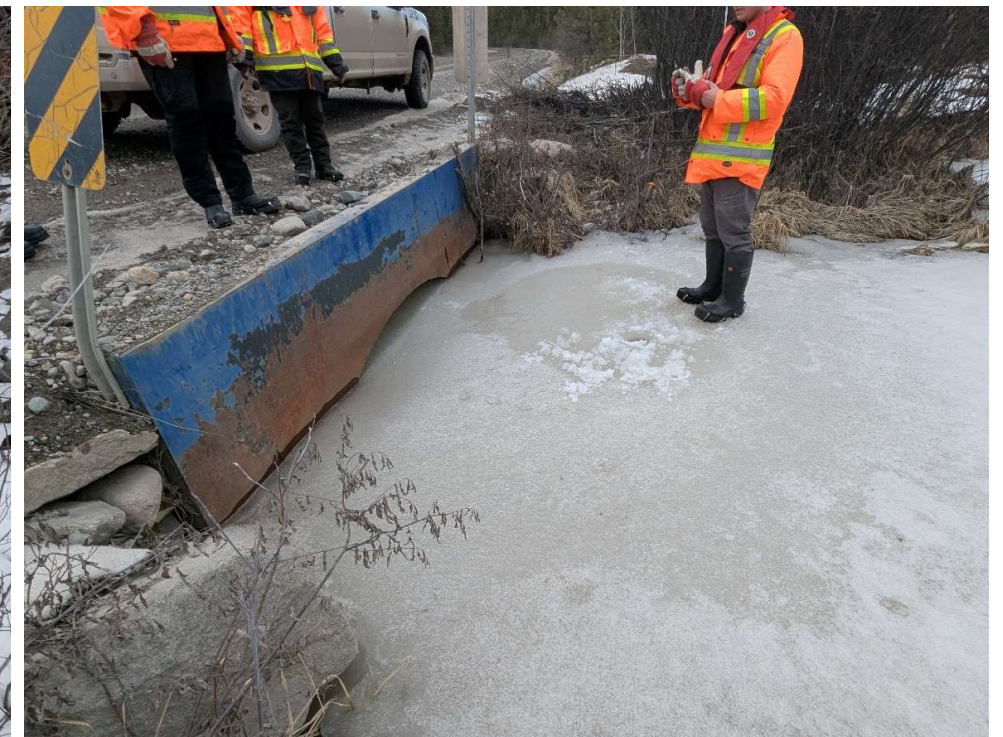
Photo 113365-2. BWG staff attempting to collect a surface water sample at Turtle Creek (located at km marker 119 on the Kluskus Forest Service Road), however, stream is frozen to bed and sample unable to be collected.

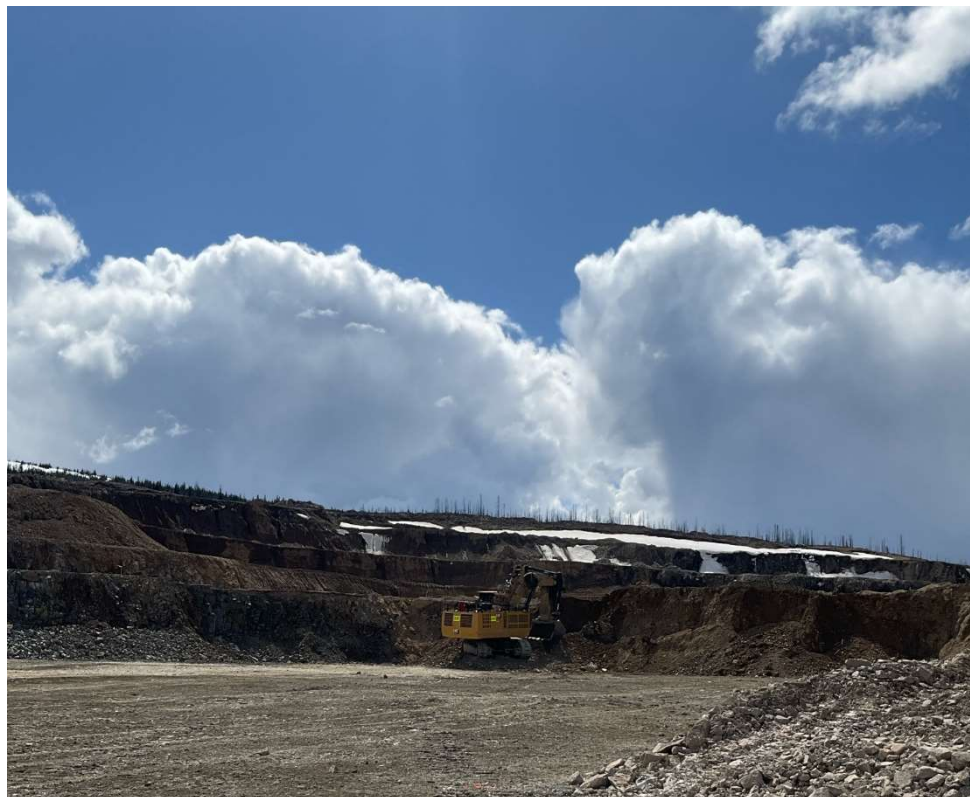
Photo 113686-1. Excavation and benching of slopes ongoing within the ore body/open pit.

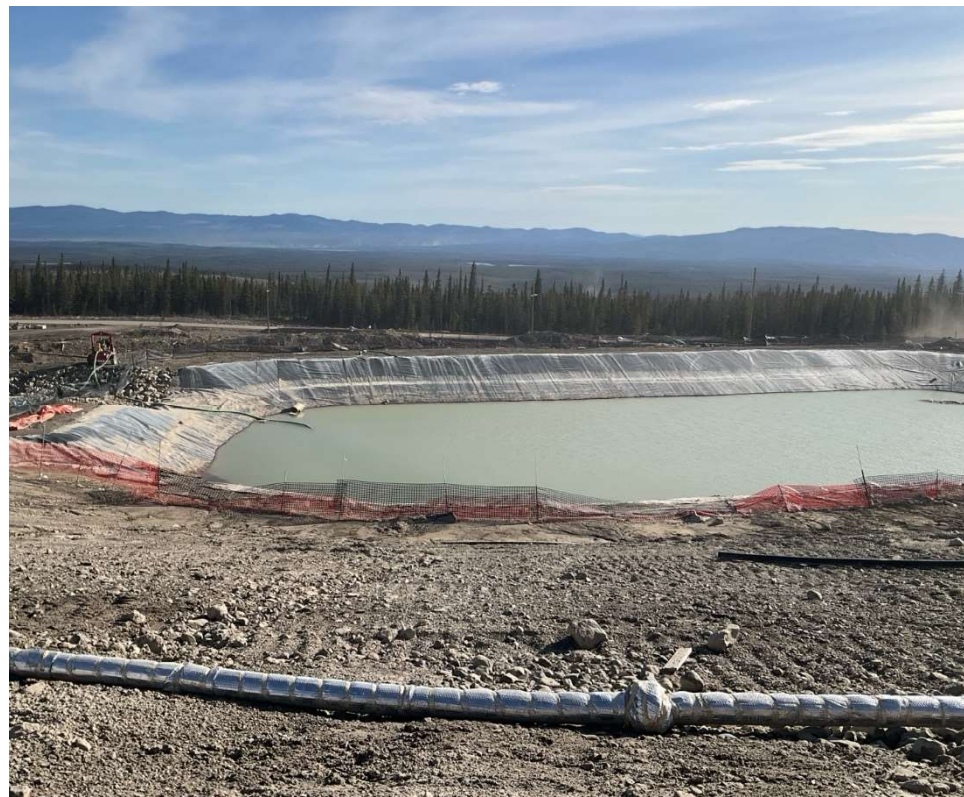
Photo 113700-1. Plant Site sediment control pond. The IEM team understands water being captured within this pond (impacted by PAG dust material at the Plant Site) is being used as process water and not being discharged to the environment.

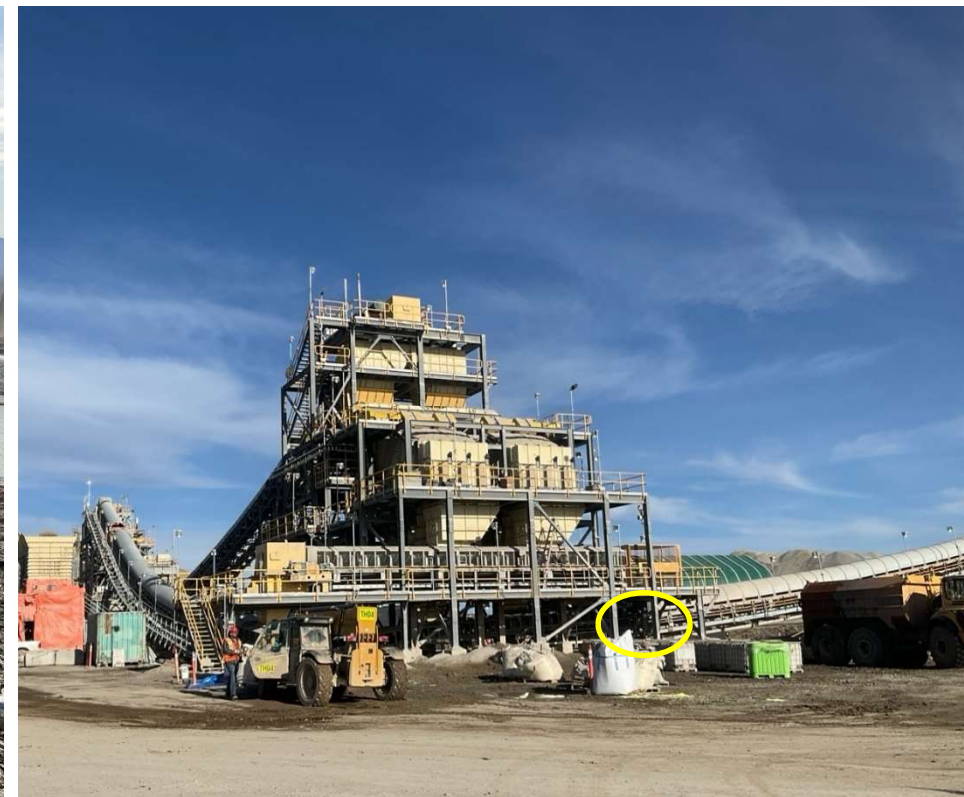
Photo 113701-1. Location on the crusher conveyor system where water is sprayed onto high grade ore prior to being stockpiled at the Plant Site.

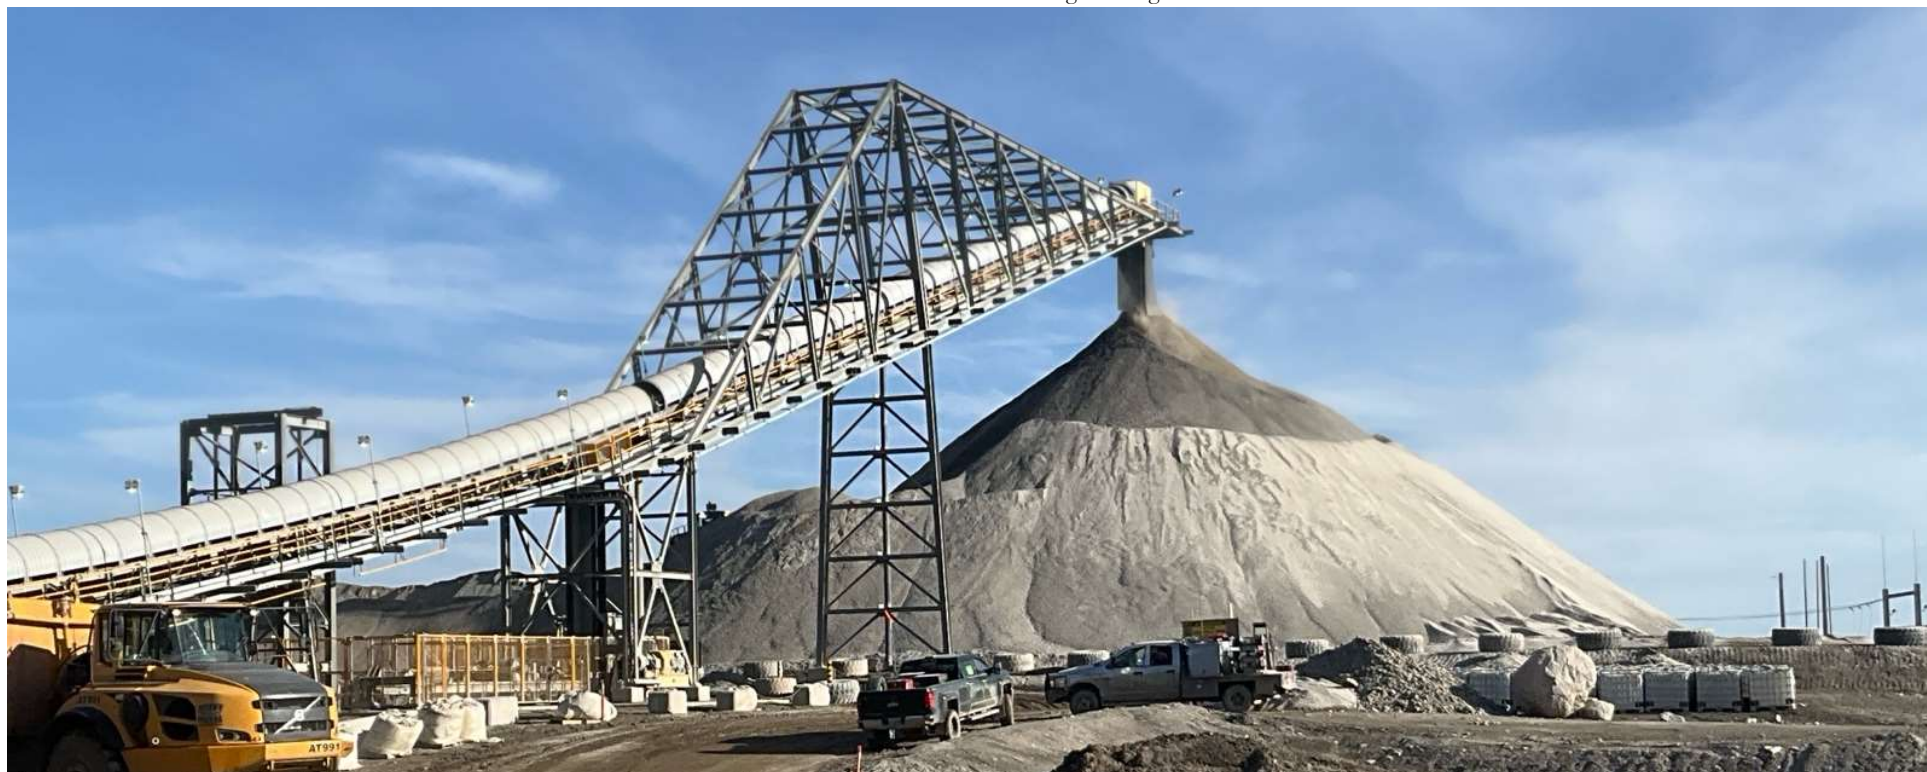
Photo 113701-2. Overview of the drop point to the stockpile at the terminus of the crusher conveyor circuit at the Plant Site.

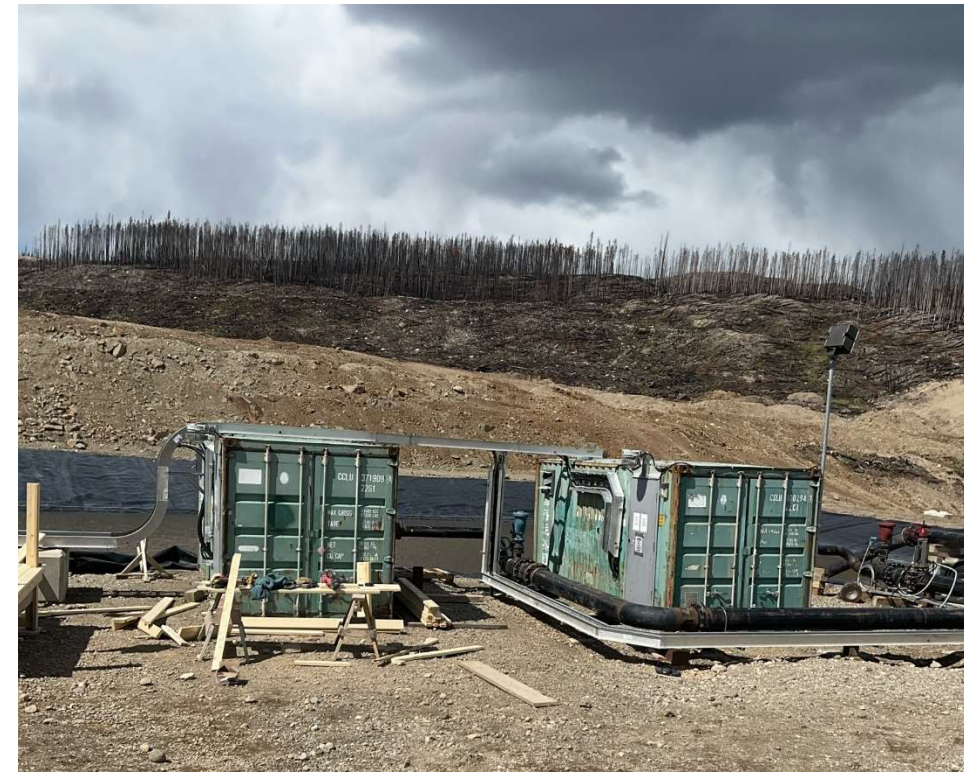
Photo 113688-2. Electric pump units installed at the CWTP to discharge water to Davidson Creek.

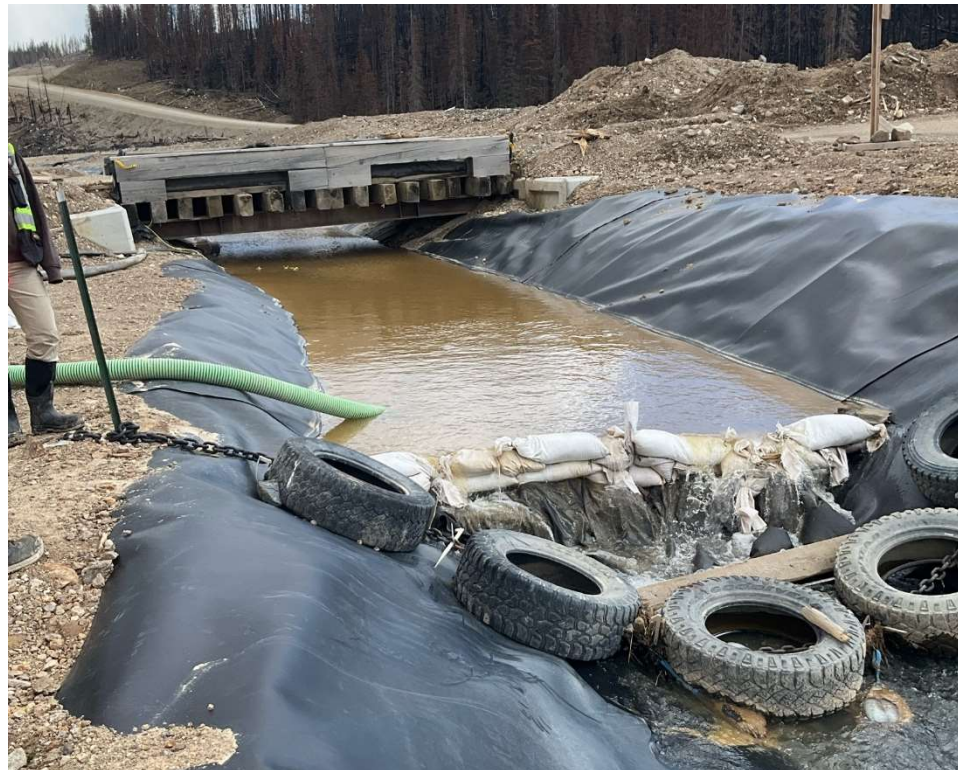
Photo 113688-1. Water flow within the south collection ditch which passively discharges into the CWTP. When turbidity levels become elevated, water can be pumped directly to the tailing's storage facility (via the pump line in place in photo).

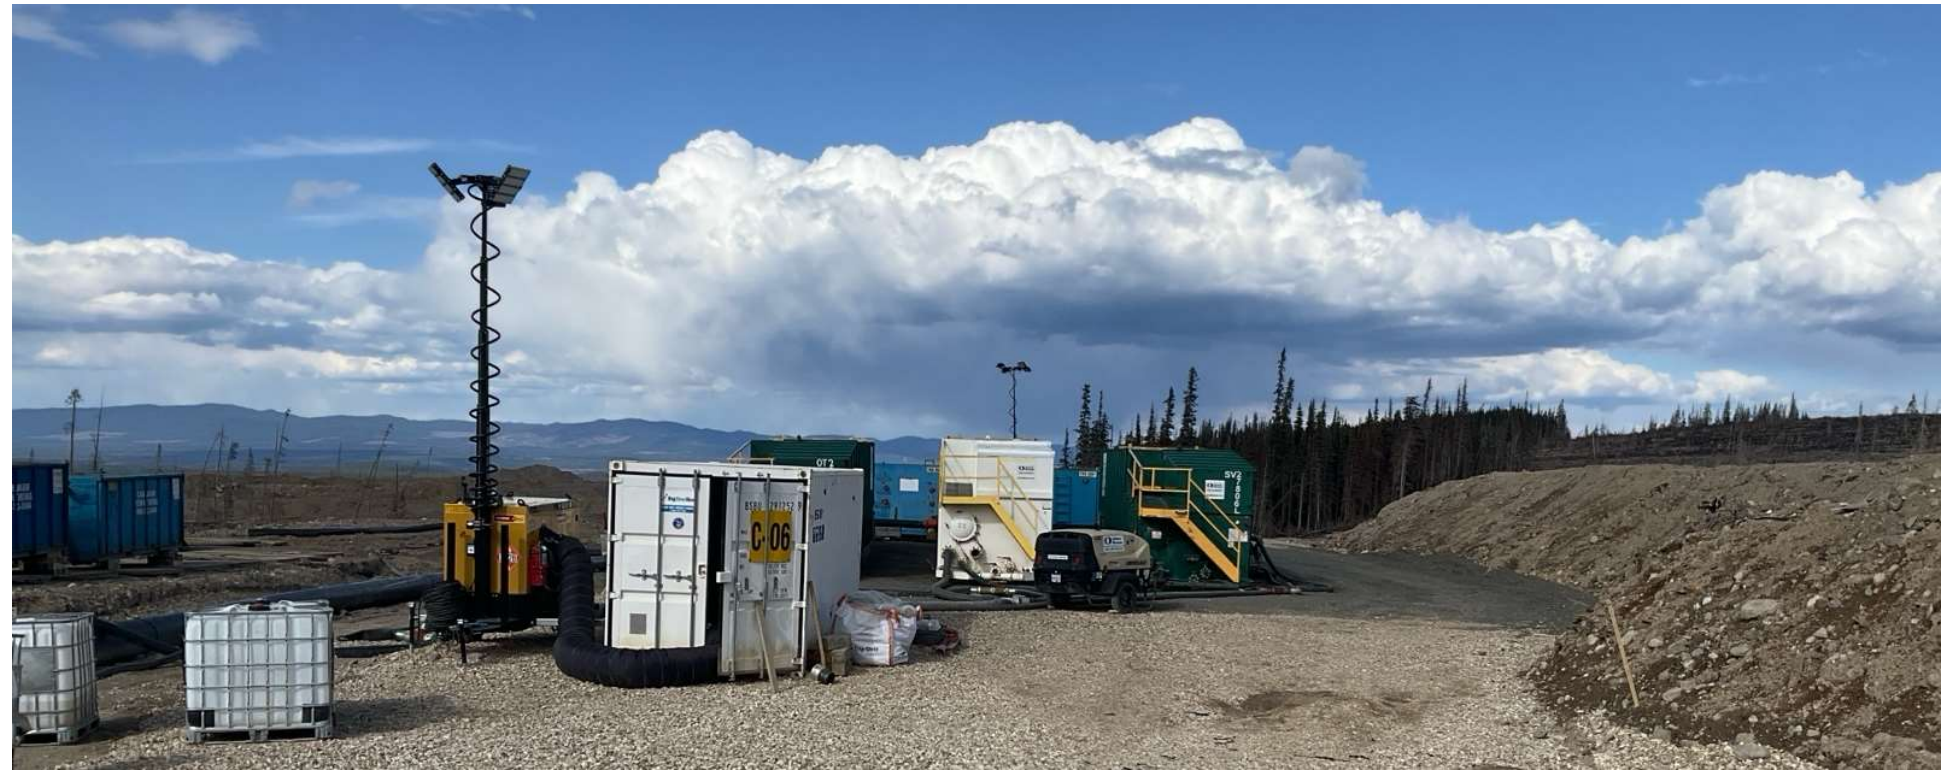
Photo 113697-2. Water treatment plant (clarifier) at the WMP to be utilized in the event water is required to be pumped to Davidson Creek.
