**Blackwater Gold Mine
IEM Site Visit Report 026
January 27 – 28, 2025**

Prepared By
EDI Environmental Dynamics Inc.
3810 18th Ave
Prince George BC V2N 4V5

EDI Project
21P0403
January 2025

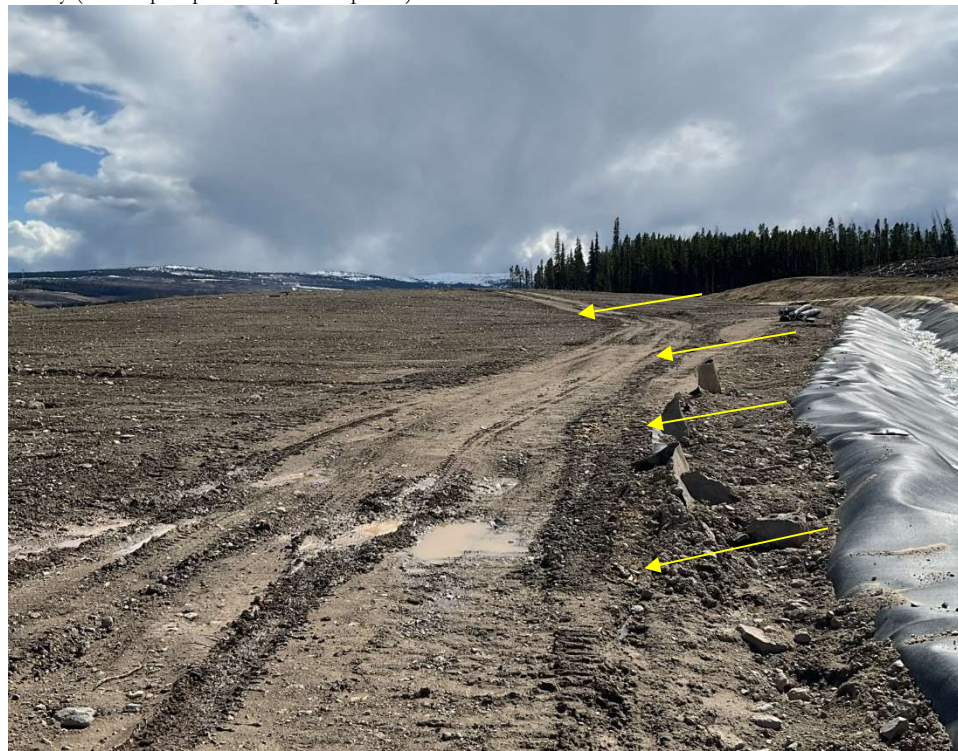
Photo 113690-1. Overview of area adjacent to the NDC following contouring to prevent water from running into ditch line. Direction of grading indicated on photo.

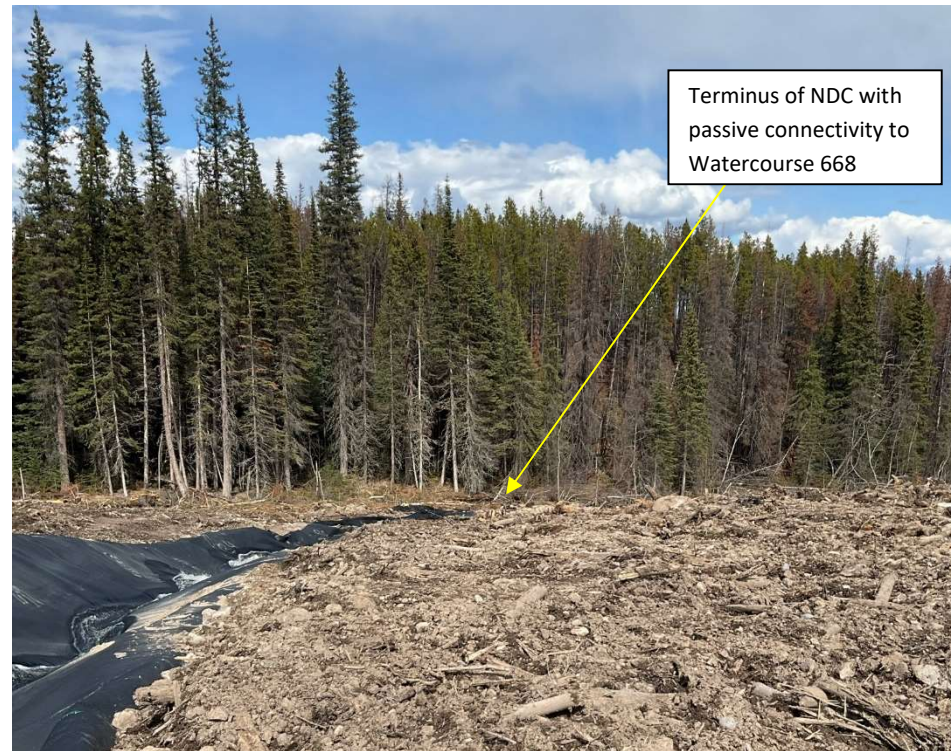
Photo 113691-3. Overview of the terminus of the NDC following application of topsoil and rough and loose surface application.

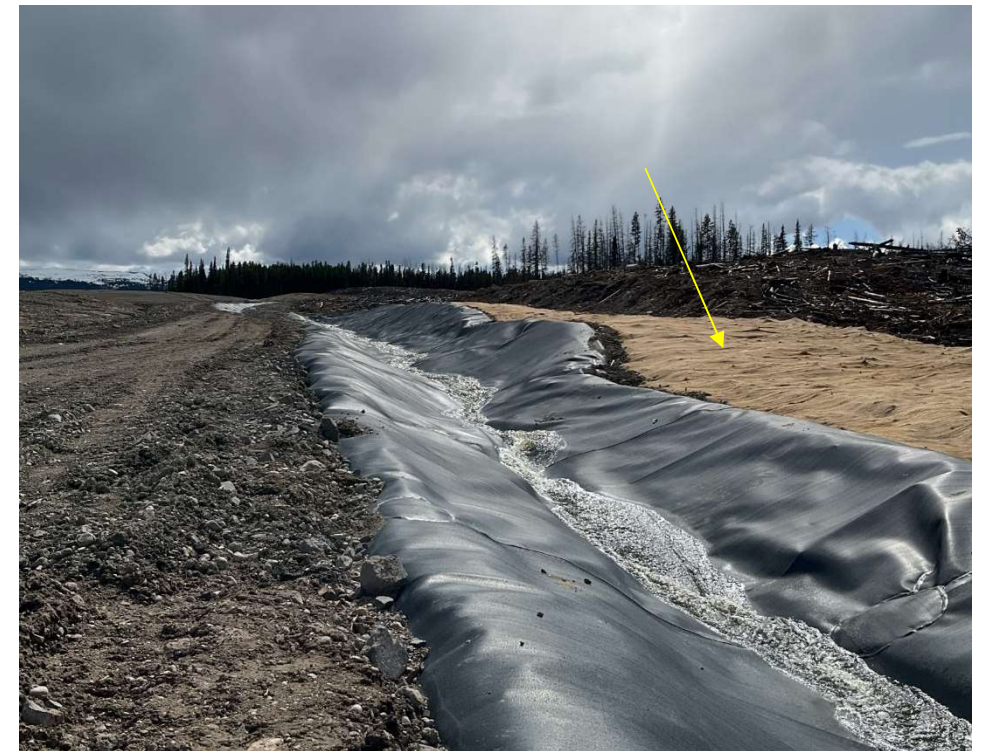
Photo 113691-4. Erosion control blankets installed along portion of high side of the NDC.

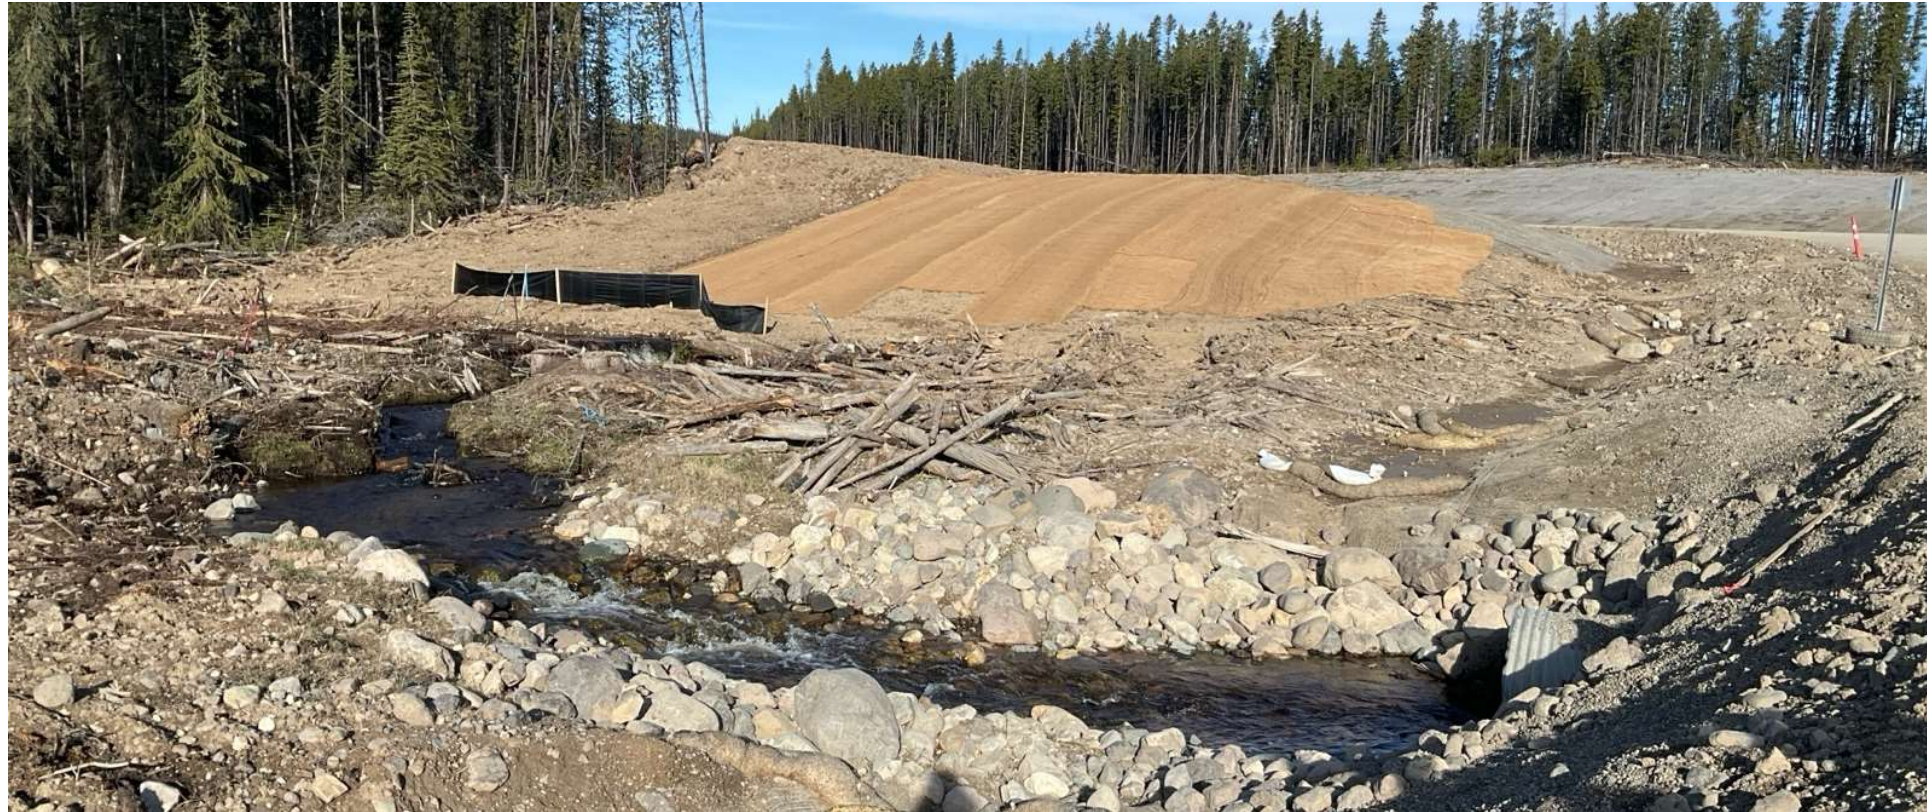
Photo 113699-1. Overview of Watercourse 146 crossing (on access road to Operations Camp). Water observed to be running clear at time of visit. Recently installed ESC measures (sediment fencing and erosion control blankets) also noted.

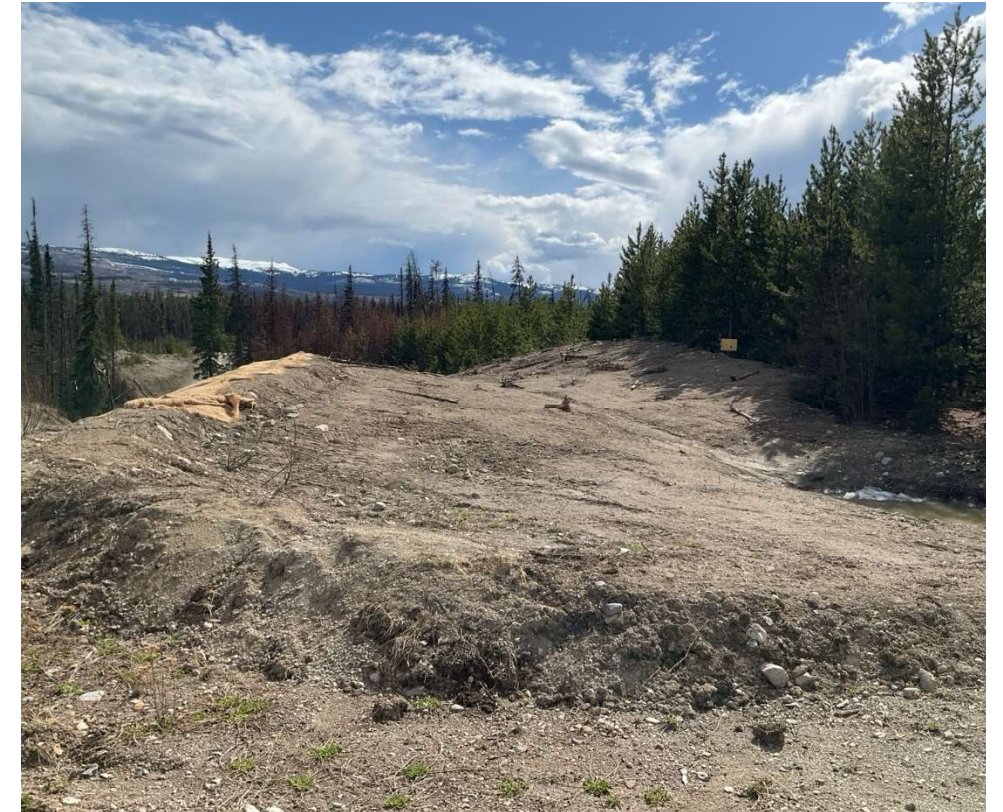
Photo 113696-2. Grading to direct water away from the slope adjacent to the C-Trail Access road crossing of watercourse 686 (km 9.5 bridge).

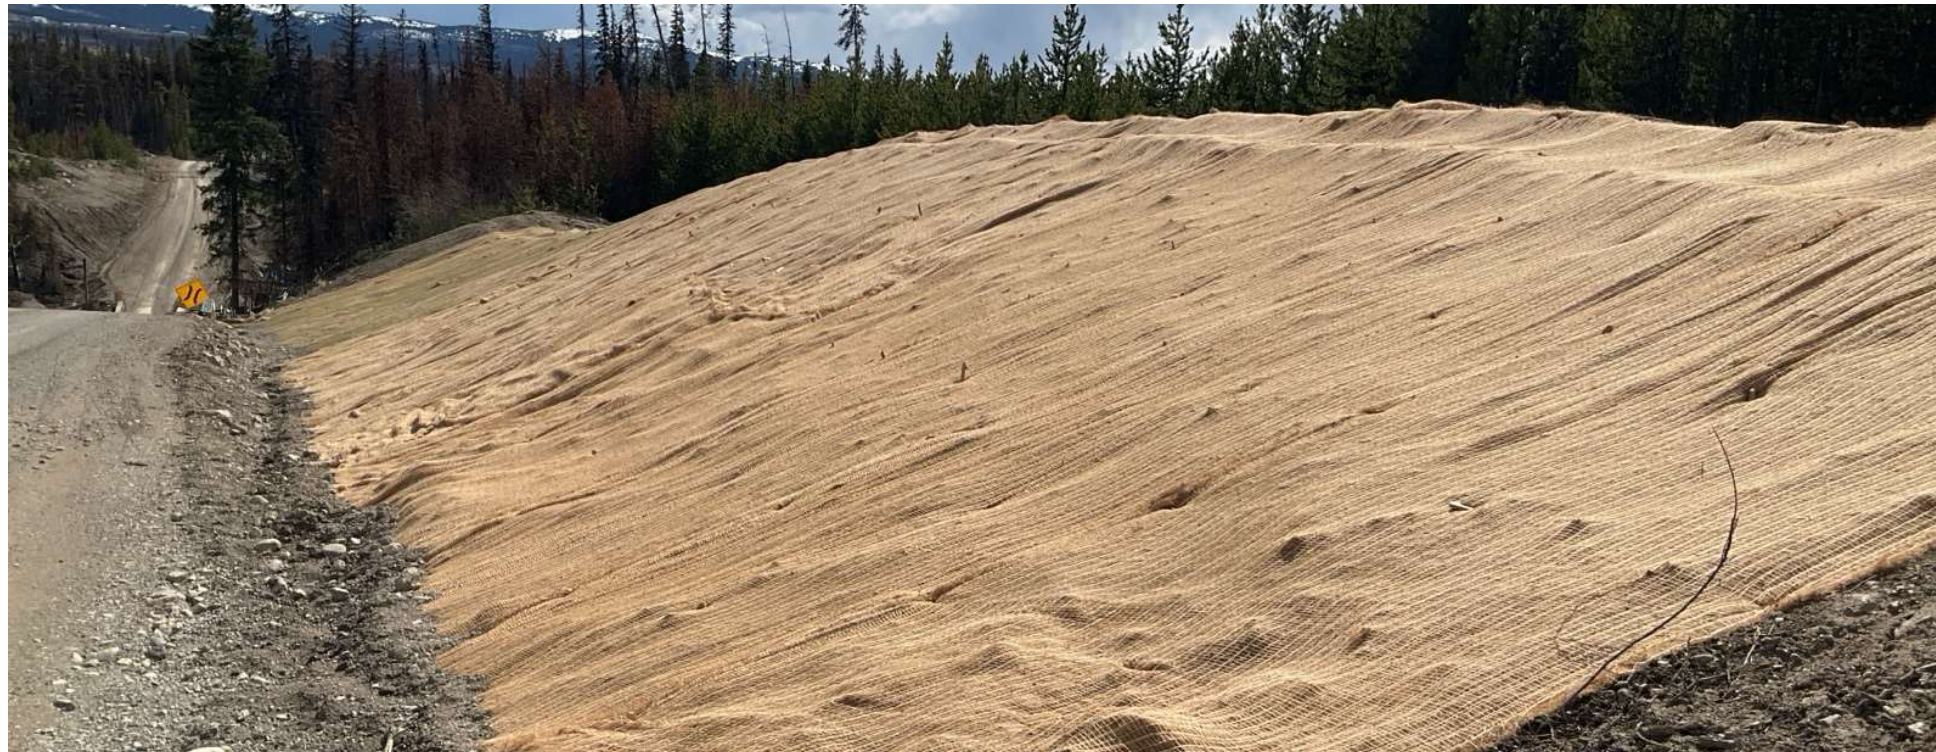
Photo 113696-5. Overview of additional erosion and sediment control blankets placed on slope along the C-Trail Access Road on approach to Watercourse 686 crossing.

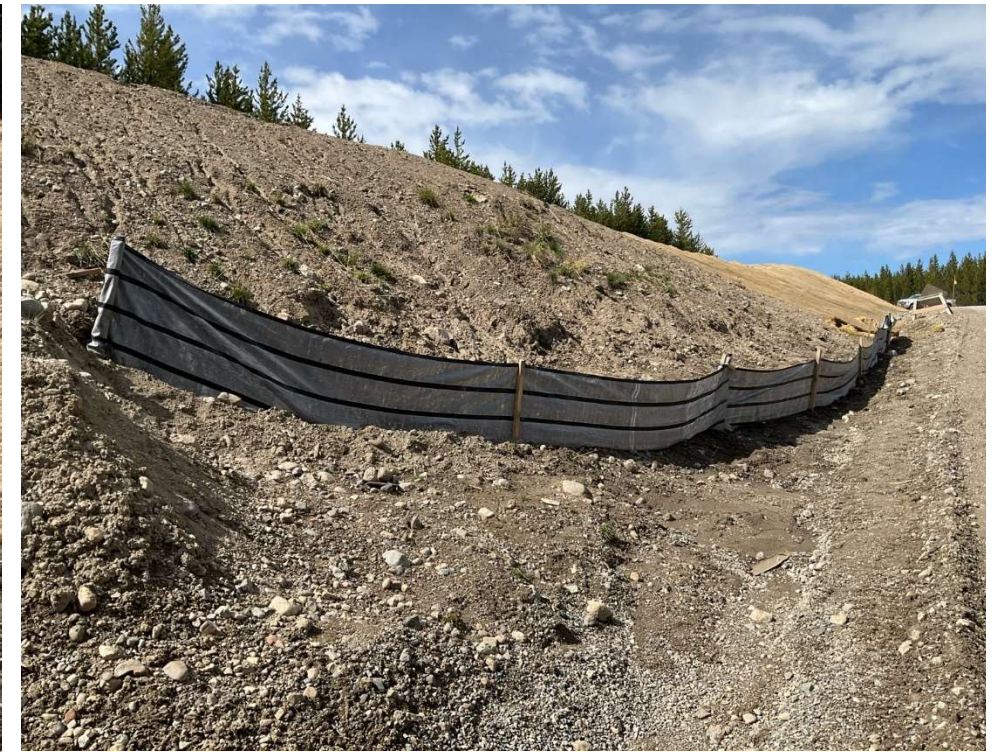
Photo 113696-3. Replacement sediment fencing installed on the slope along the C-Trail Access Road on approach to Watercourse 686 crossing.

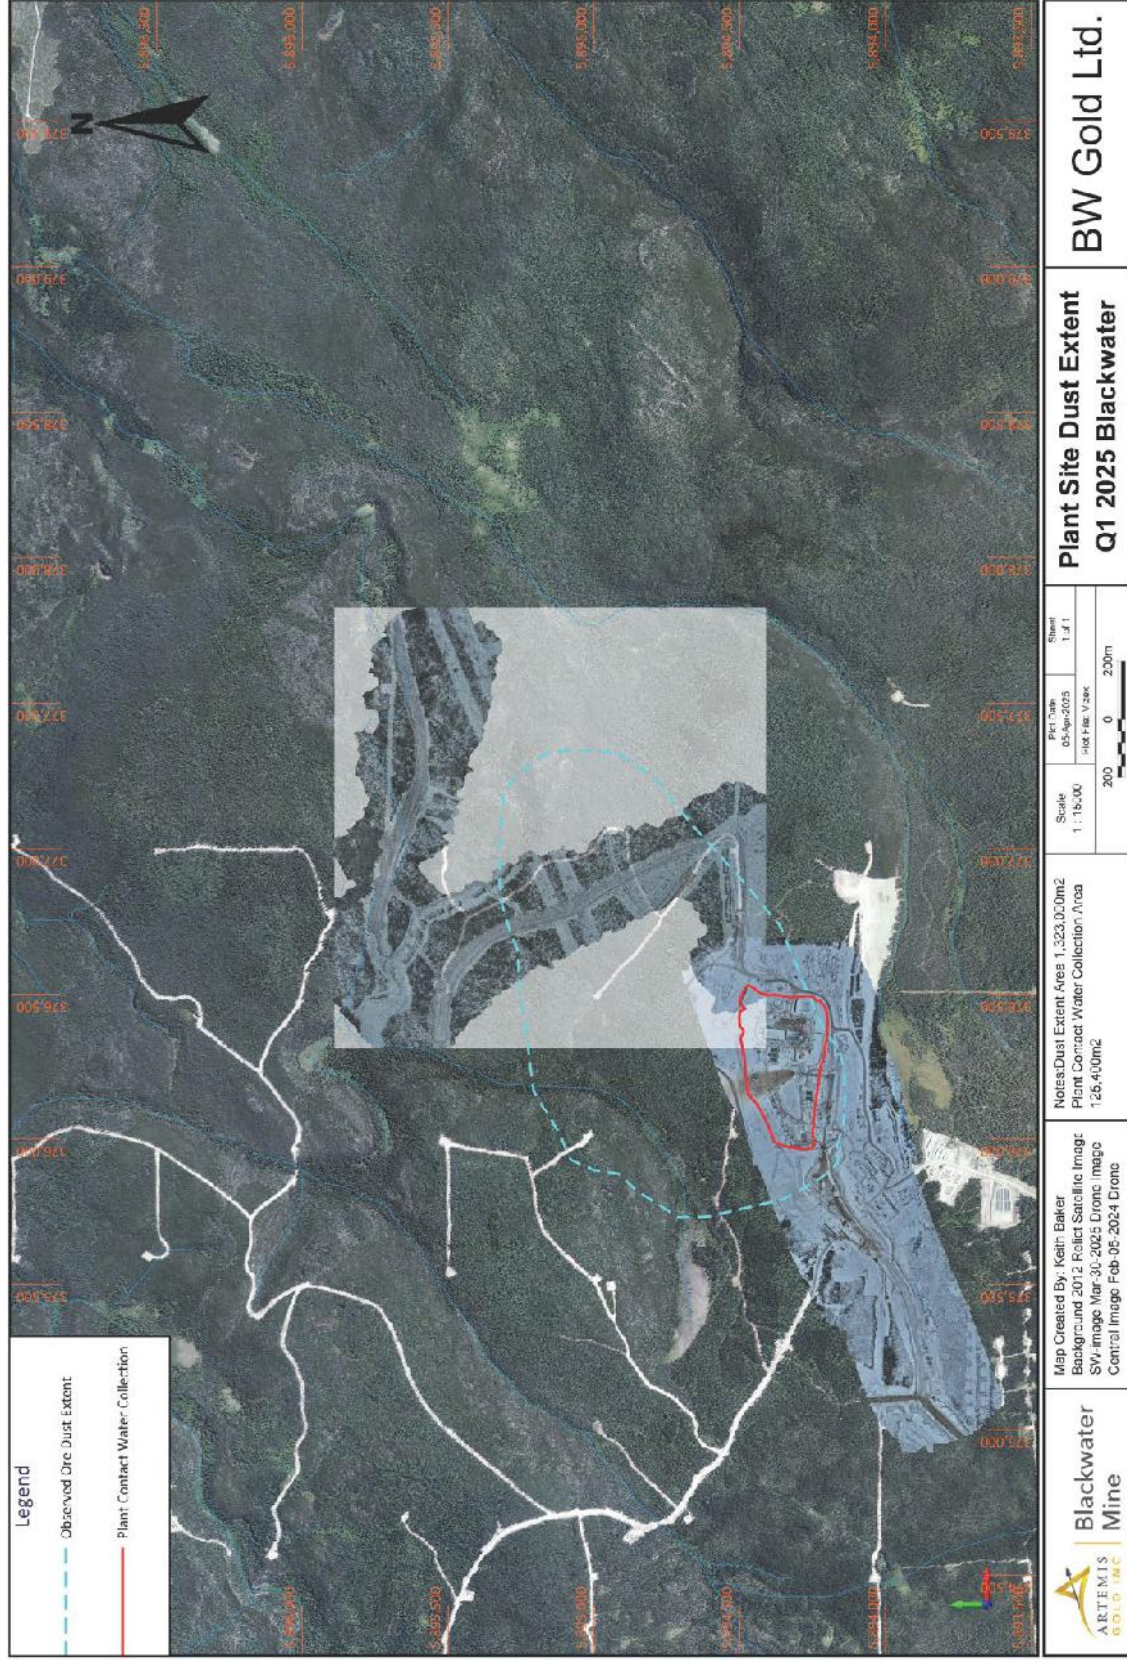
Figure 1: Map showing area impacted by dustfall around the mill site.

The area covered by dust was estimated as 1,323,000 m² from satellite imagery on February 26, 2025 (personal communication, K. Baker, April 4, 2025). Of this area, 125,400 m² is within the plant site area where drainage will be captured by catchment ditches and collection ponds and the remaining 1,197,600 m² is outside of the plant site area with drainage reporting to Stream 505 (personal communication, K. Baker, April 4, 2025) (Figure 1). ERM provided an estimate for the dust produced between January 1 and April 30 using the AP42 methodology, which uses wind speed, moisture content, and material drop rates. They estimated a total of approximately 1.2 tonnes of dust was emitted from the material stockpile drop operation over this period (personal communication, D. Cassanova, April 30, 2025).

BW Gold is currently planning to implement wind fencing to minimize the extent of dust fall. At the time of this memo, engineers evaluating the structure completed a site inspection in April. In addition, BW Gold is conducting a review of the spray bar dosing locations along the crusher conveyor circuit to determine if additional dosing locations would provide a practical benefit to reducing dust.

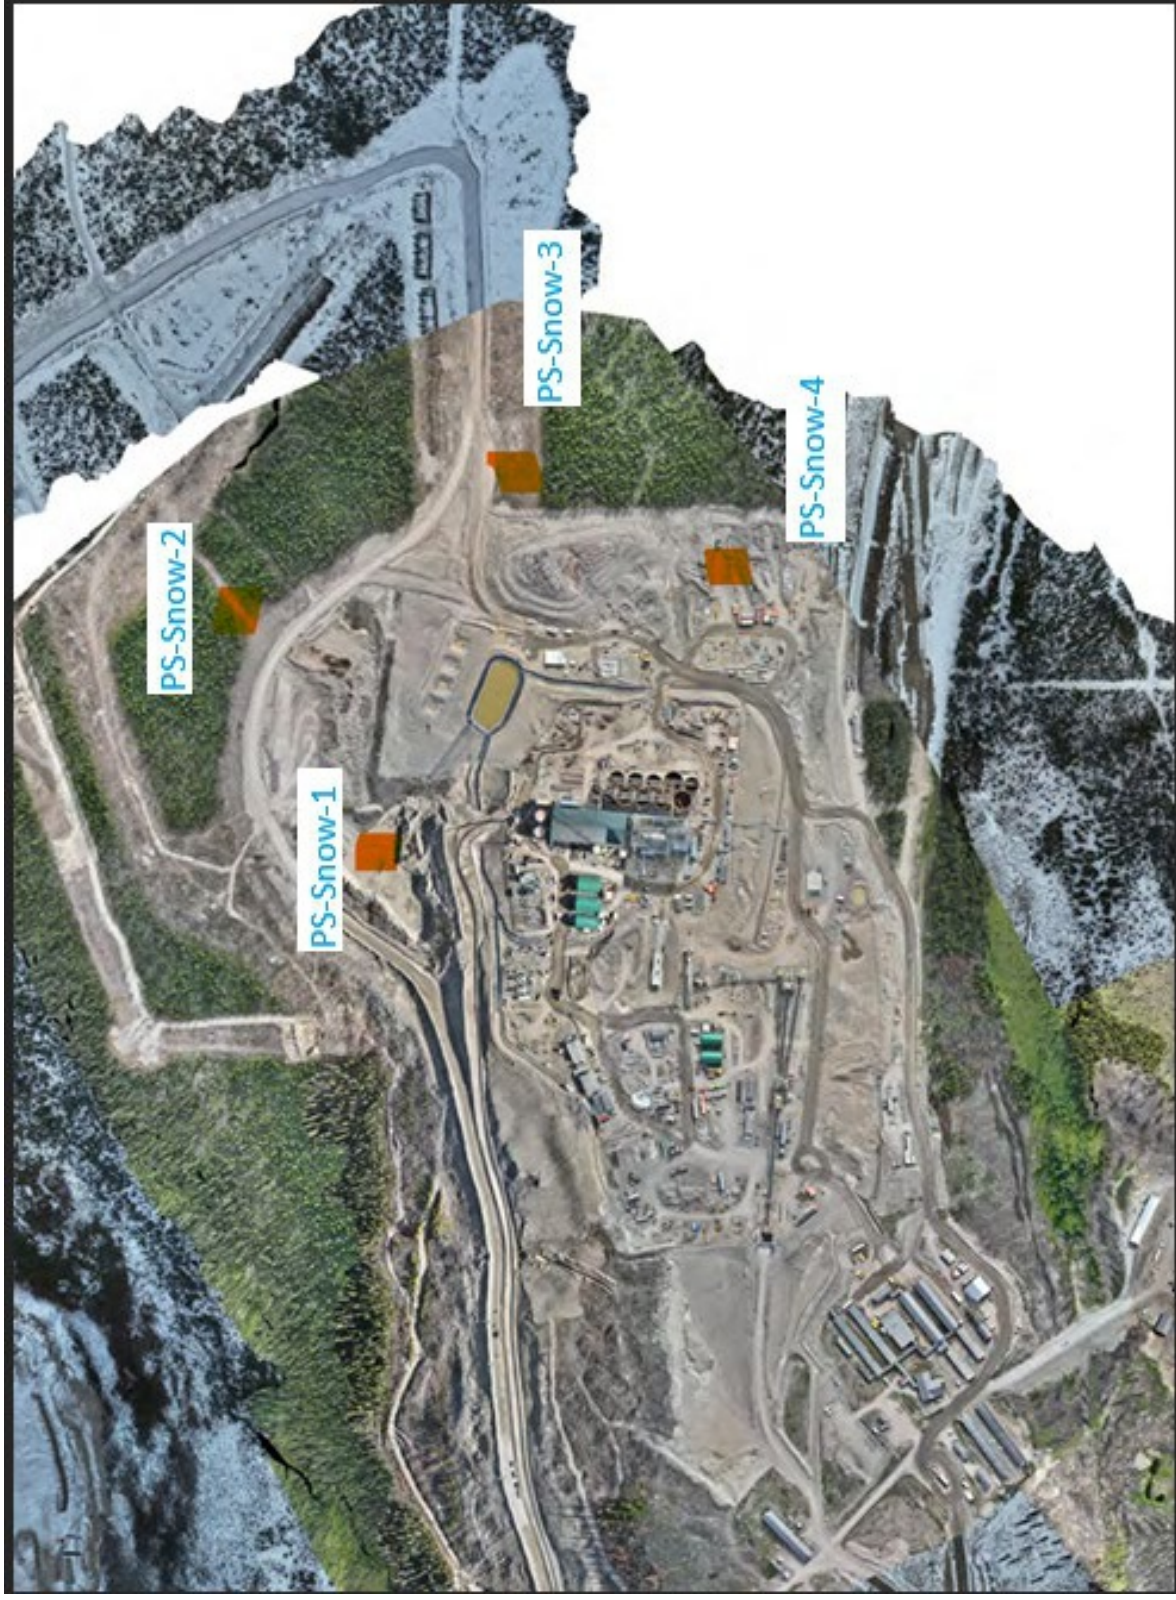
Figure 2: Location of dust-covered snow samples (provided by BW Gold)

Four dust-covered snow samples were collected from areas surrounding the plant site in April 2025 (Figure 2; Appendix A). These samples are believed to represent an upper end-member of concentrations that may be achieved from ore-dust influenced snowmelt owing to the proximity to the primary and secondary crusher. These samples were collected by snowcore through multiple layers of dust, melting the snow, and collecting the melted snow and dust mixture. The samples were submitted to ALS Laboratory for analysis for analysis of pH, acidity, alkalinity, nutrients, total dissolved solids (TDS), total suspended solids (TSS), sulphate, total metals, and dissolved metals (Table 2). The pH of these samples is consistent with rainwater pH (approximately 5.6) and does not indicate ARD. Metal concentrations in these samples are high and indicate that undiluted snowmelt from the area near the plant site will have elevated metal concentrations. The most impacted areas will be captured within the catchment ditches and collection ponds immediately around the plant site area (Figure 1). Some impact from the dust may be observed in headwater drainages; however, the load from the dust is anticipated to not be detectable further downstream, with concentrations returning to near baseline at 661-10.

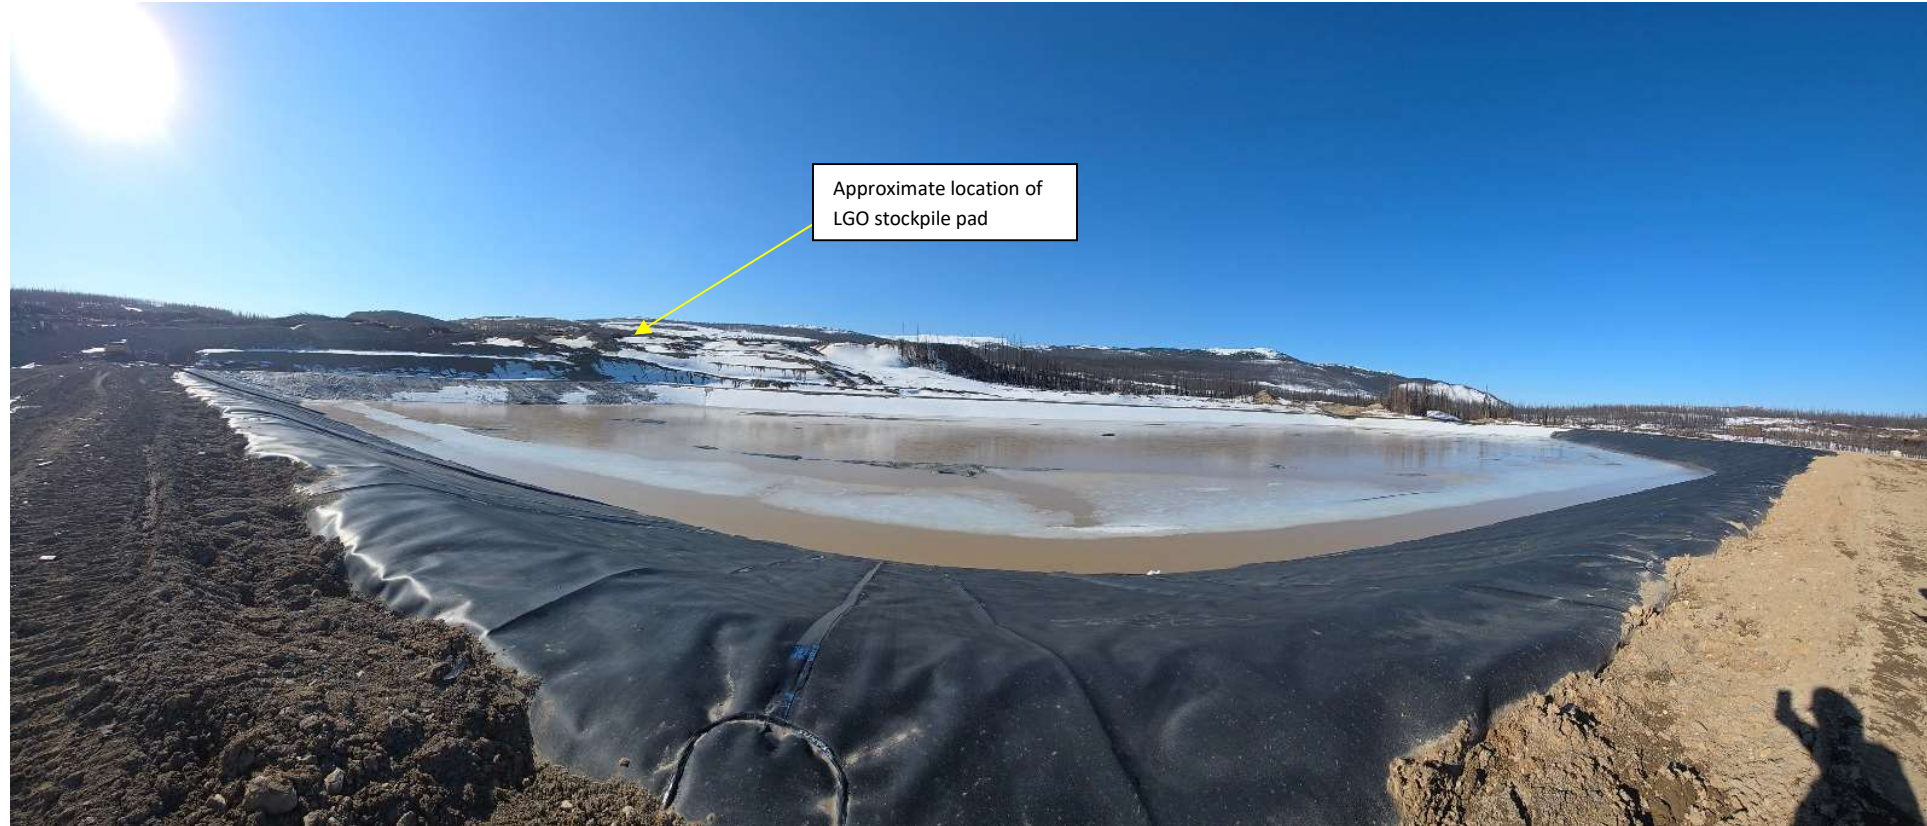
Photo 113556-1. Overview of the LGO stockpile pond (downstream of the LGO stockpile pad) which has started to capture water from the pad and surrounding area. This water is considered 'PAG contact water' and it is understood will be utilized in the plant site for process water.

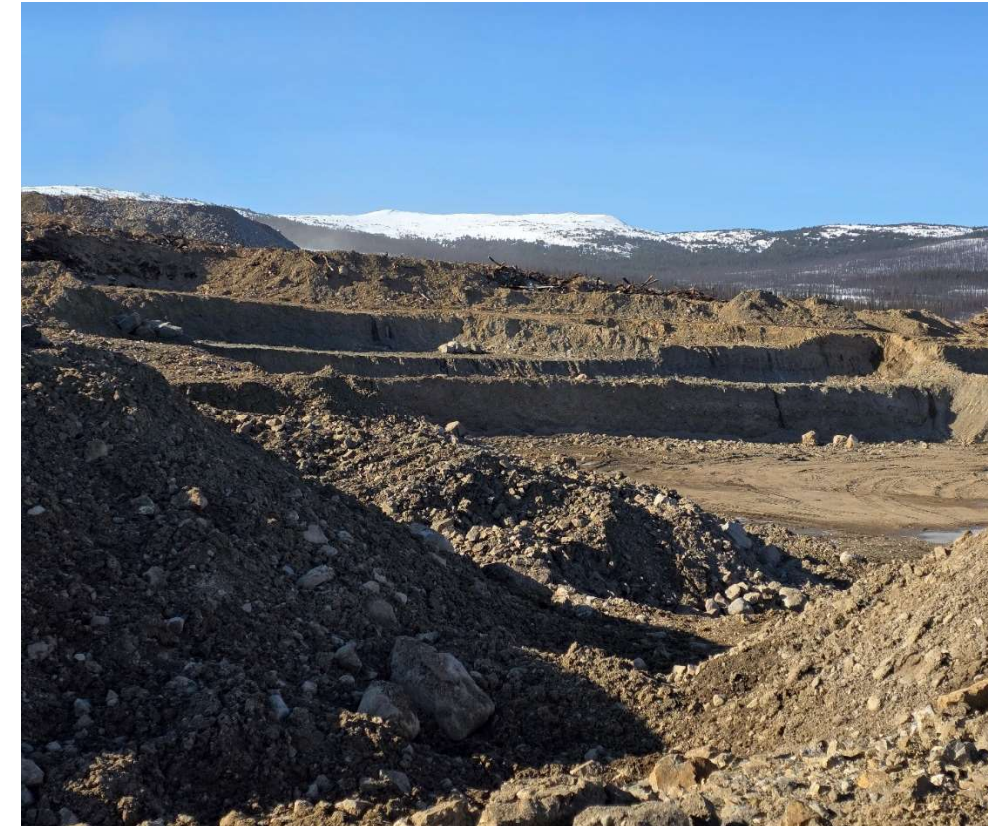
Photo 113556-7. Development of Borrow Pit 4 (source of zone s till material) adjacent to the LGO stockpile pad.

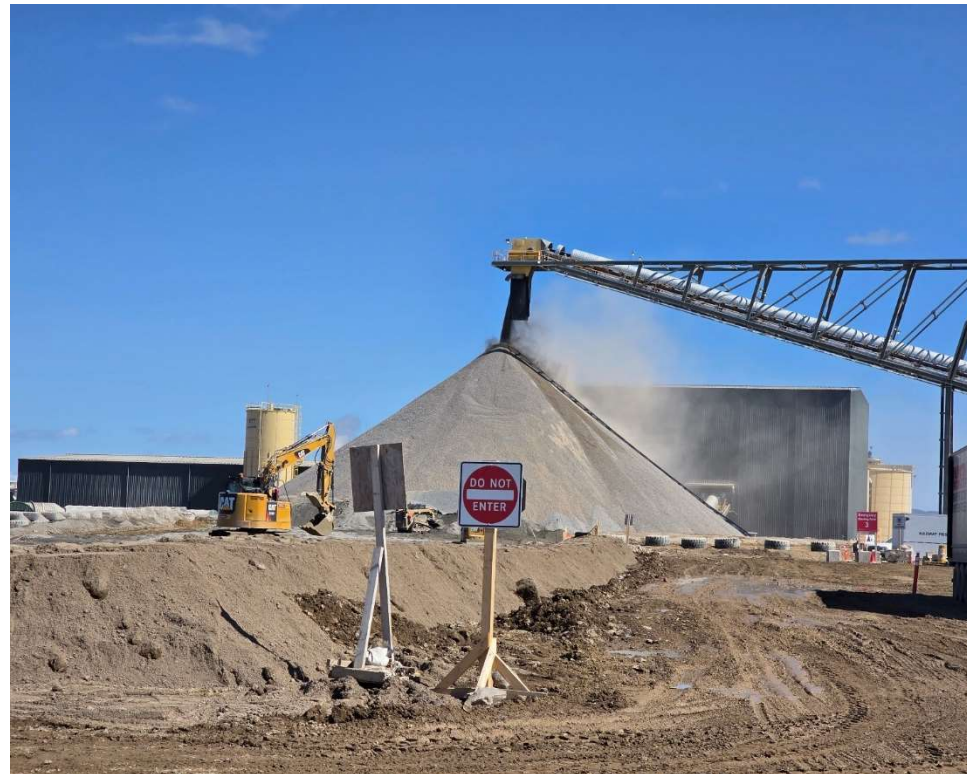
Photo 113515-1. Stockpile of high-grade ore at the drop point of the till conveyor. Stockpile height noted to be elevated in comparison to previous site visits, reducing drop height from conveyor.

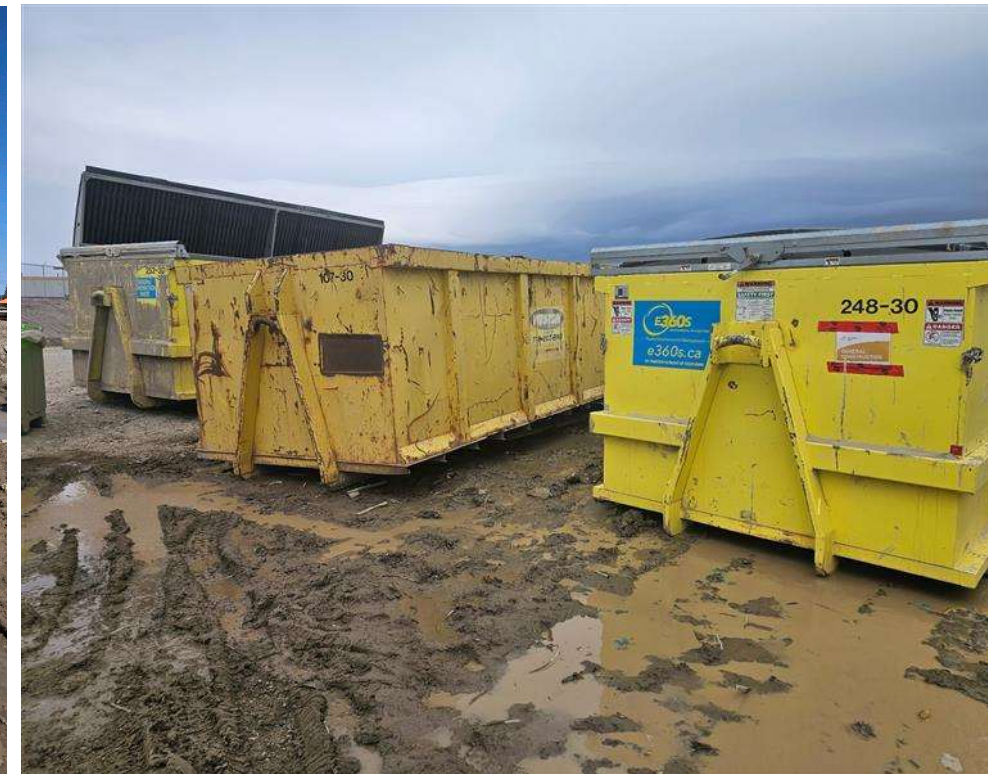
Photo 5. Construction waste bins at the Plant Site following clean up by BWG. Photograph provided by BWG on April 23, 2025.

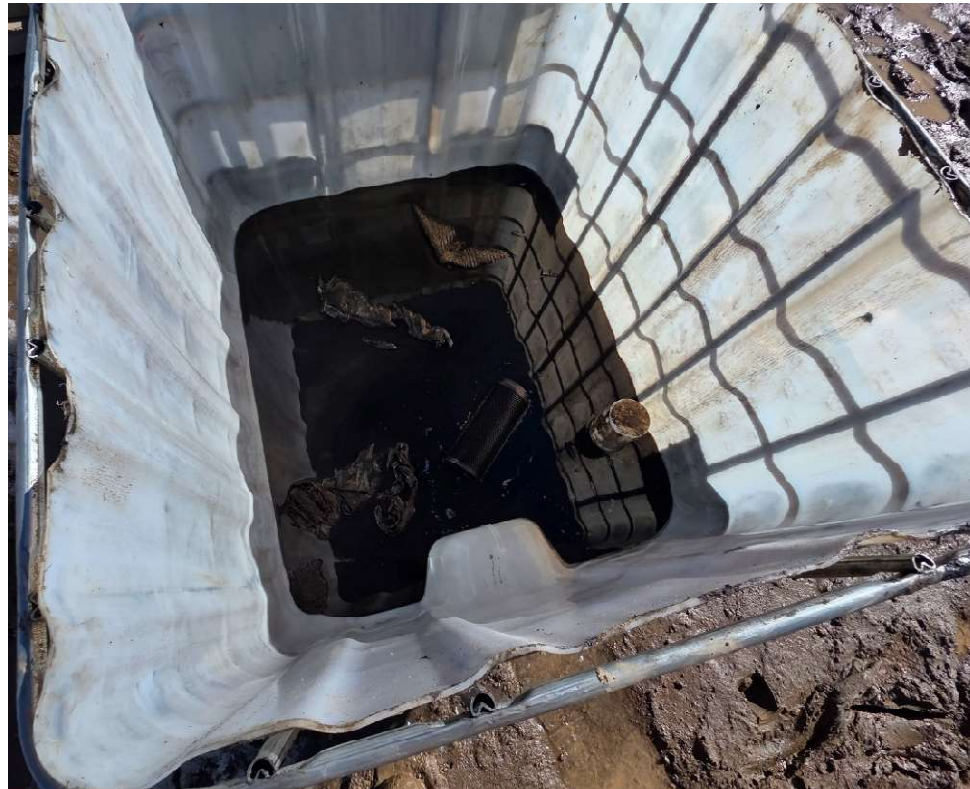
Photo 113521-5. Example of former storage tote being utilized as a drip tray containing used oil and oil filters at the mobile maintenance yard.

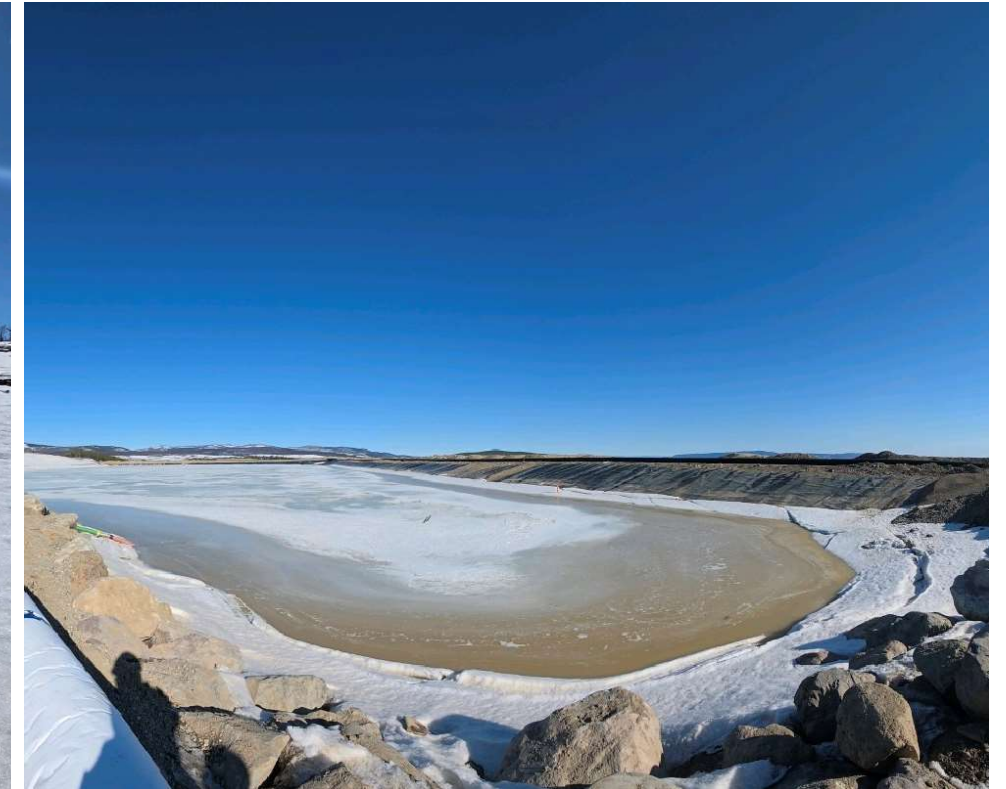
Photo 113550-1. Overview of a portion of the WMP. The IEM understands BWG continue to have issues with the turbidity of the water within the pond and are currently reviewing options for treatment.

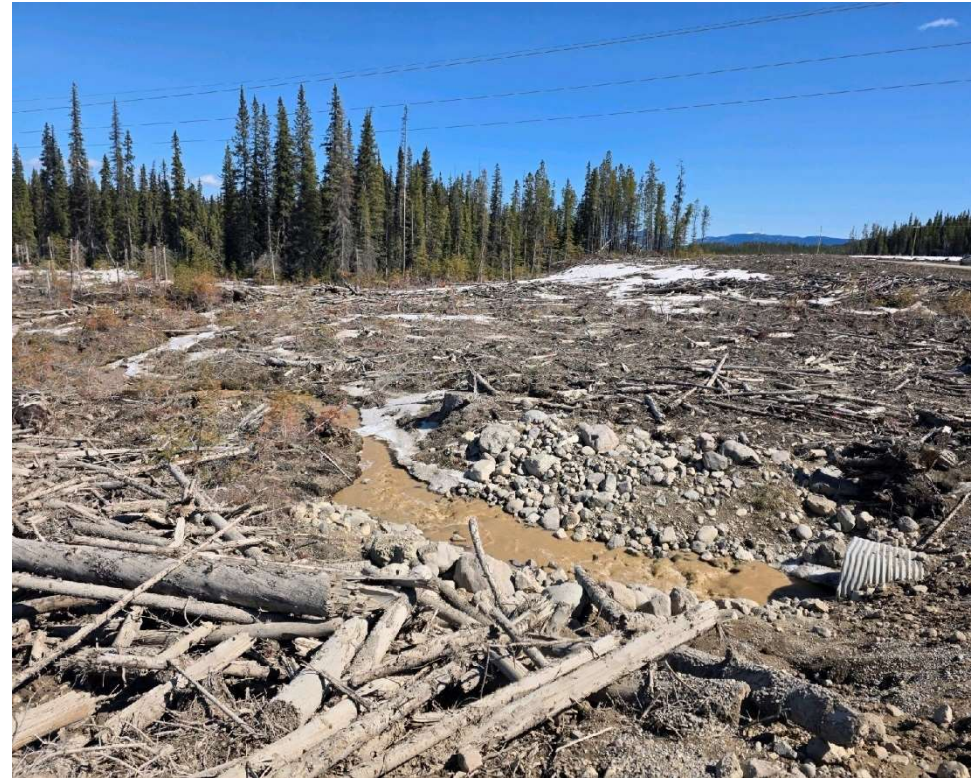
Photo 113513-10. Turbid flow in Watercourse 146 (fish salvaged) sourced from roadside ditches (see Photo 113513-9). Photo taken morning of April 15, 2025.

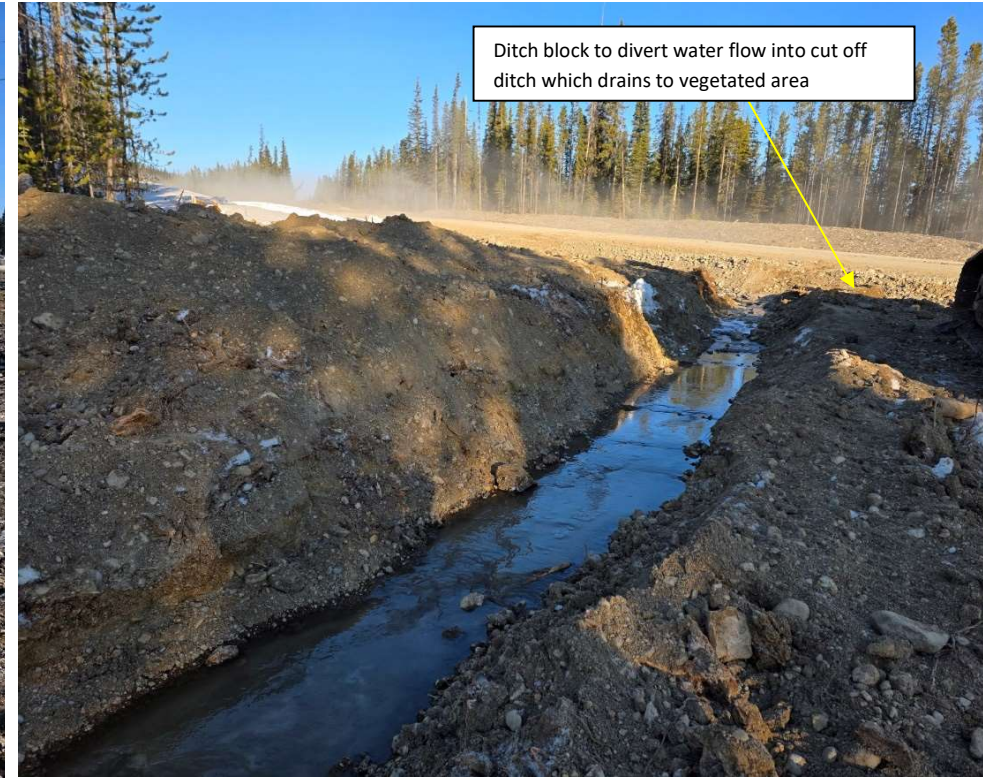
Photo 113513-3. Ditch block and cutoff ditch leading to vegetated area to prevent turbid water from draining into Watercourse 146. Photo taken morning of April 16, 2025.

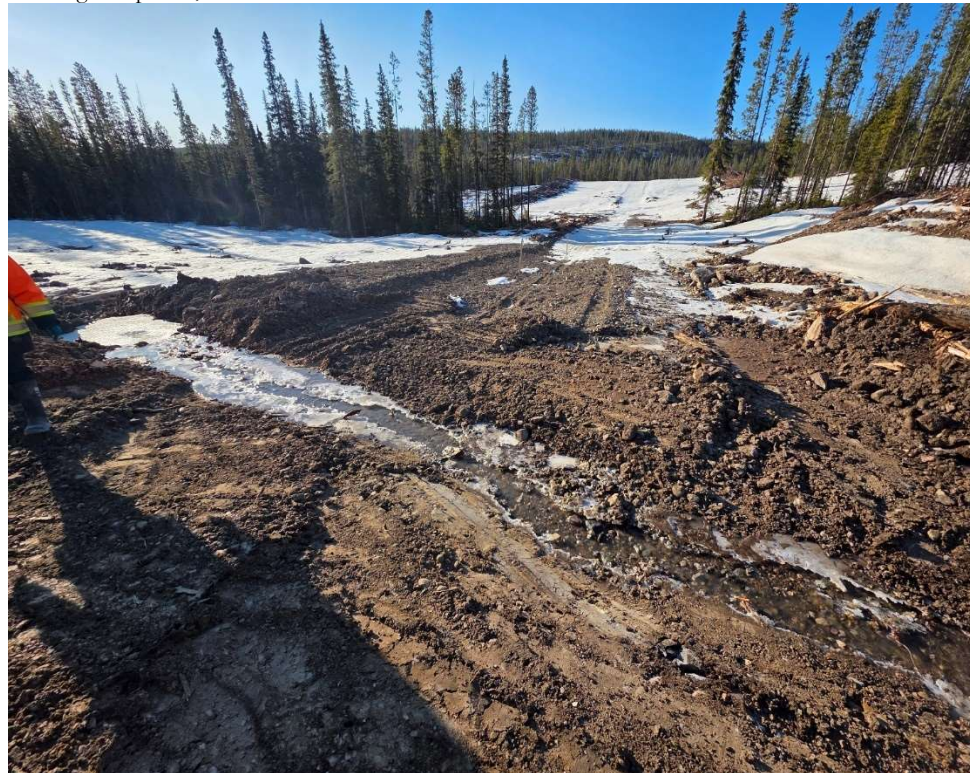
Photo 113513-4. Terminus of cutoff ditch (see photo 113513-3) installed to prevent turbid water from draining into Watercourse 146 along the access road to Operations Camp. Photo taken morning of April 16, 2025.

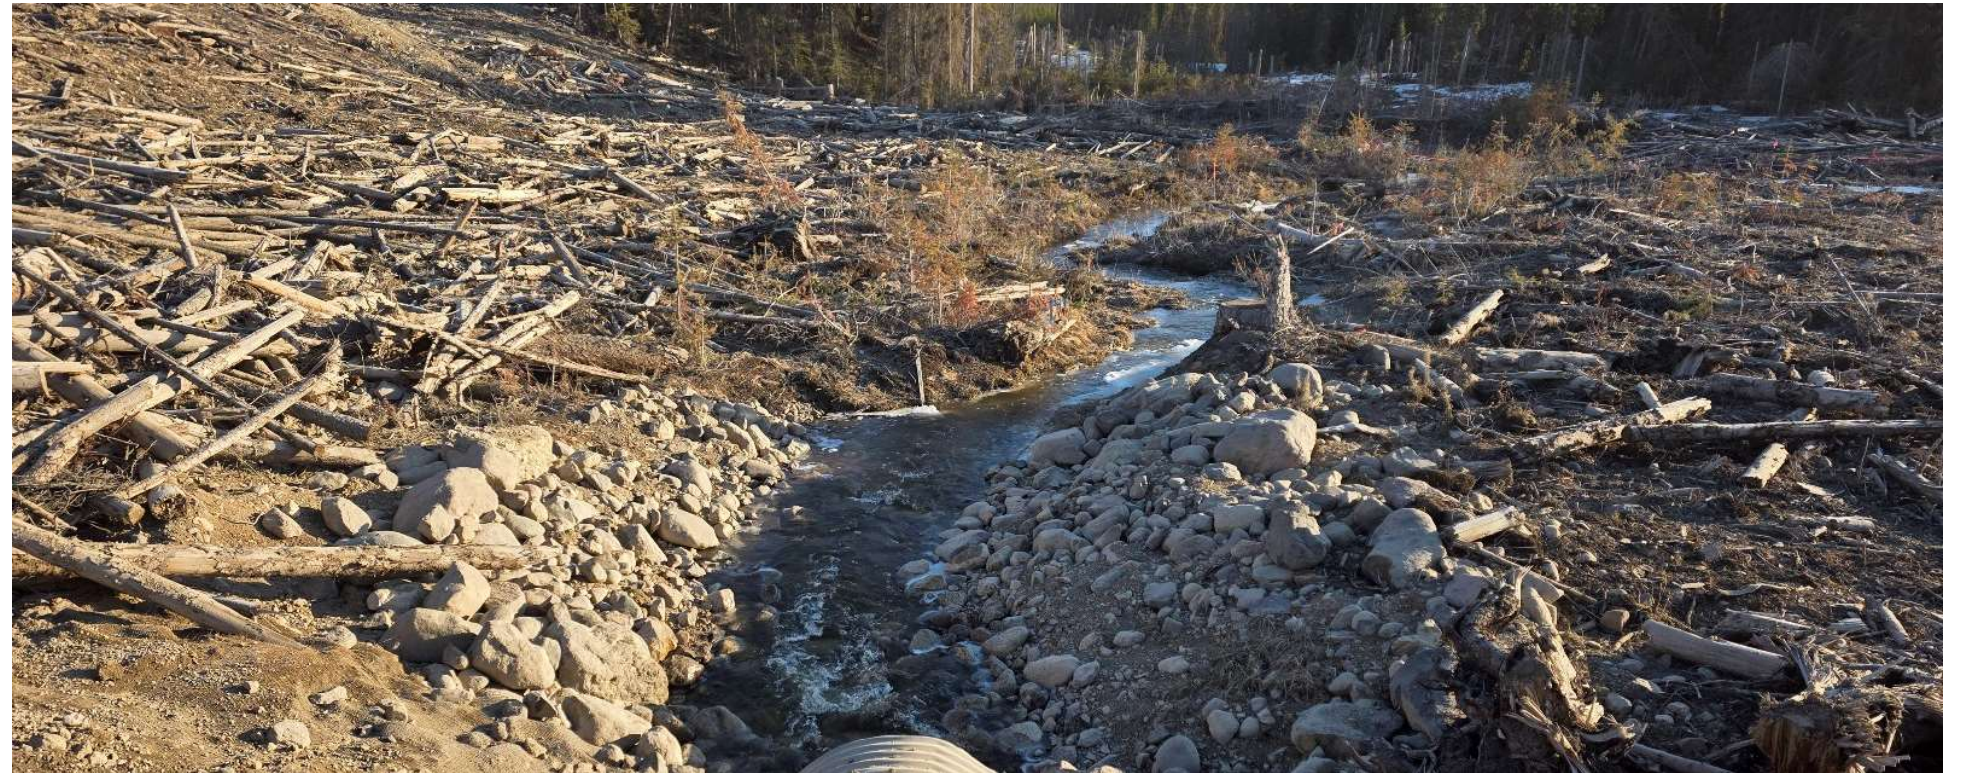
Photo 113513-5. Overview of flow in Watercourse 146 following the installation of upstream ditch block to divert turbid water flow. Photo taken morning of April 16, 2025.

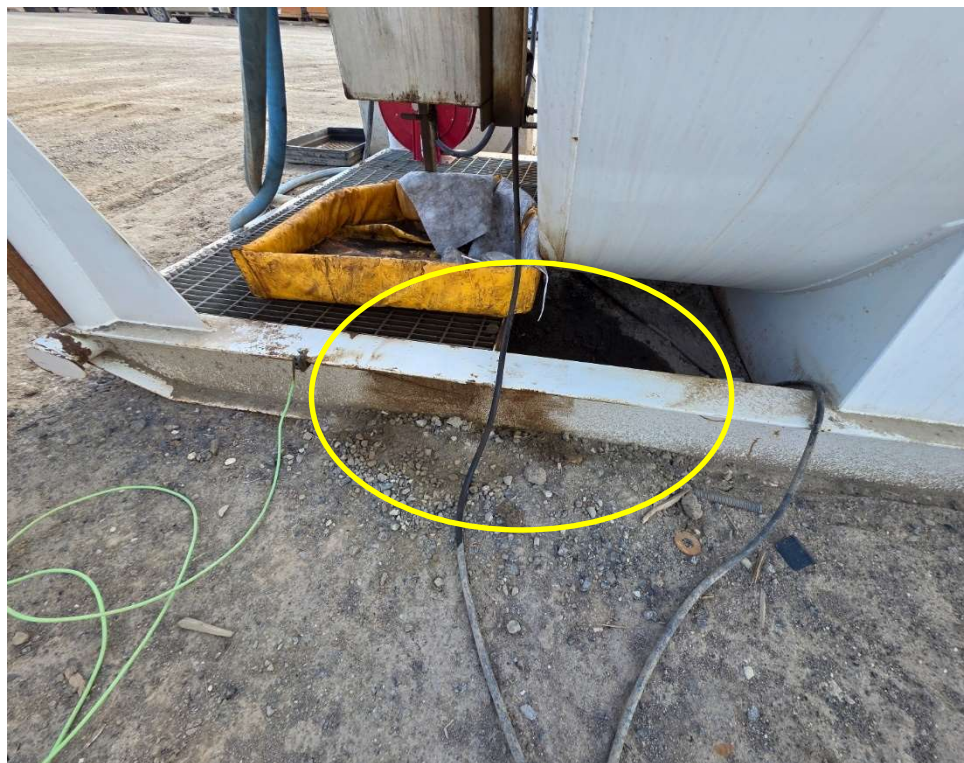
Photo 114080-1. Hydrocarbon spill to ground beneath fuel tank staged at the Andrew's Hill laydown.
