**Blackwater Gold Mine
IEM Site Visit Report 026
January 27 – 28, 2025**

Prepared By
EDI Environmental Dynamics Inc.
3810 18th Ave
Prince George BC V2N 4V5

EDI Project
21P0403
January 2025

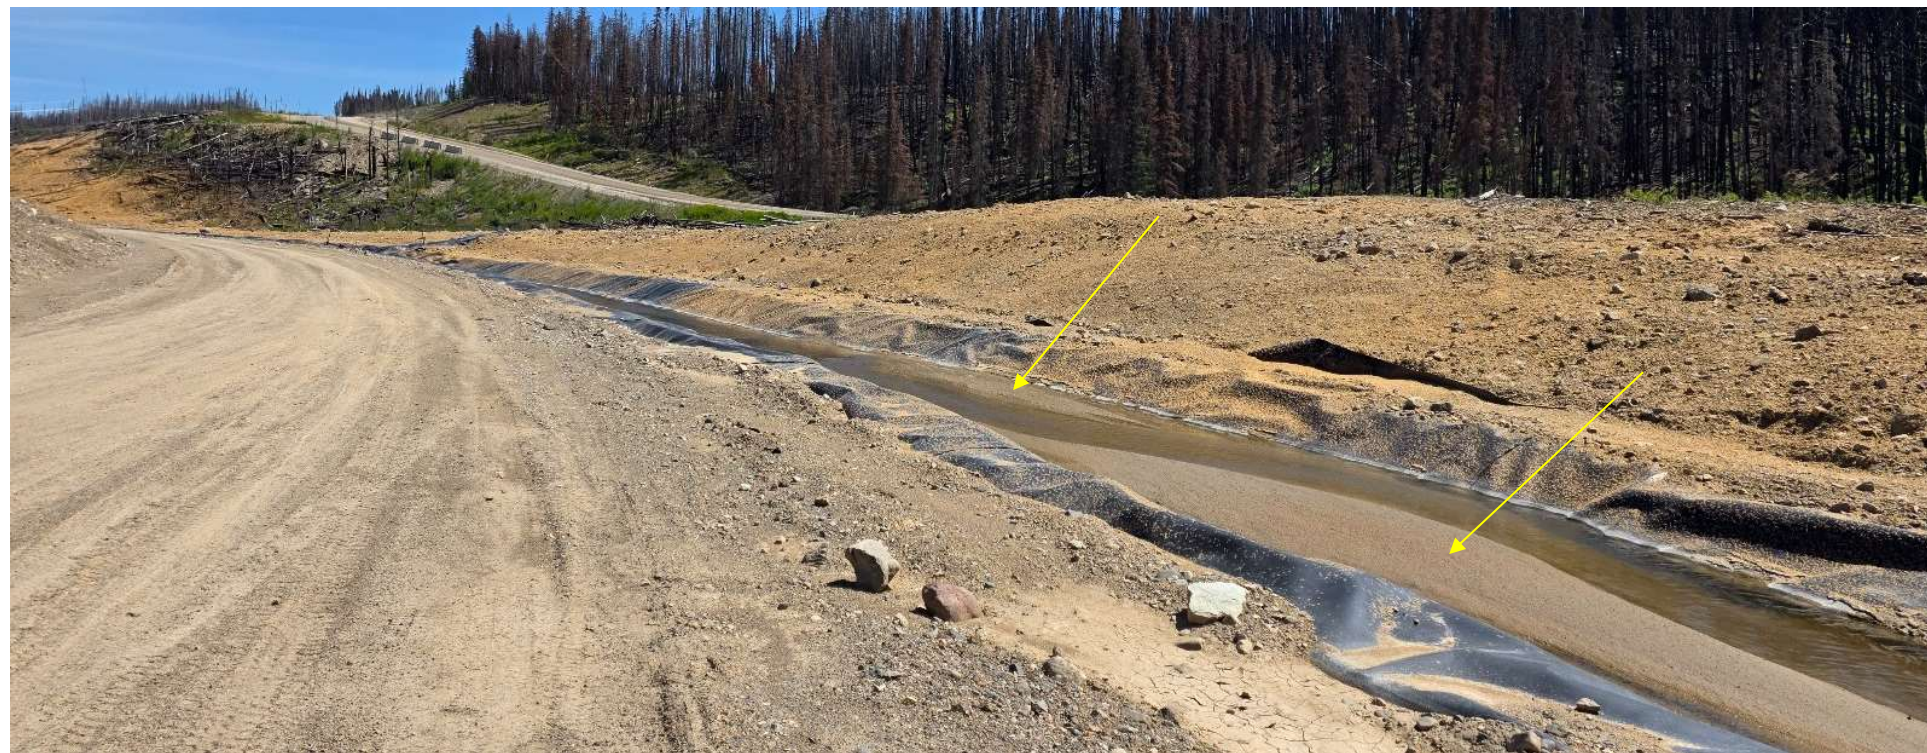
Photo 114078-3. Excess sediment accumulation within the lower extents of the Southern Collection Channel near its discharge point into the Central Water Transfer Pond.

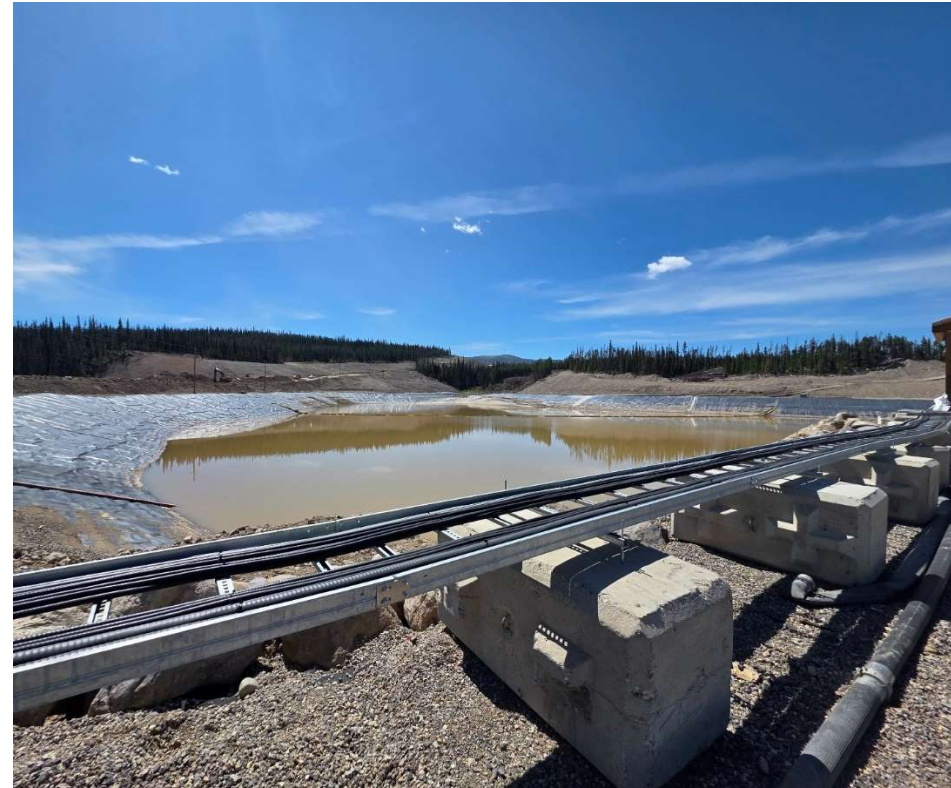
Photo 114071-4. Overview of turbid water within the water management pond.

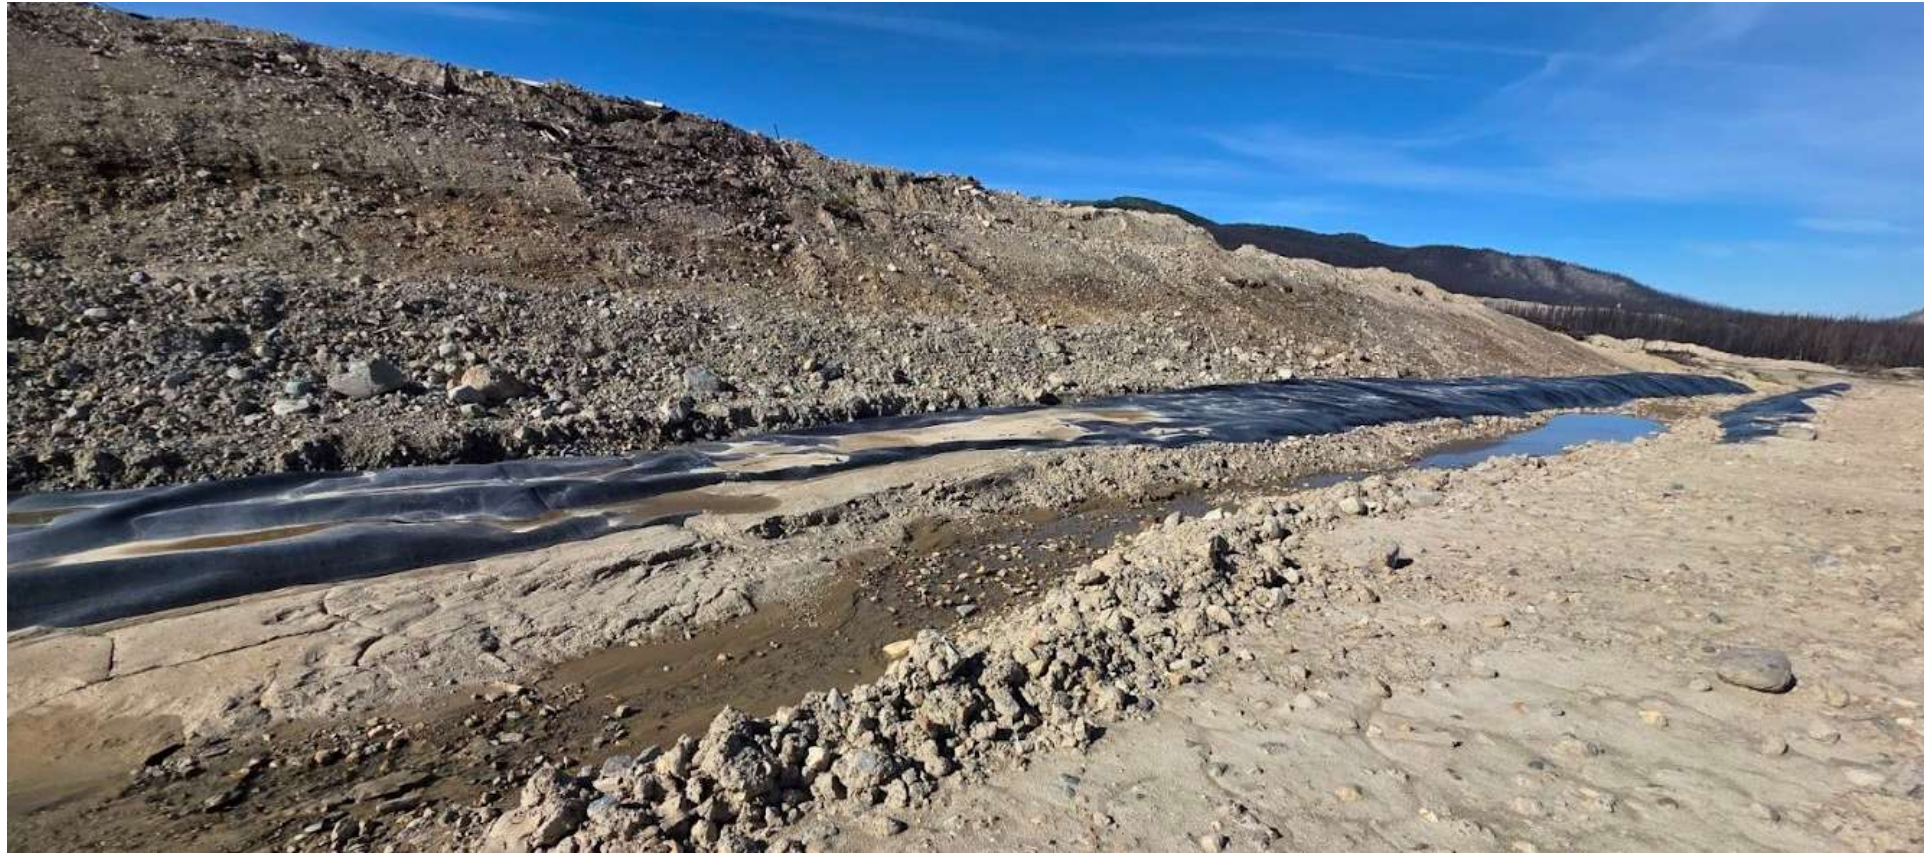
Photo 114083-1. Excess sediment accumulation (along with what appears to be fill material from the nearby pad) within the lined PAG contact water ditch line adjacent to the Low-Grade Ore stockpile.

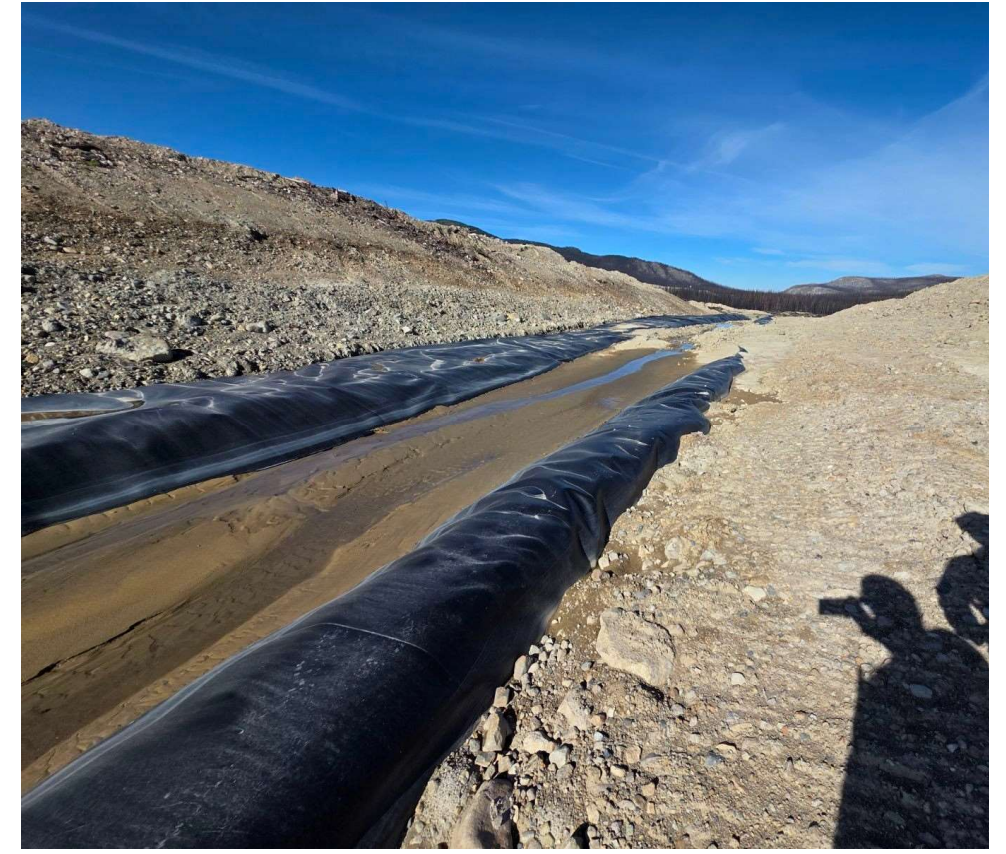
Photo 114083-2. Excess sediment accumulation within the lined PAG contact water ditch line adjacent to the Low-Grade Ore stockpile.

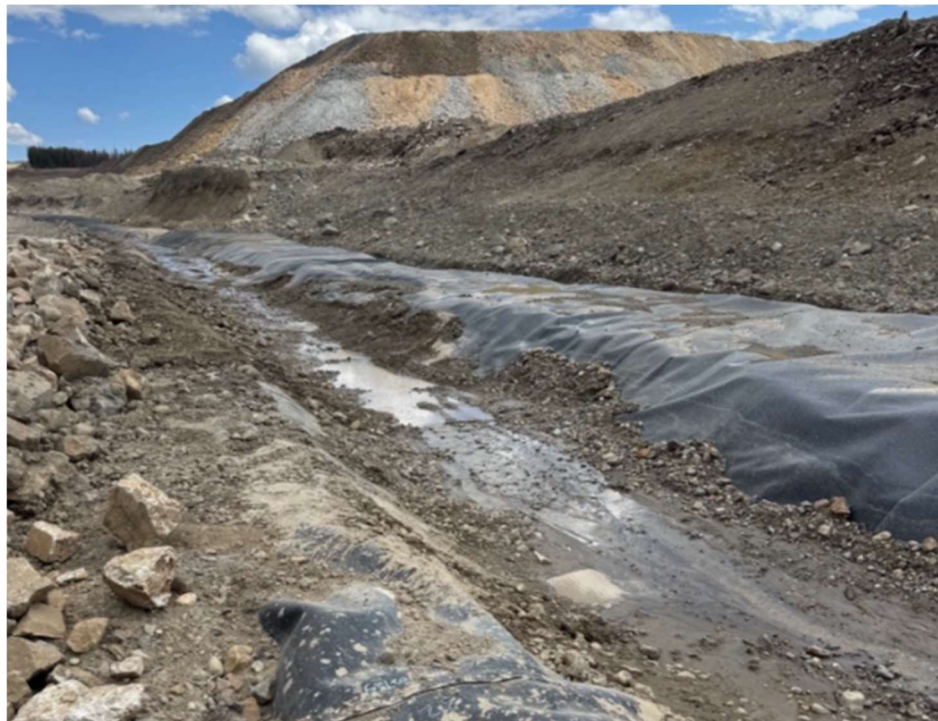
Photo 17. Confirmation material was removed from the PAG contact water ditch line adjacent to the Low-Grade Ore Stockpile. Photograph provided by BWG on July 28, 2025.

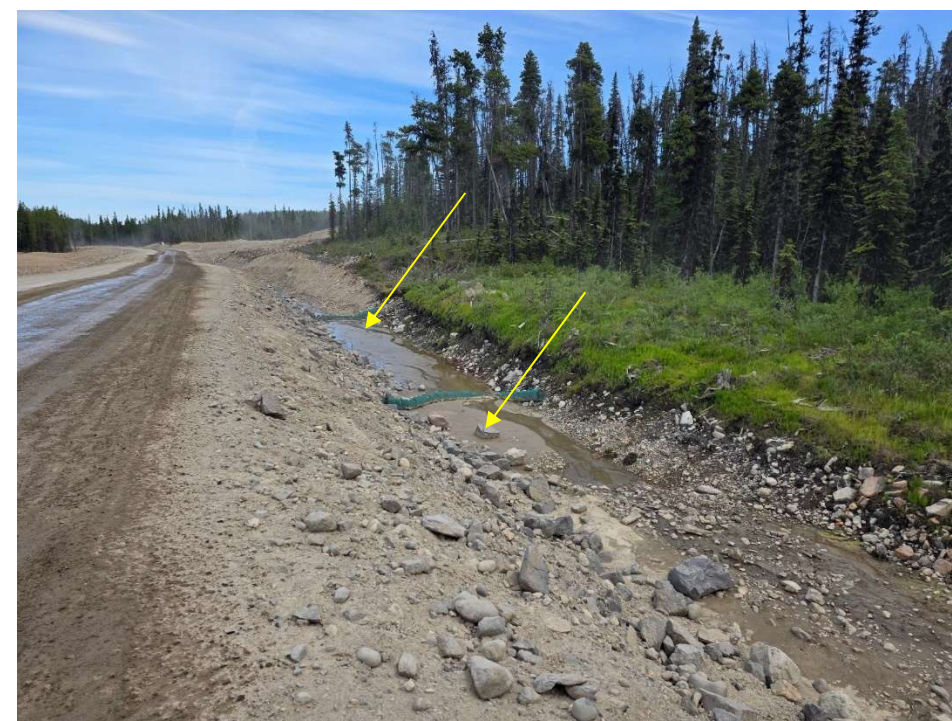
Photo 114077-3. Example of location along access road to Operations Camp where sediment accumulation has occurred within check dams. Examples also noted at other locations not included in photograph.

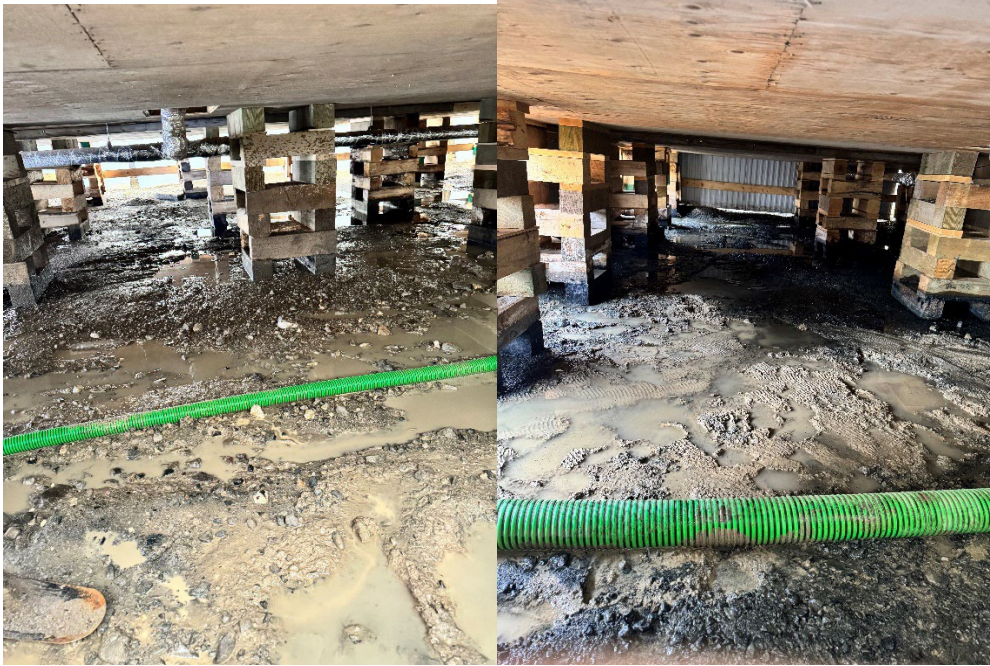
Pipe under camp had developed crack leading to leak.

Mechanical failure.

Photos 1 & 2: Spill Photos

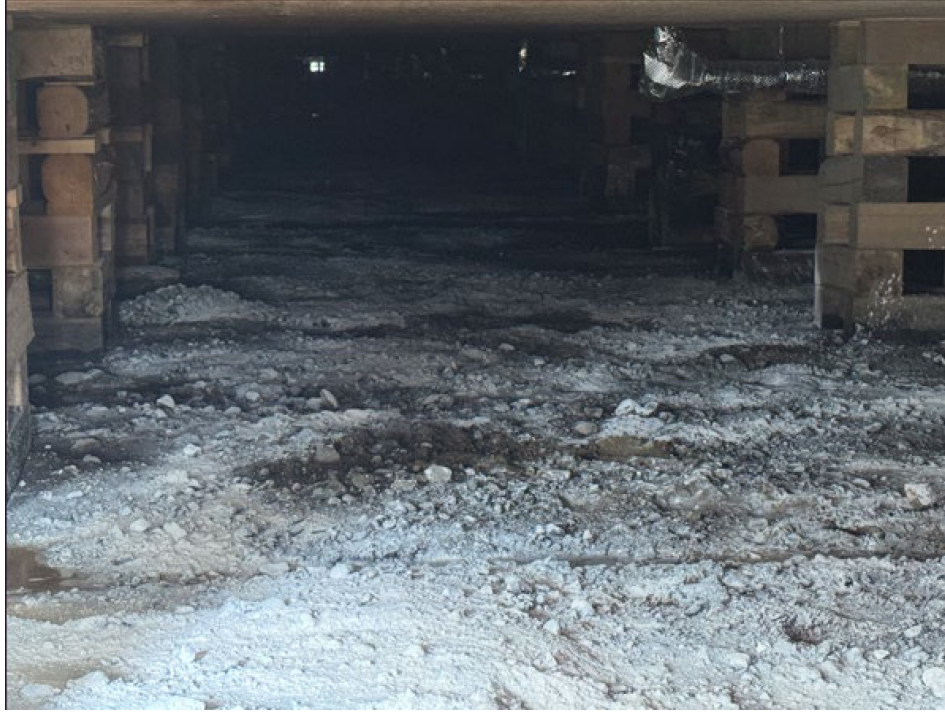
Photo 6: Spill Clean Up

Exact spill date is not known and approximated at May 28. Initial pipe bypass was put in place after notification was received. Spill clean up was planned including coordination of confined space training for Hydro-Vac operators and scheduling cleanup once shift change was complete and night shift employees were not staying in dorm. Once spill cleanup was initiated a full connection repair was put in place for the pipe on June 12.

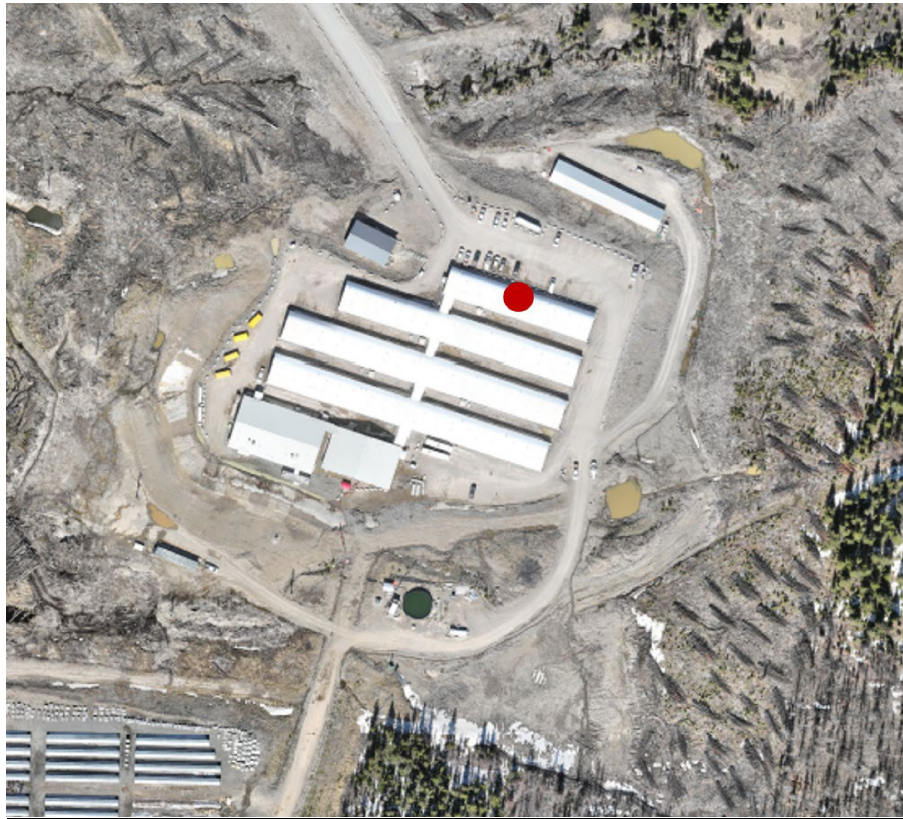
Photo 7: Drone Photo of Spill Location at BWG Construction Camp

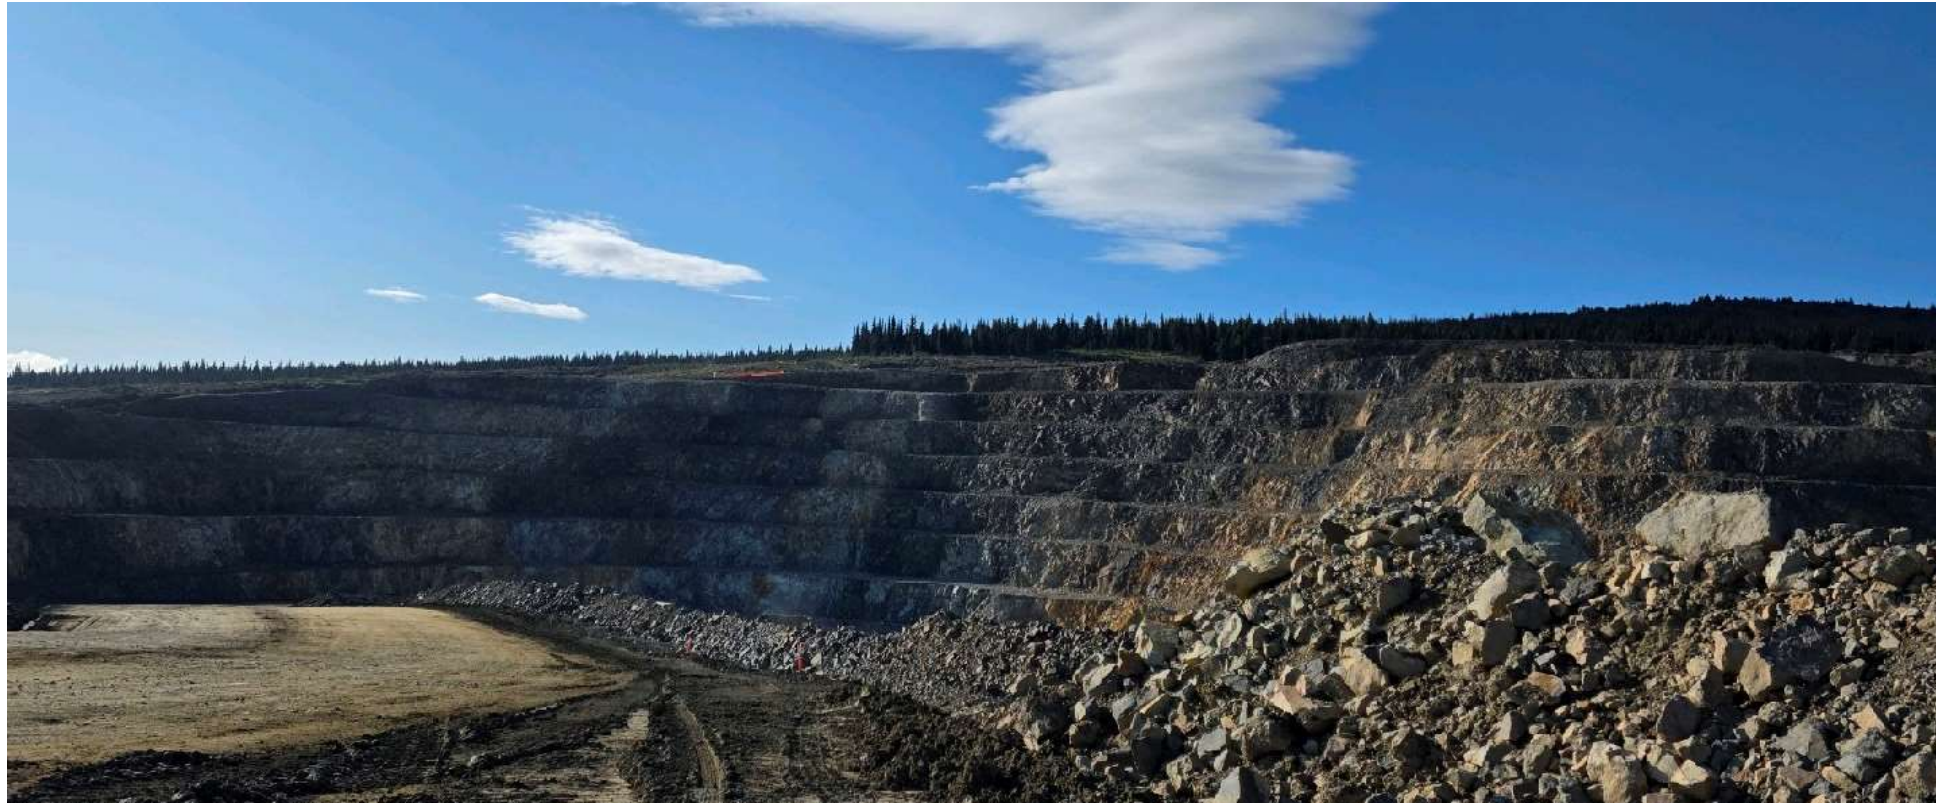
Photo 114222-5. Overview of status of ongoing mining practices within the open pit.

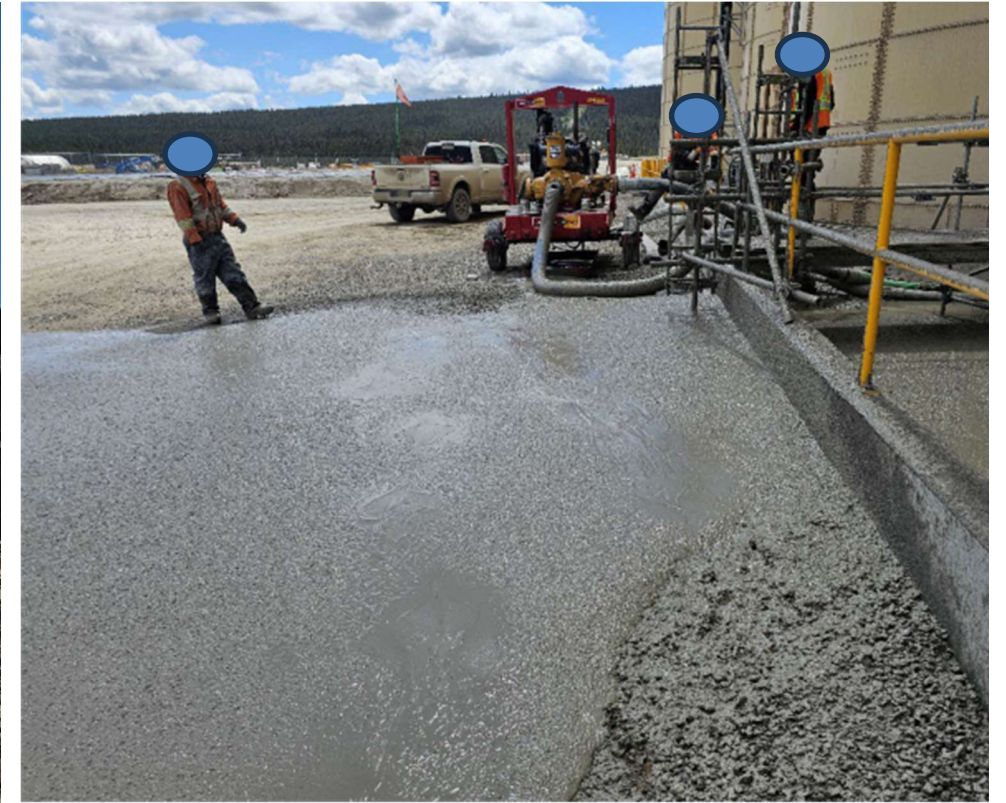
Photo 2. Spill of processing slurry that occurred on July 3, 2025, at the Plant Site. Photograph from end of spill report to ENV provided by BWG to IEM team on August 13, 2025.

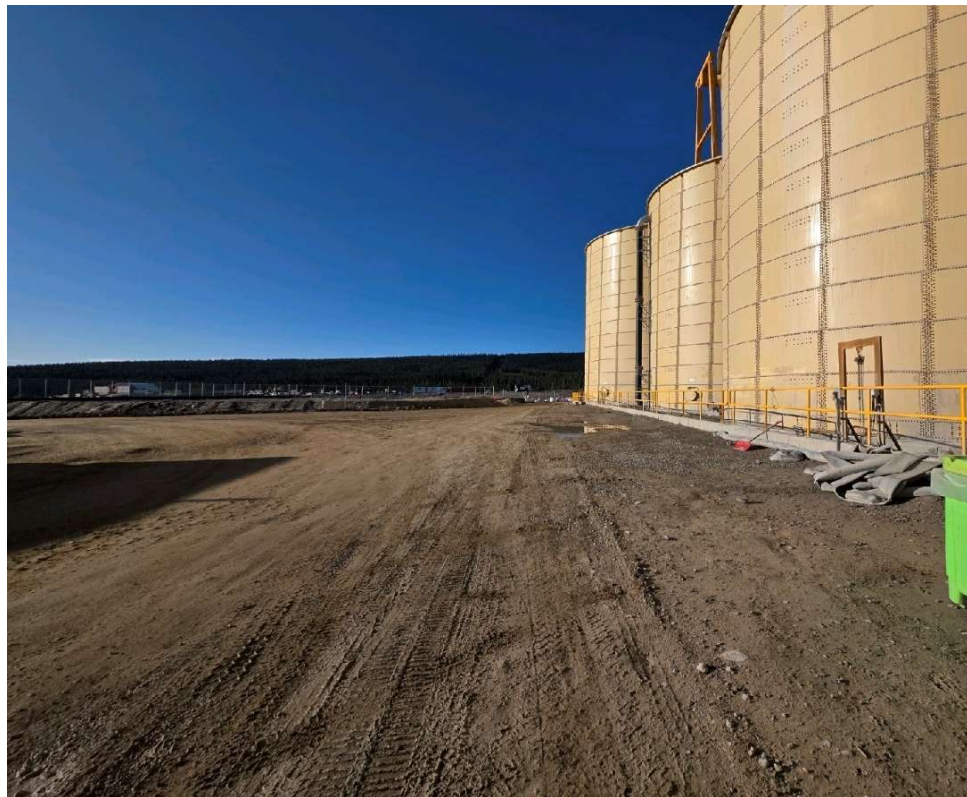
Photo 114223-4. Area adjacent to the leach circuit tanks at the Plant Site following clean up of the 50,000L spill of processing slurry that occurred on July 3, 2025.

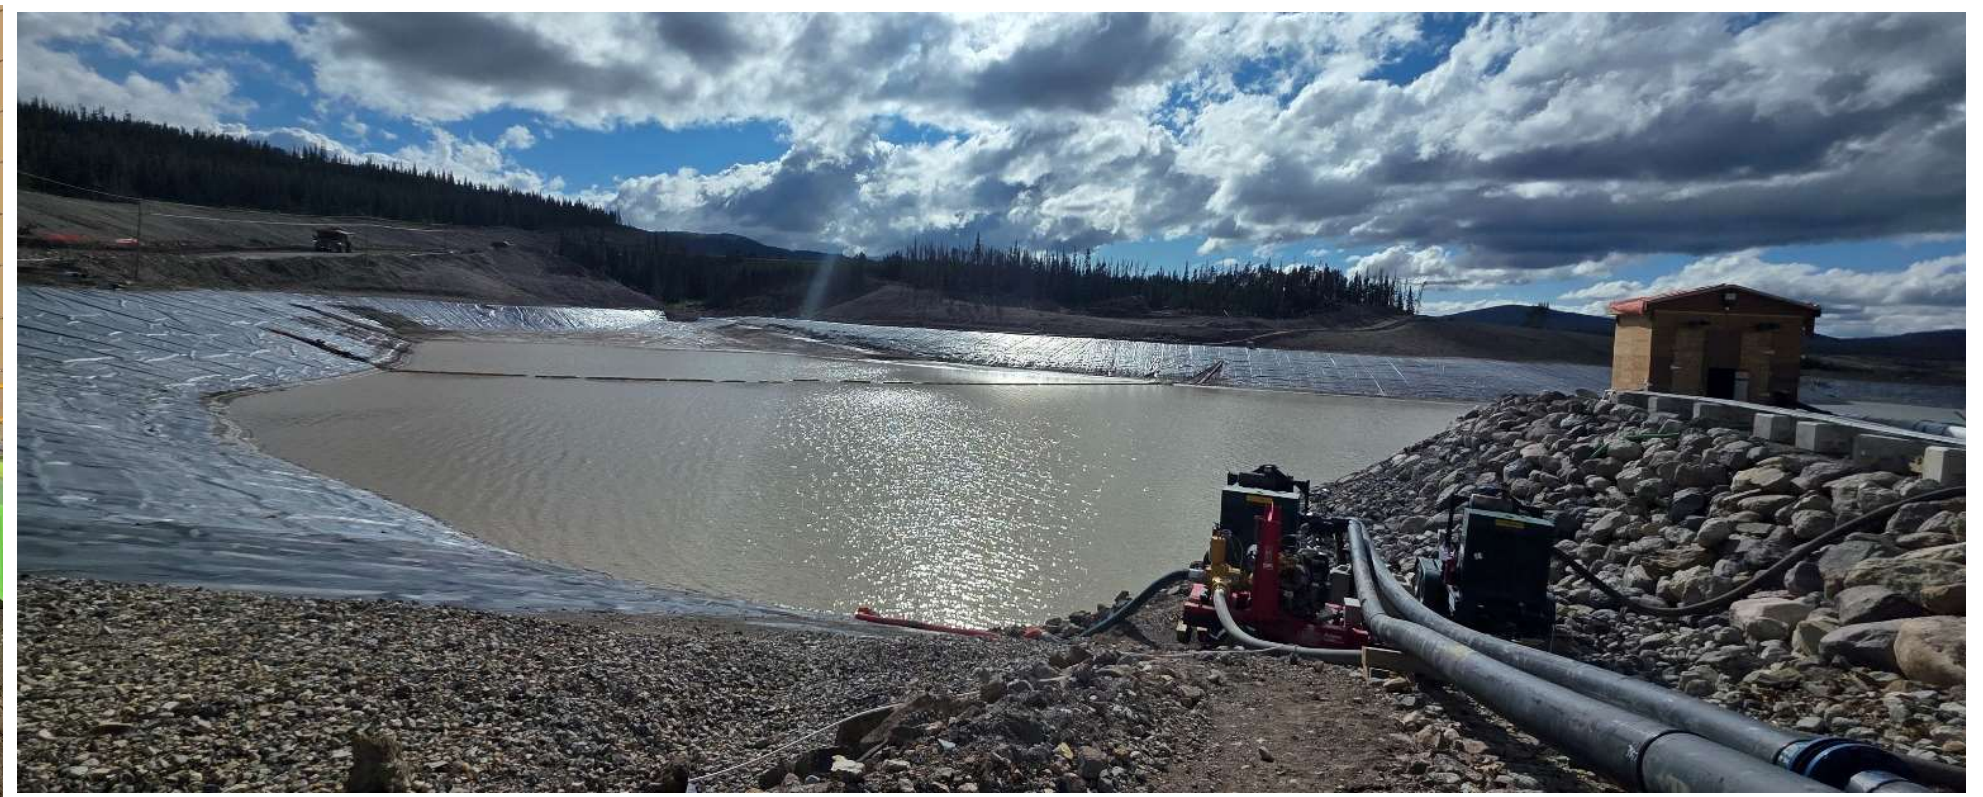
<p>Water levels within the Water Management Pond (WMP) were observed to be substantially lower than during previous visits (Photo 114205-4). The IEM understands BWG continues to use water from the WMP to meet instream flow needs (IFN) in Davidson Creek.</p>	<p>No</p>
<p>Following onsite discussions with the plant operator at the WMP water treatment plant, it was indicated to the IEM team member that turbidity of water being released from the plant to the Davidson Creek outfall is usually at a turbidity level between 30 to 60 Nephelometric Turbidity Units (NTU). The onsite BWG staff was not sure of the validity of this claim and indicated he would follow up to confirm these values.</p> <p>An RFI was submitted to confirm the turbidity of water discharged to Davidson Creek from the WMP was within the 30-60 NTU range and if so, have there been any water quality exceedances at the downstream compliance sampling point, DC-05.</p> <p>BWG provided a response on August 25, 2025, which indicated that this information was not correct and that regular sampling at the DC-05 compliance point confirmed that TSS levels remain compliant with permitted discharge requirements.</p>	<p>No</p>

Photo 114205-4. Overview of low water level within the Water Management Pond.

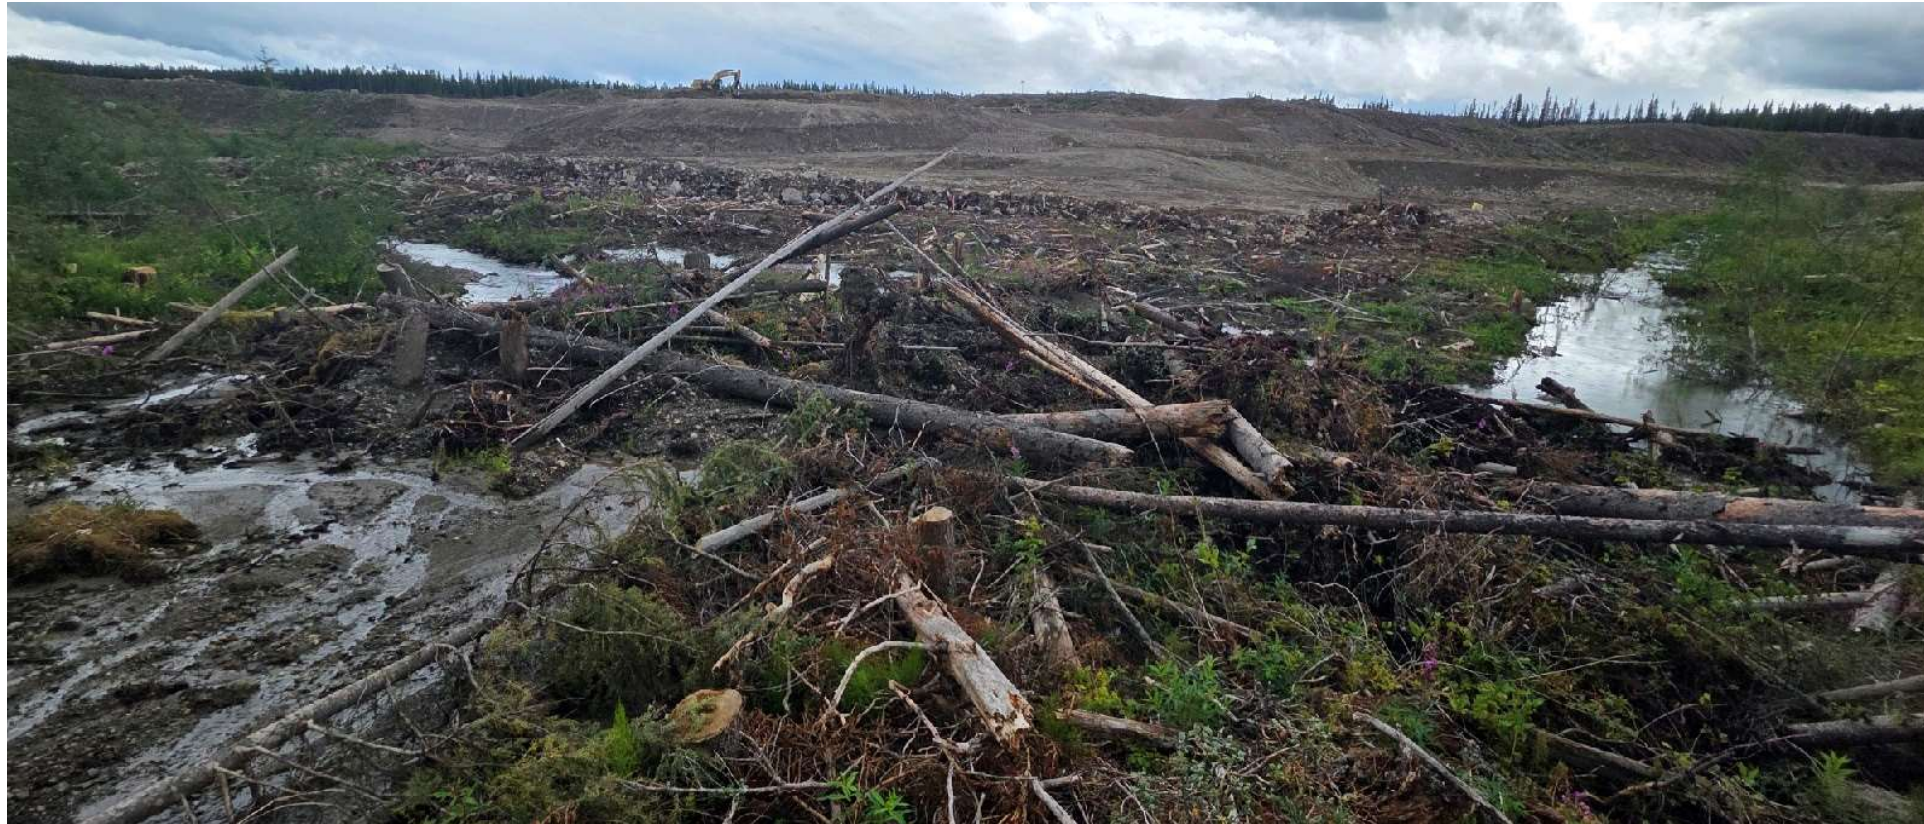
Photo 114201-7. Current state of Davidson Creek following slope failure within the Fresh Water Reservoir footprint that occurred on June 24, 2025. Current channel can be seen on high side of slide.

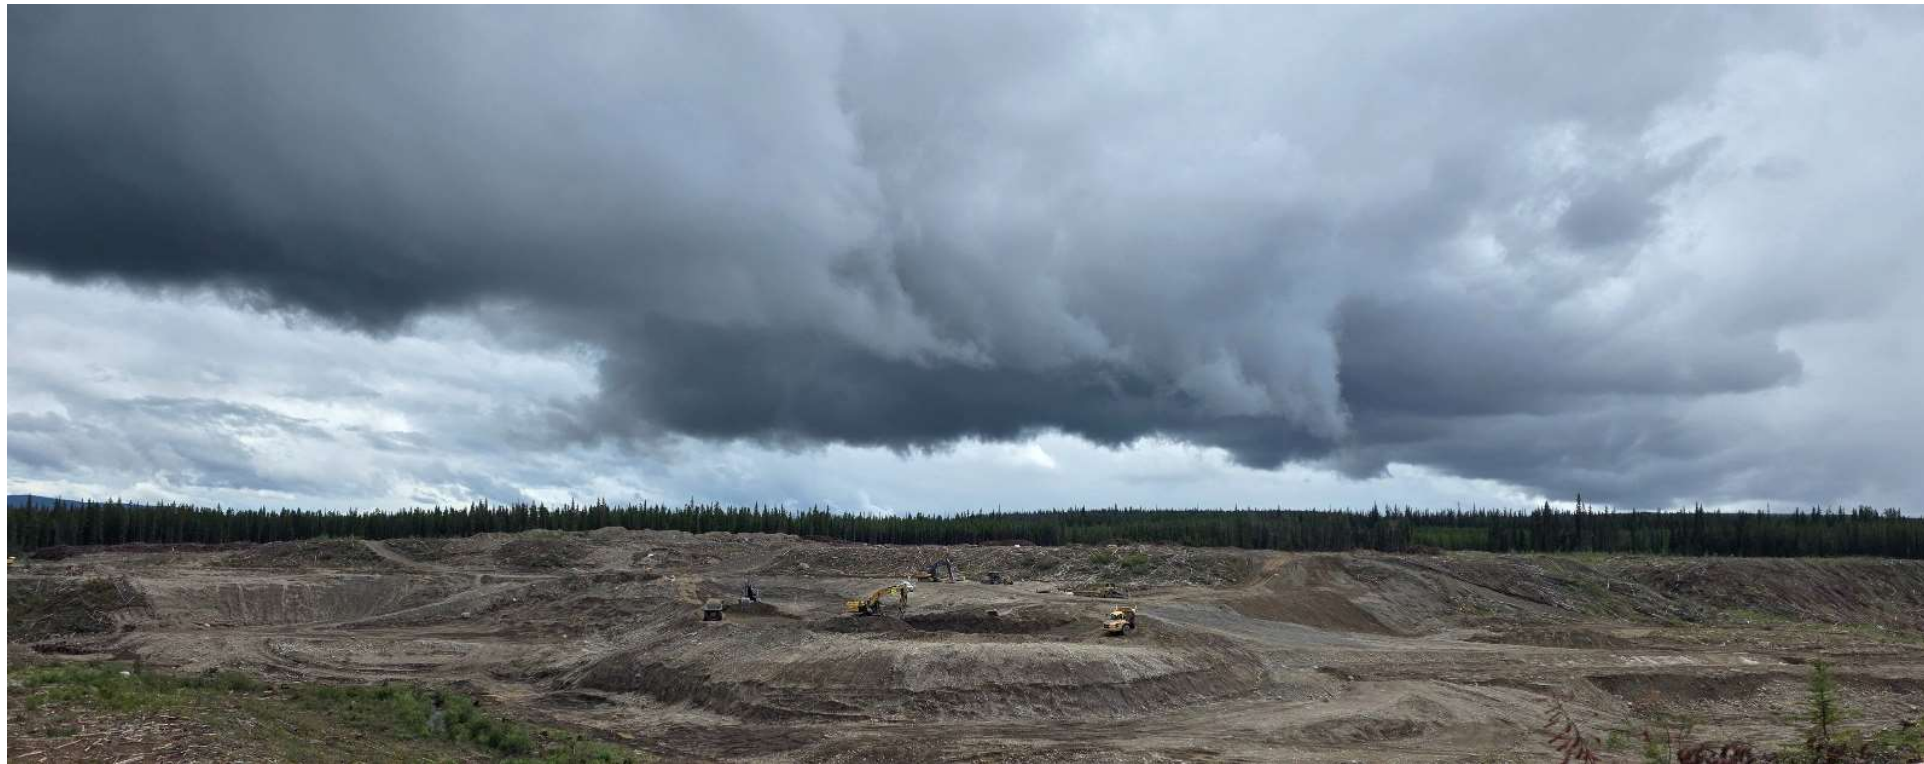
Photo 114202-5. Overview of crews working on excavation and shaping of the Fresh Water Reservoir.

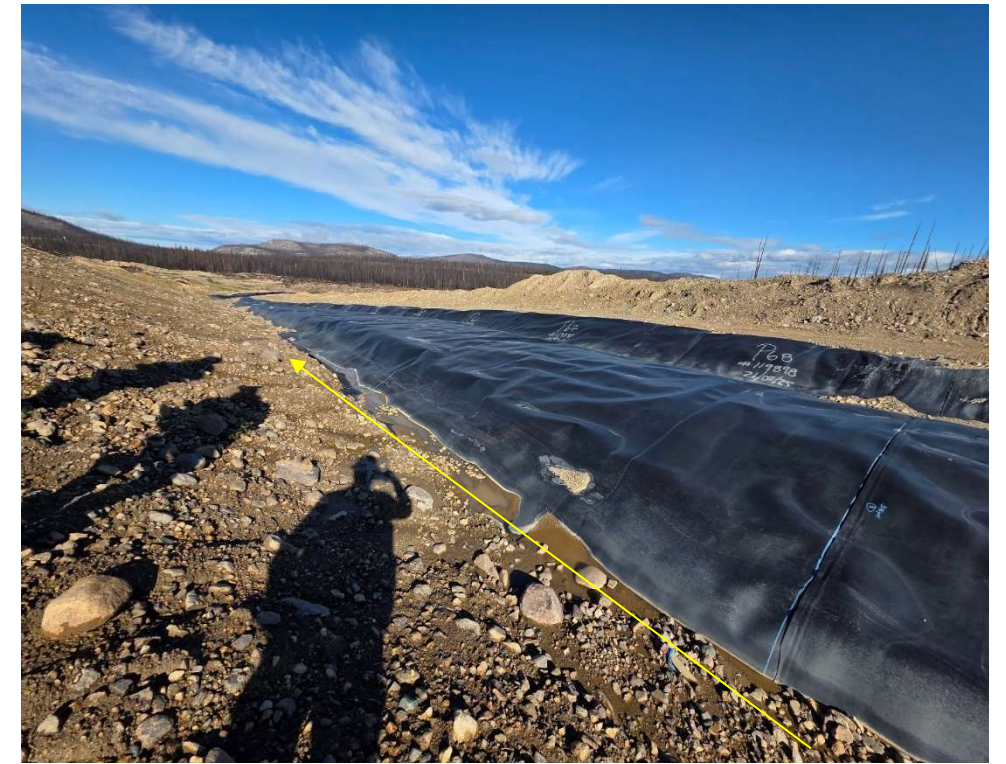
Photo 114219-4. Raised edge of LGO stockpile drainage ditch resulting in water flowing alongside channel as opposed to within it.

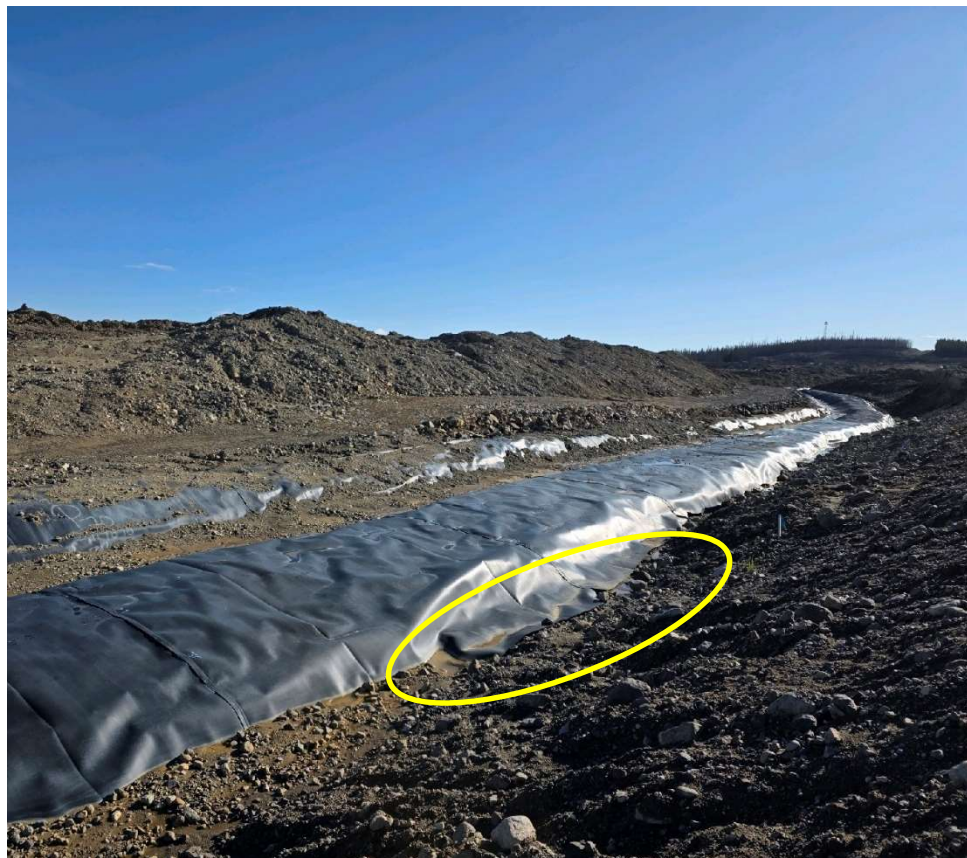
Photo 114219-2. Example location along LGO stockpile ditch line where liner is raised (not keyed in) and allowing water to flow beneath it.

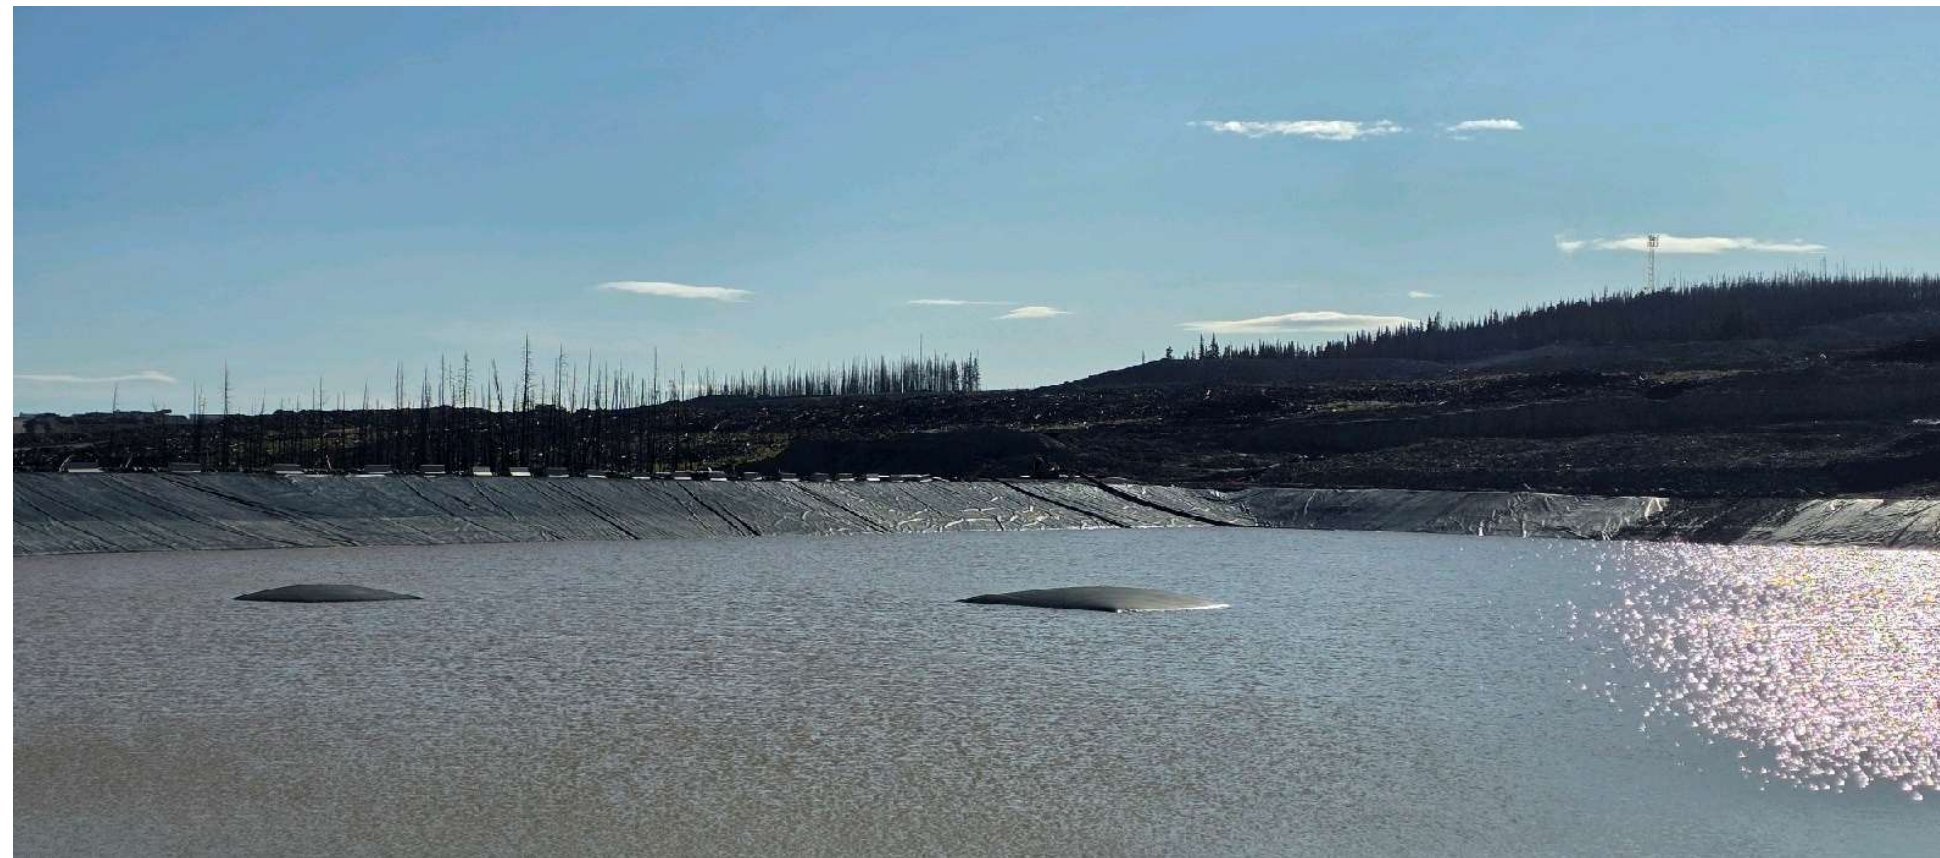
Photo 114220-1. Portions of the liner along the base of the LGO stockpile pond protruding in 'bubble-like' formations. BWG detailed the cause of the protrusions is trapped air beneath the liner and that there are no concerns with the integrity of the liner as confirmed by the Engineering departments.

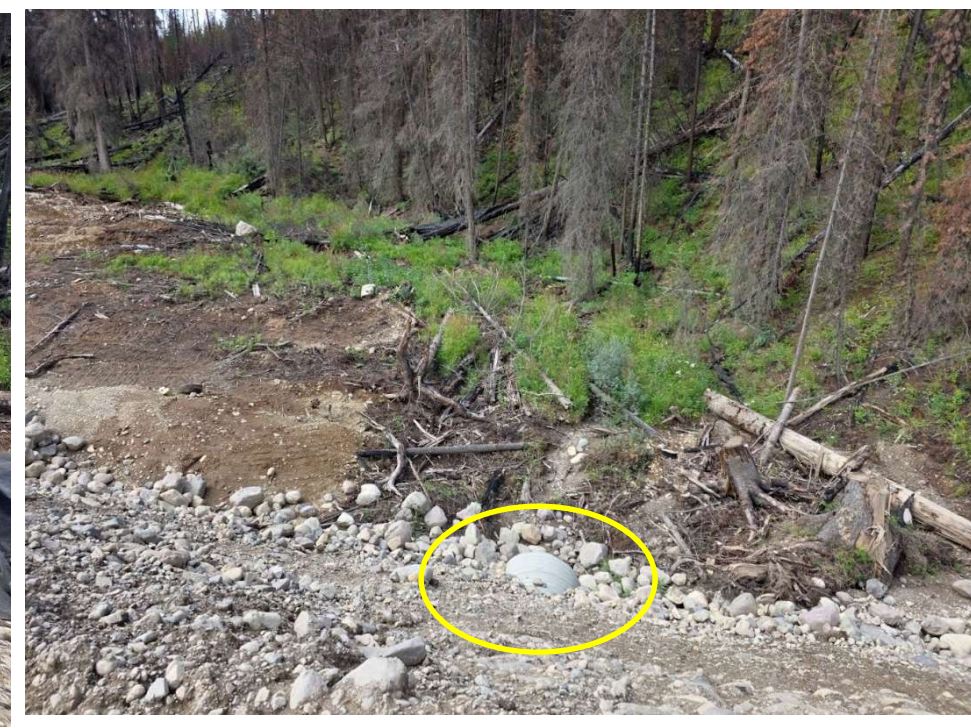
Photo 114199-1. Upstream side of culvert crossing of Watercourse 636 at 9.5km on the C-Trail access road.

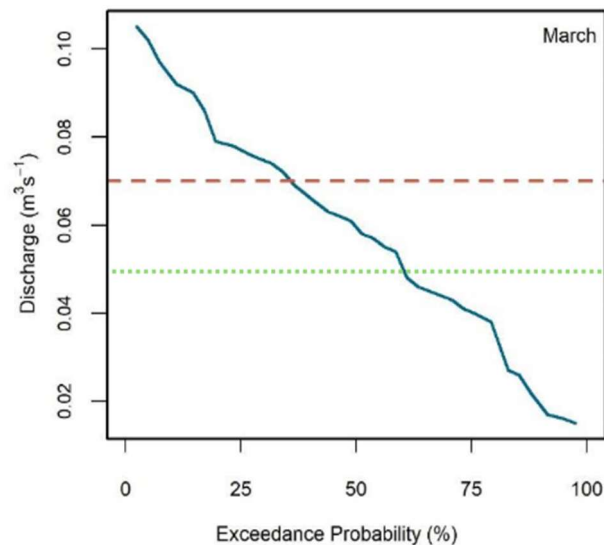
A reduction in flow below 0.07m³/s at DC-05 is not outside the parameters of the natural flow drop in Davidson Creek for the month of March with flows only having exceeded the CIFN threshold 35% of the time within the data set between 1981-2020 (Figure 3, Palmer, 2023b). Appendix D: Construction Phase Temporary Minimum Flow Threshold Memo of the FAA application states, “*The proposed temporary threshold is significantly more conservative during winter than it is during summer.*” (page 10, Palmer, 2023b). The CIFN being conservative provides a buffer if flows are reduced to be closer to the mean discharge of approximately 0.06m³/s.

Figure 3: March flow-duration curve (solid blue line) for Davidson Creek, using modelled monthly data (1981-2020). The dashed red line represents CFIN and dotted green line representing lowest flow recorded on March 14th, 2025 (Palmer, 2023b).

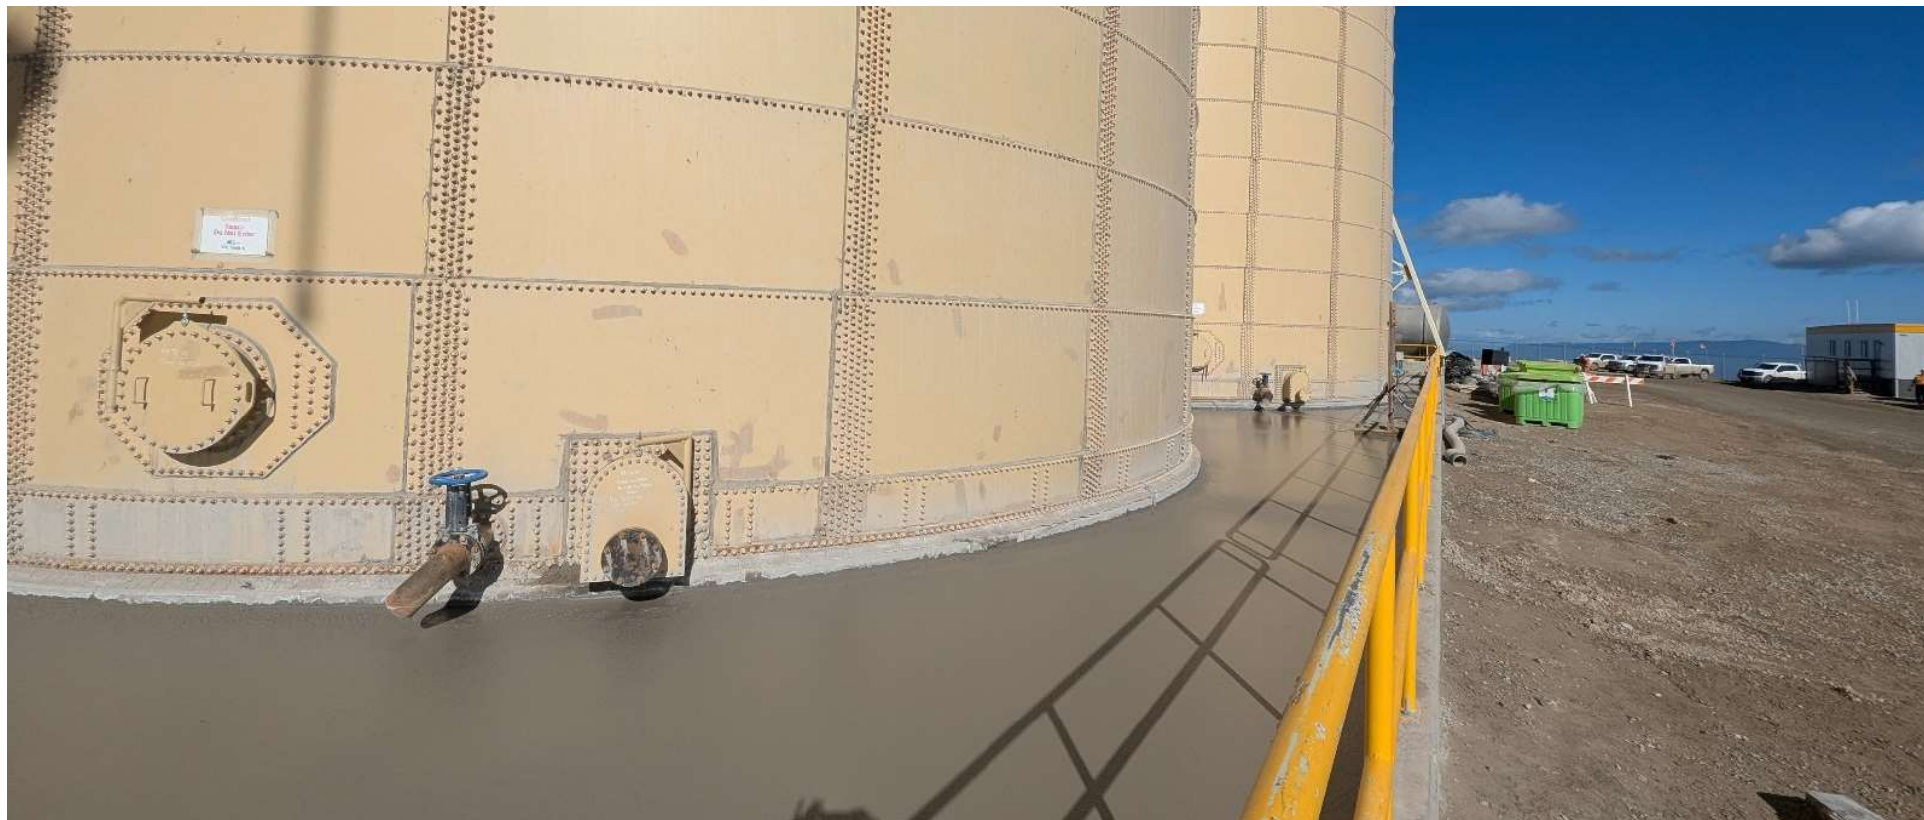
Photo 114311-4. Process slurry (containing cyanide) being temporarily held within the engineered concrete secondary containment structure surrounding the tanks during maintenance at the Plant Site.
