**Blackwater Gold Mine
IEM Site Visit Report 026
January 27 – 28, 2025**

Prepared By
EDI Environmental Dynamics Inc.
3810 18th Ave
Prince George BC V2N 4V5

EDI Project
21P0403
January 2025

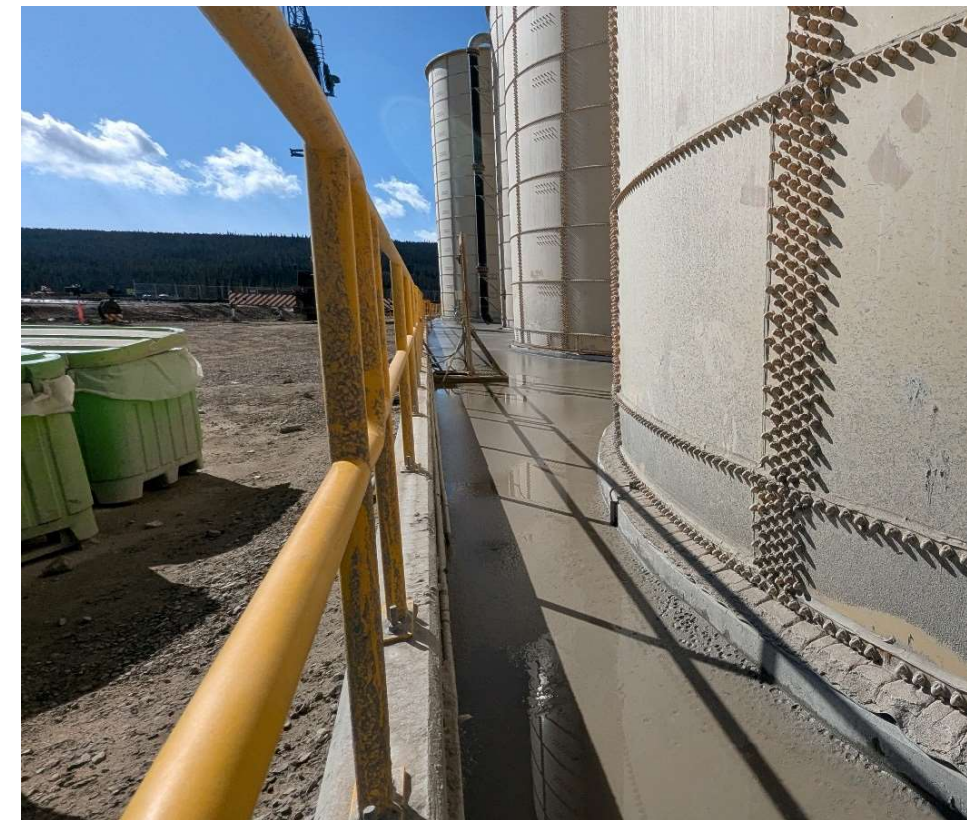
Photo 114311-10. Process slurry (containing cyanide) being temporarily held within the engineered concrete secondary containment structure surrounding the tanks during maintenance at the Plant Site.

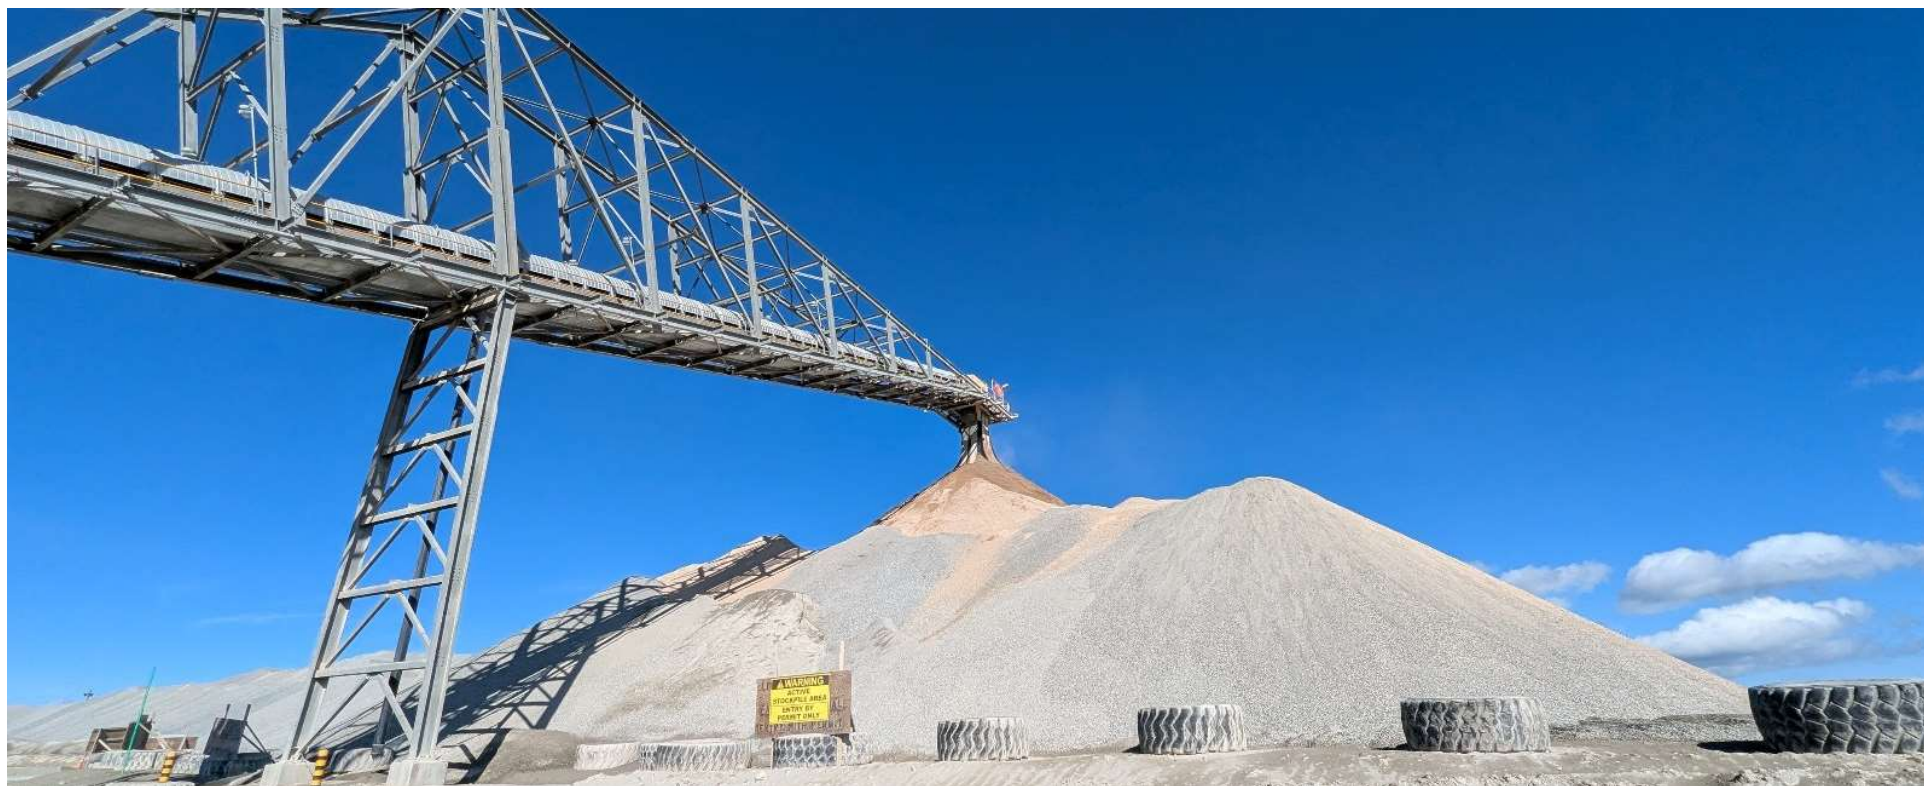
Photo 114312-1. Overview of high-grade ore stockpile at the Plant Site. BWG advised sprayers have recently been installed near the drop point from the conveyor to the pile.

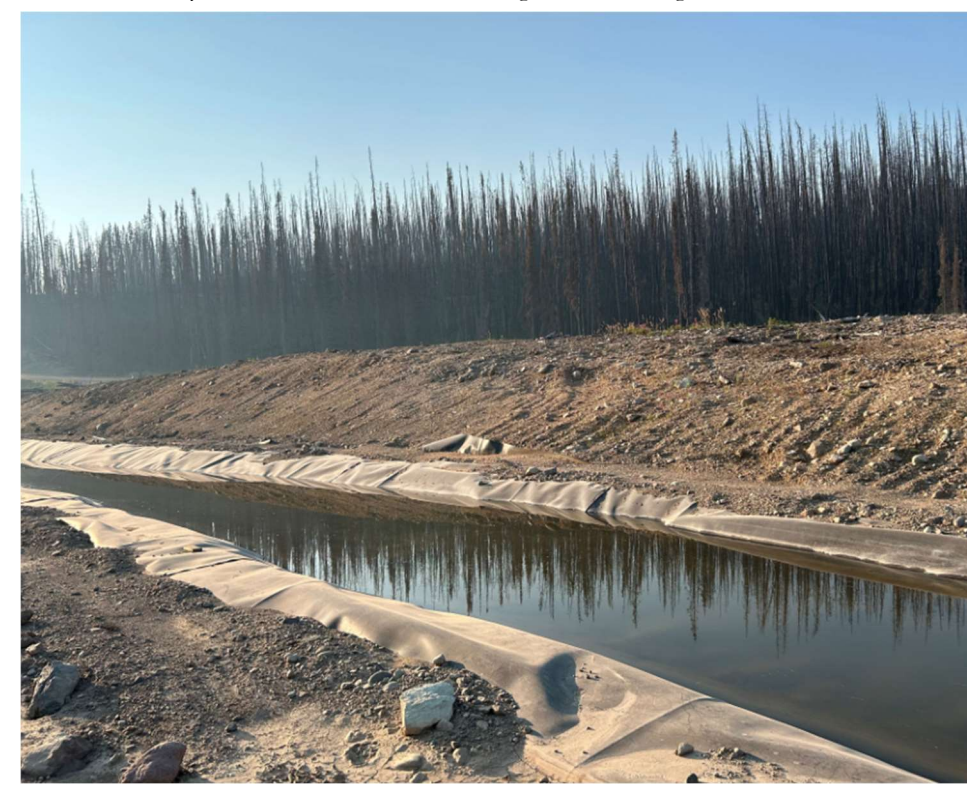
Photo 4. Confirmation of removal of sediment accumulation from the South Collection Channel. Photograph provided by BWG on September 8, 2025.

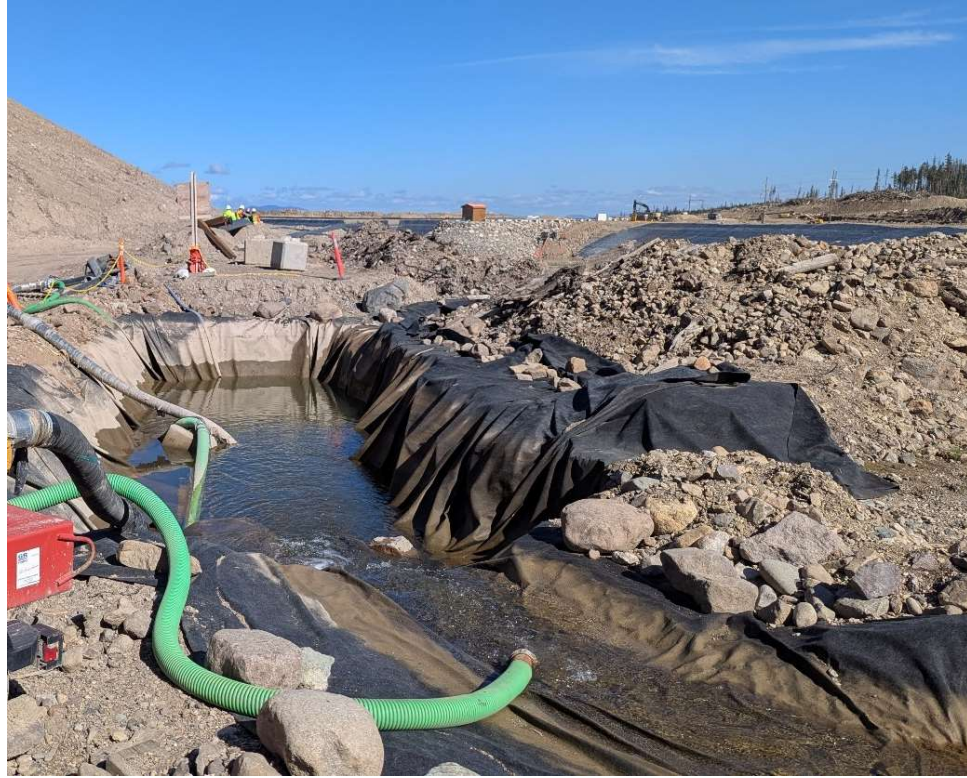
Photo 114314-2. Collection point for water from Mine Creek prior to entry into the WMP. Water is being pumped to CWTP via the South Collection Channel.

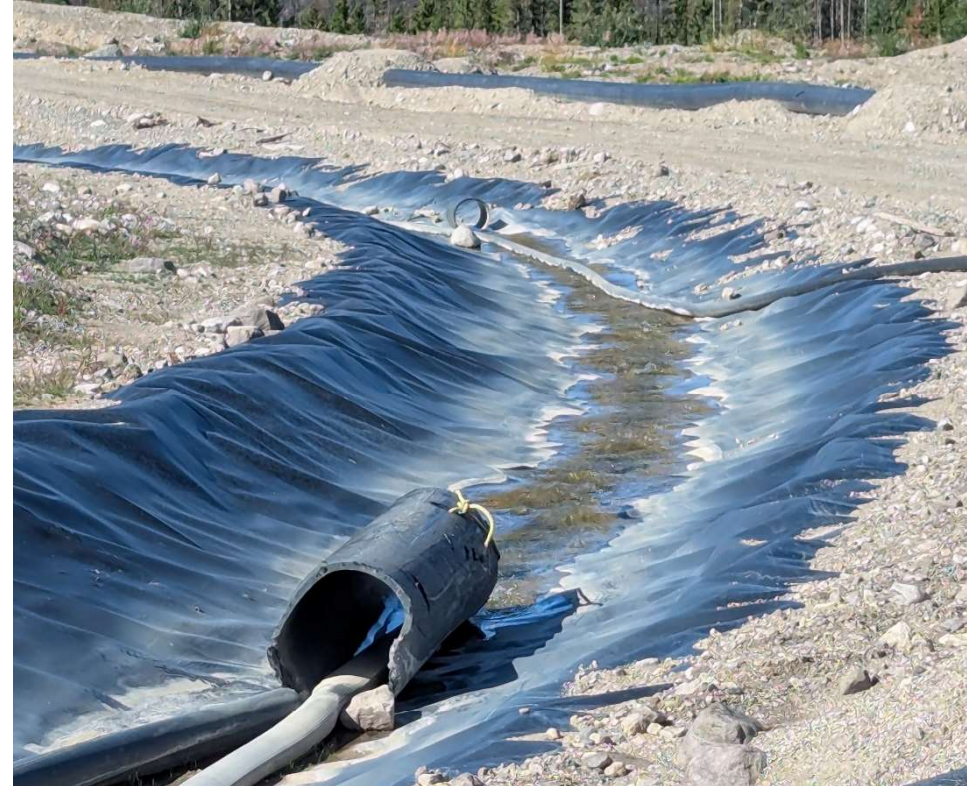
Photo 114314-5. Discharge point of water from the Mine Creek Diversion (prior to entering WMP) into the South Collection Channel (ultimately leads to the CWTP).

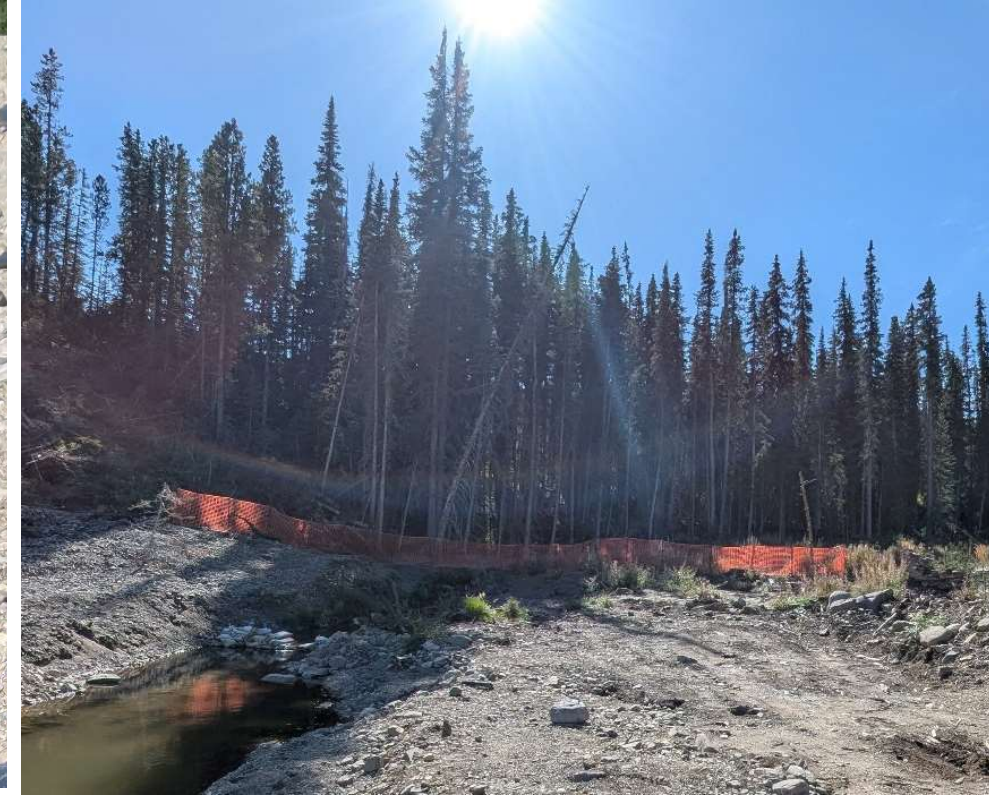
Photo 114313-3. Fencing installed at inlet to WMP to deter wildlife entry.

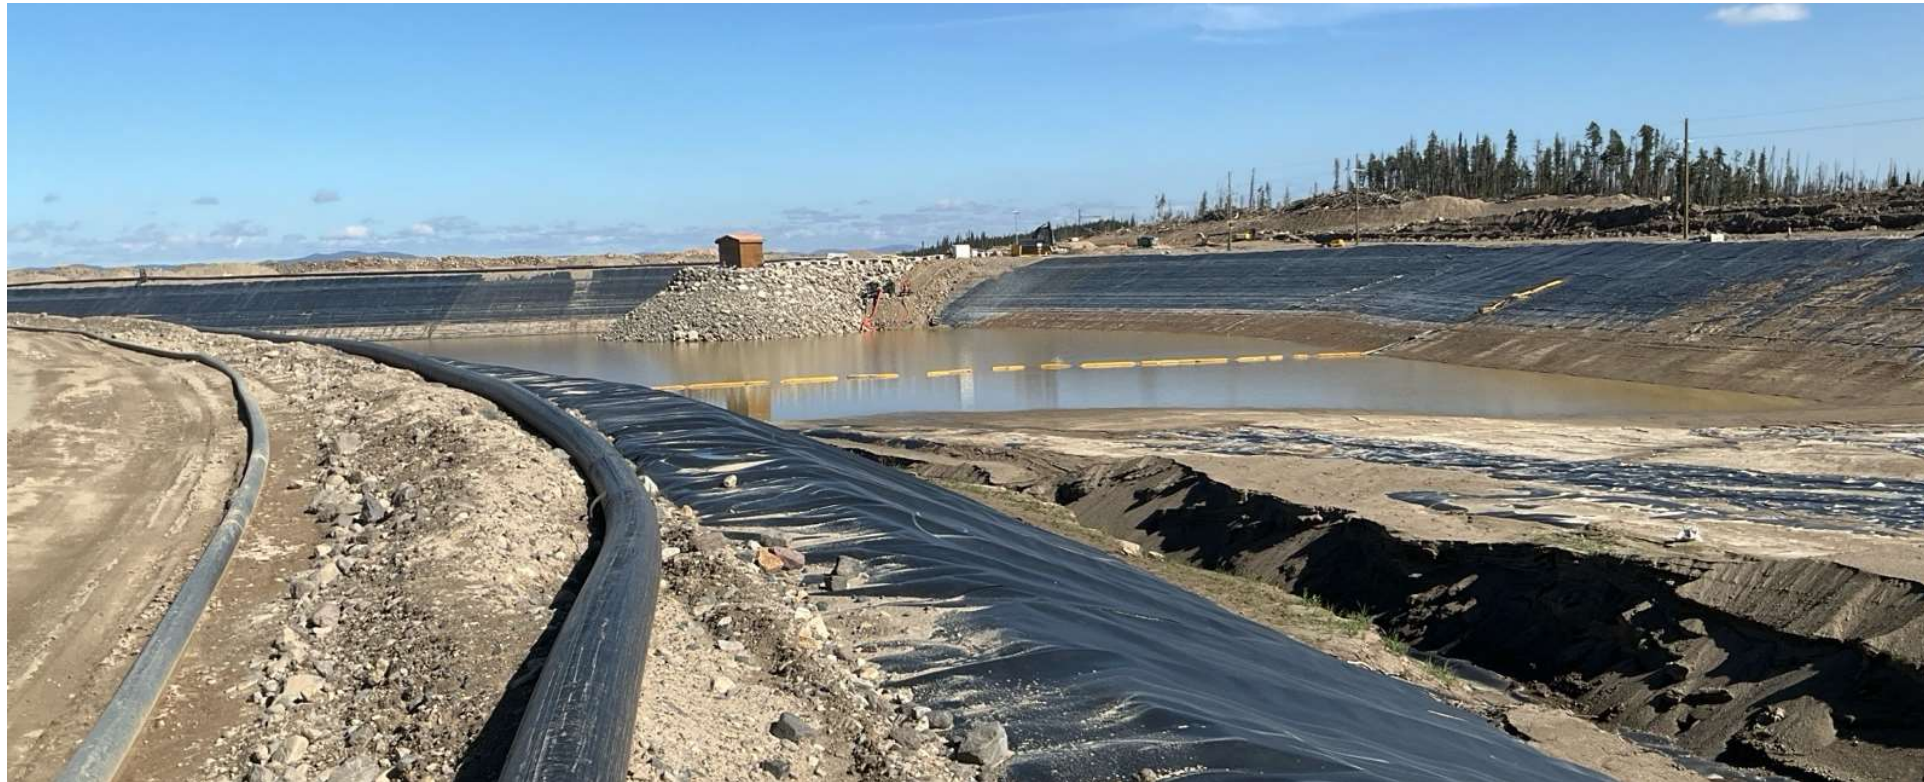
Photo 114313-7. Overview of the WMP. Decant tower currently not able to be used to send water to Plant Site due to sediment accumulation within the pump intakes.

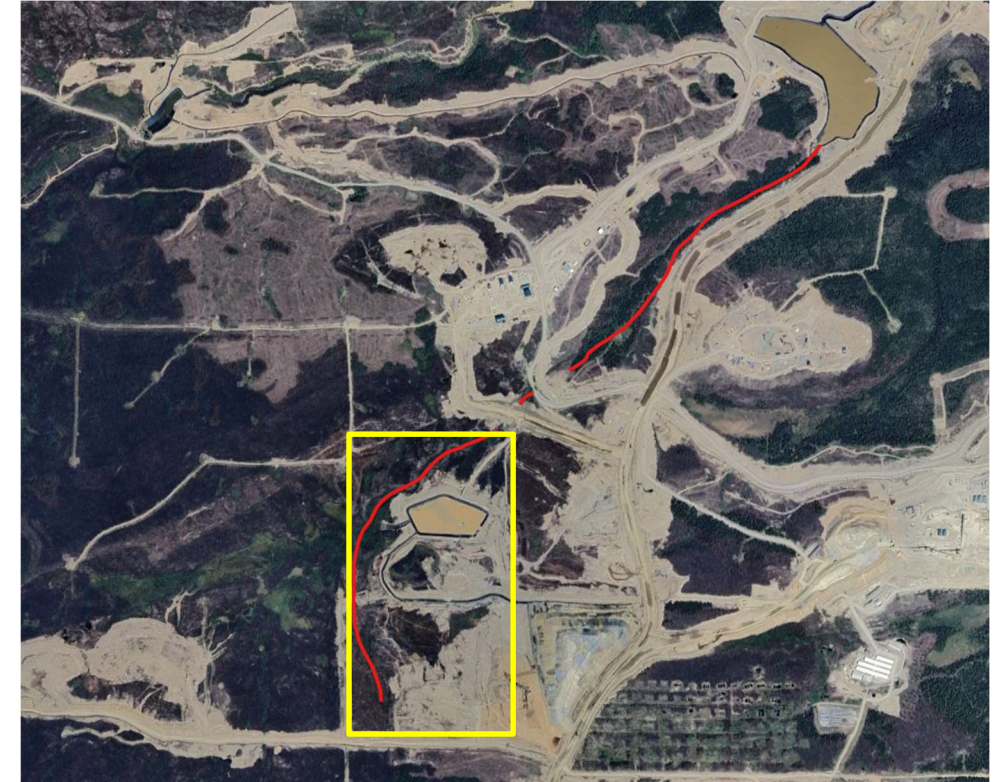
Photo 9. Approximate area where various ESC and water management measures will be installed to attempt to improve the quality of water that flows into the WMP. Approximate pathway of Mine Creek (which drains into the WMP) is included in red on drawing for reference.

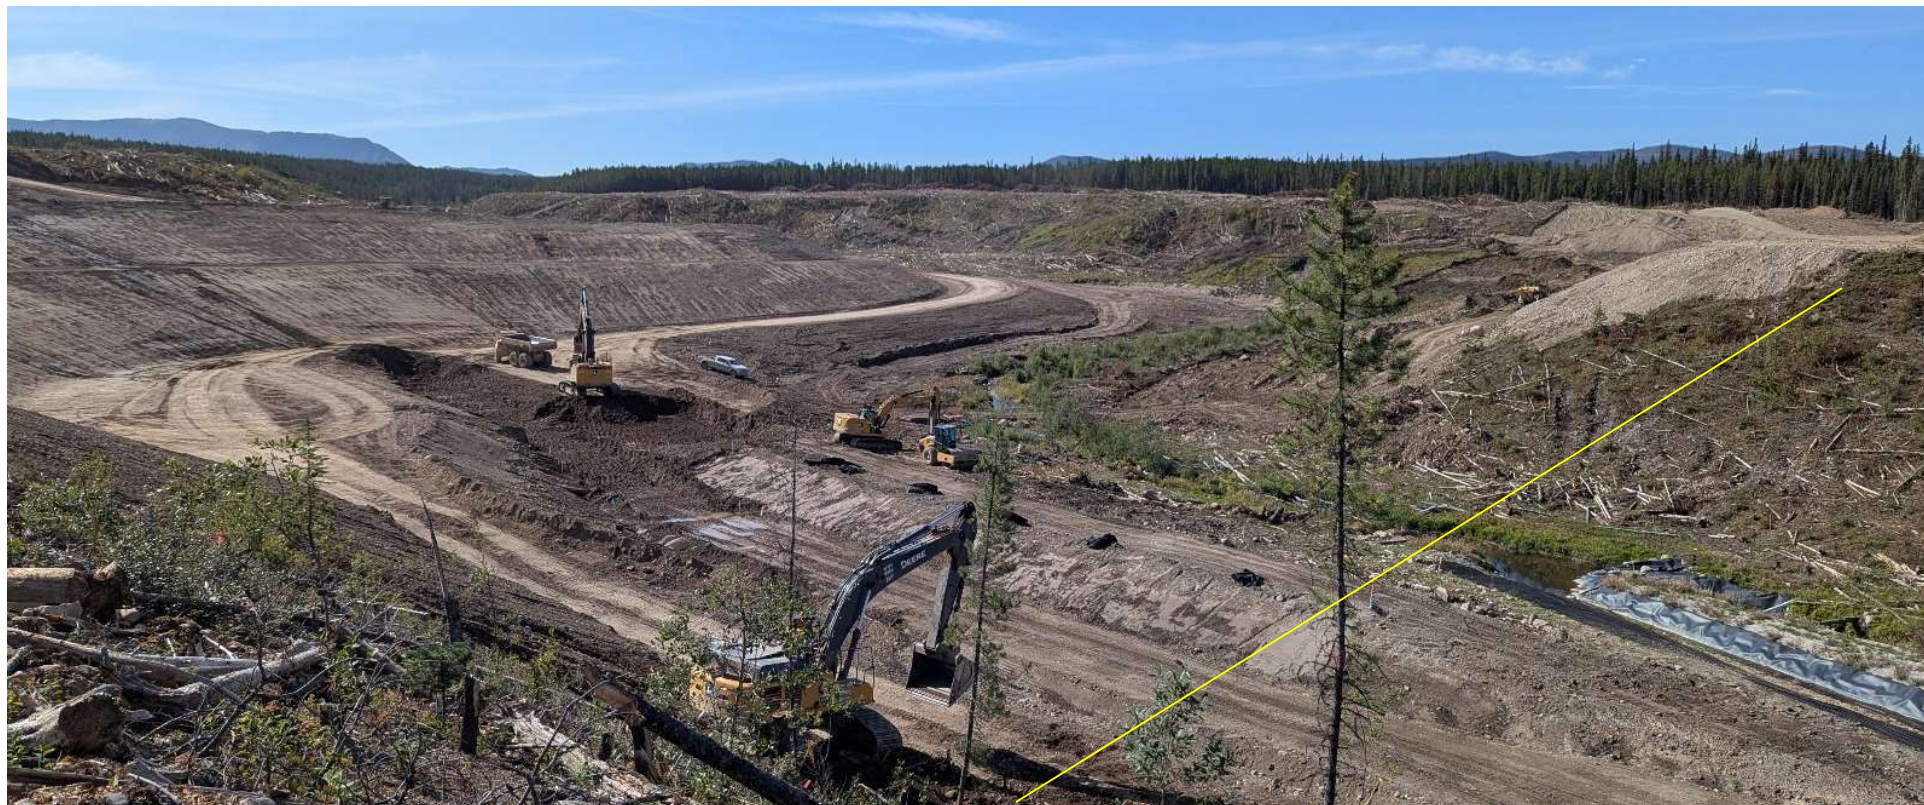
Photo 114317-7. Overview of crews working within the FWR. Approximate centerline of future dam indicated on photo.

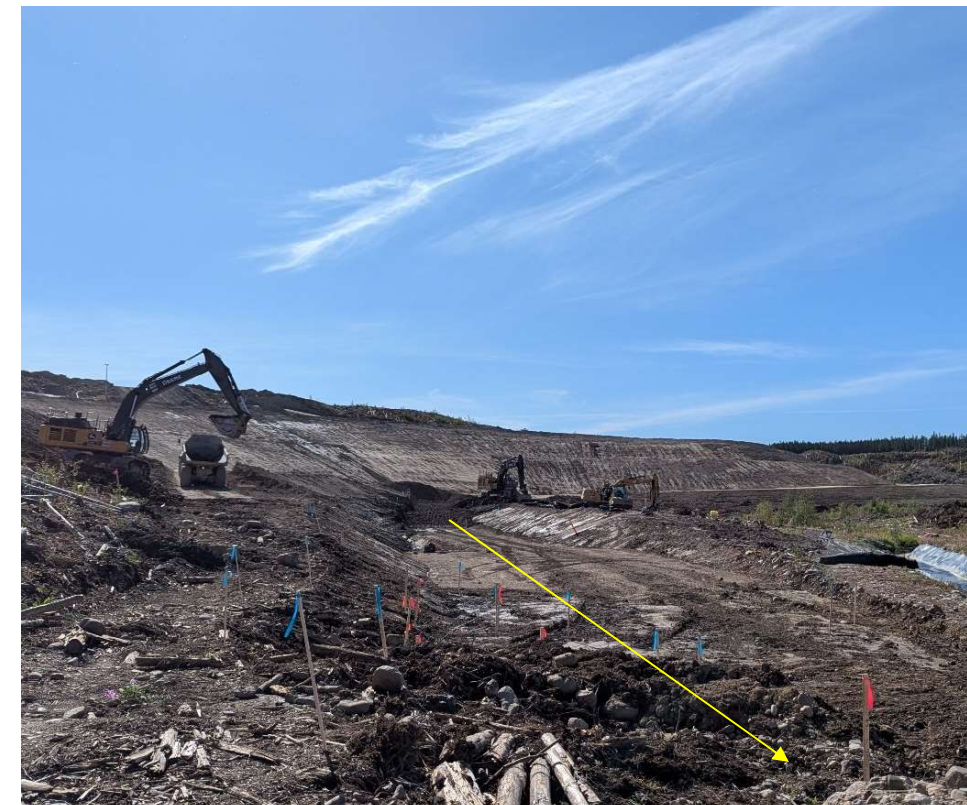
Photo 114317-1. Works on the floor of the FWR to develop the future diversion channel and concrete flow chamber structure to facilitate water passage through the site during construction, and ultimately IFNs to Davidson Creek from downstream side of dam once complete. Flow direction indicated on photo.

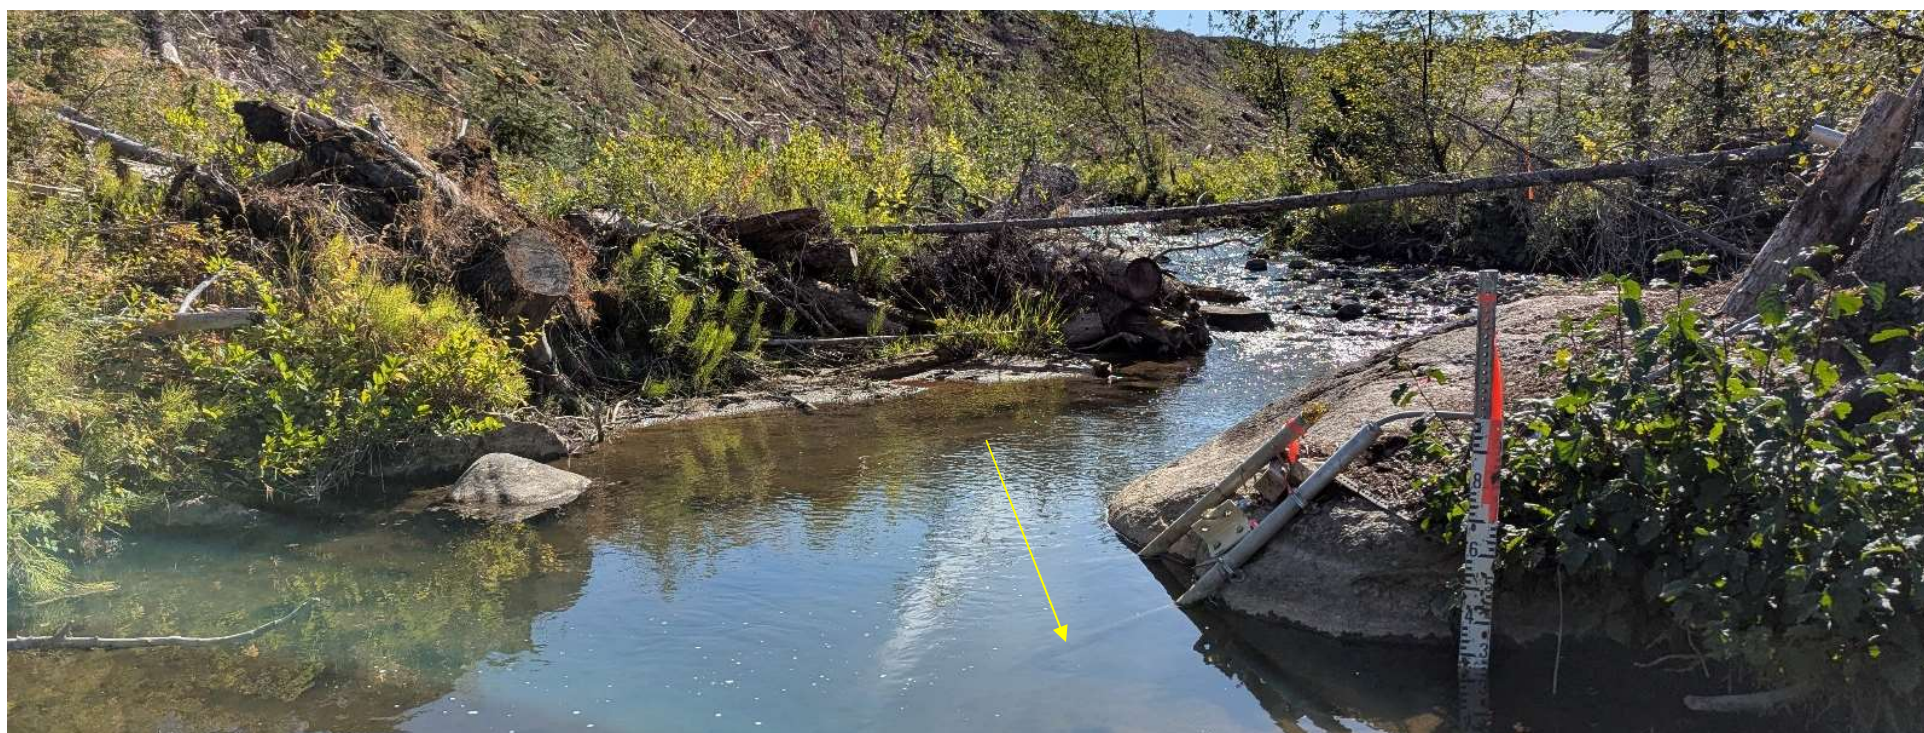
Photo 114318-4. Overview of Davidson Creek compliance sampling point for water quality and instream flow needs (DC-05). Location of probes indicated on photo.

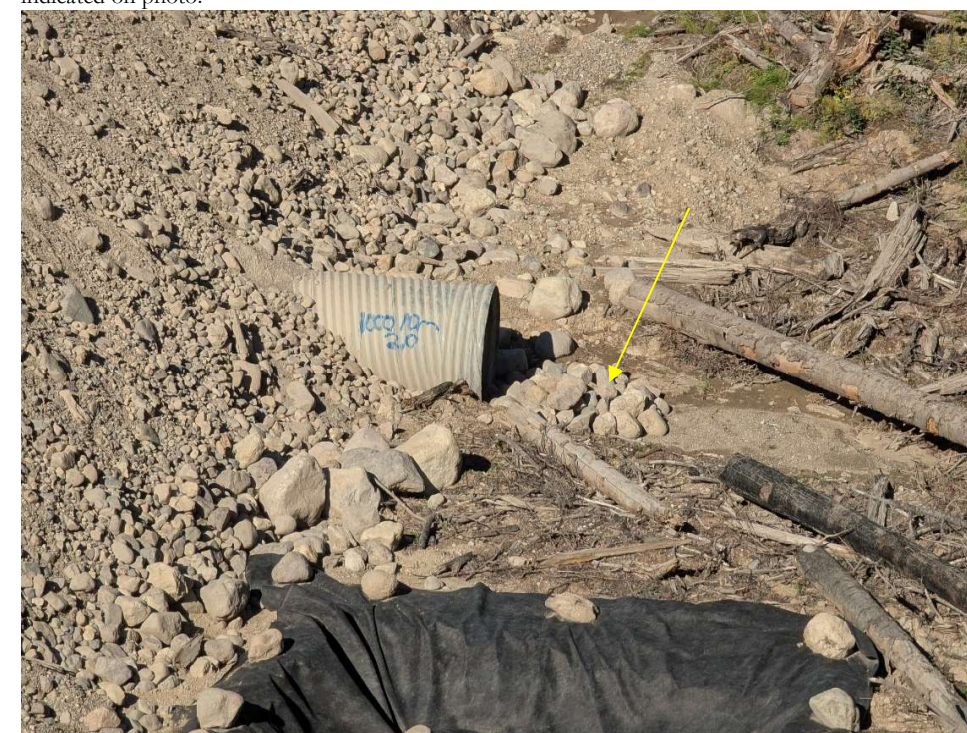
Photo 114319-1. Rock placed at outlet of culvert at Watercourse 636 at crossing along C-Trail Access Road (kilometer 9.5).

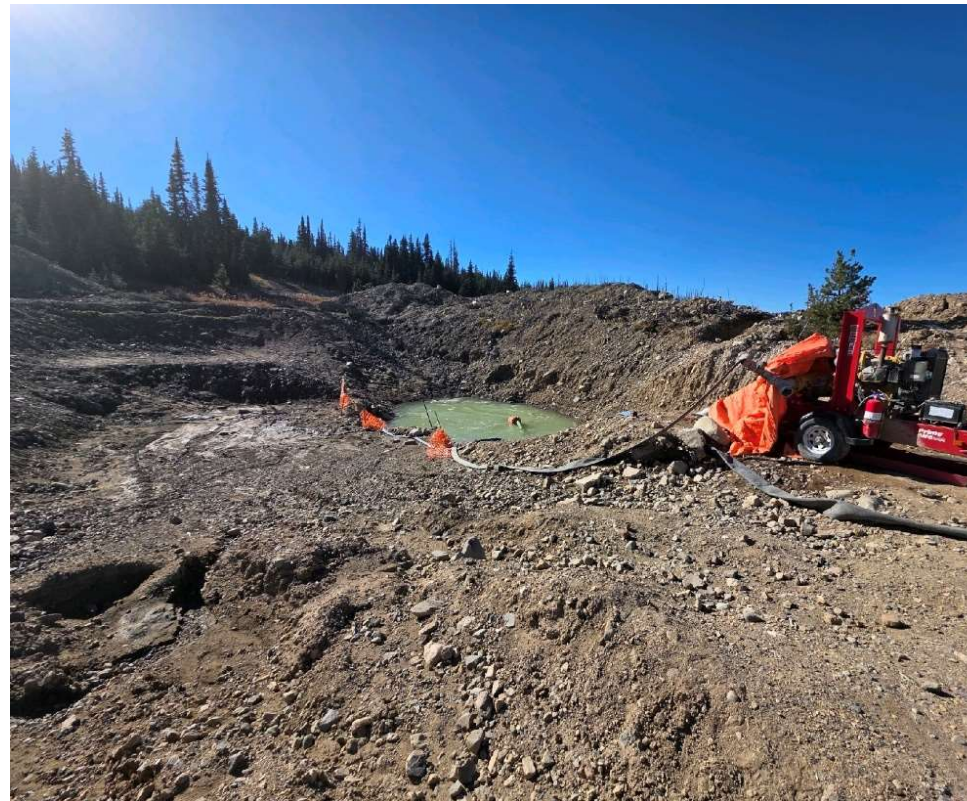
Open Pit/Ore Body	
<p>The IEM team completed a visit to the area south (upslope) of the Open Pit to observe a groundwater capture sump which has been established to intercept and divert water around the open pit (Photo 114451-1). Water captured within this collection sump is pumped to a ditch immediately west and sends the water towards the Mine Creek drainage which ultimately terminates in the Water Management Pond.</p>	No
<p>Water that has come into contact with potentially acid generating (PAG) material (PAG contact water) within the open pit, is currently being captured and managed at two locations (Photo 2).</p> <p>Within the Open Pit, PAG contact water is captured in a low spot in the northwestern portion of the Pit and is understood to be hauled (by vac-truck) to the plant site to be passed through the metals water treatment plant and used for process water. Following onsite discussions, the IEM team understands a more permanent pipeline will be installed prior to spring of next year (preliminary works already underway) to remove the reliance of hauling by truck.</p> <p>PAG contact water is also being captured in a collection sump along the lower extent of the haul road. Following onsite discussions, the IEM team understands PAG contact water collected at this location is being transported by vac-truck to the LGO stockpile pond. A more permanent solution is also expected to be constructed prior to spring, and is likely to involve the installation of a pipeline to the plant site to facilitate water removal from the area.</p>	No

Photo 114451-1. Groundwater capture sump upslope of the open pit. Water from the sump is being pumped to a ditch line which sends the water towards the Mine Creek drainage (terminating within the WMP).

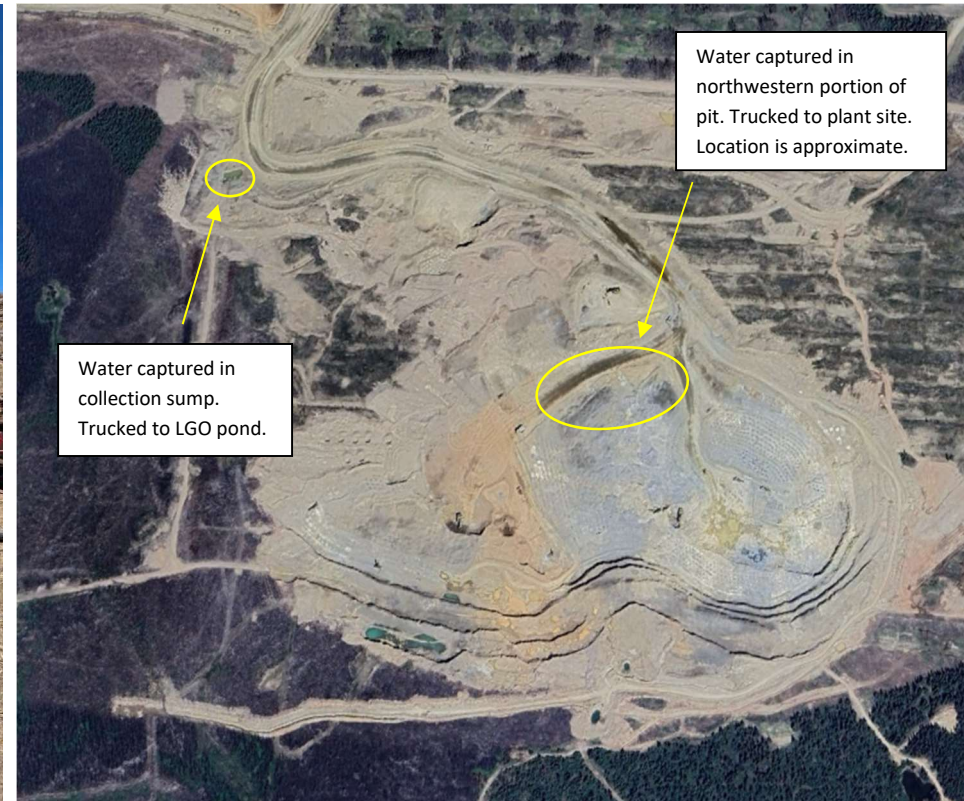
Photo 2. Locations of PAG contact water capture points at the Open Pit.

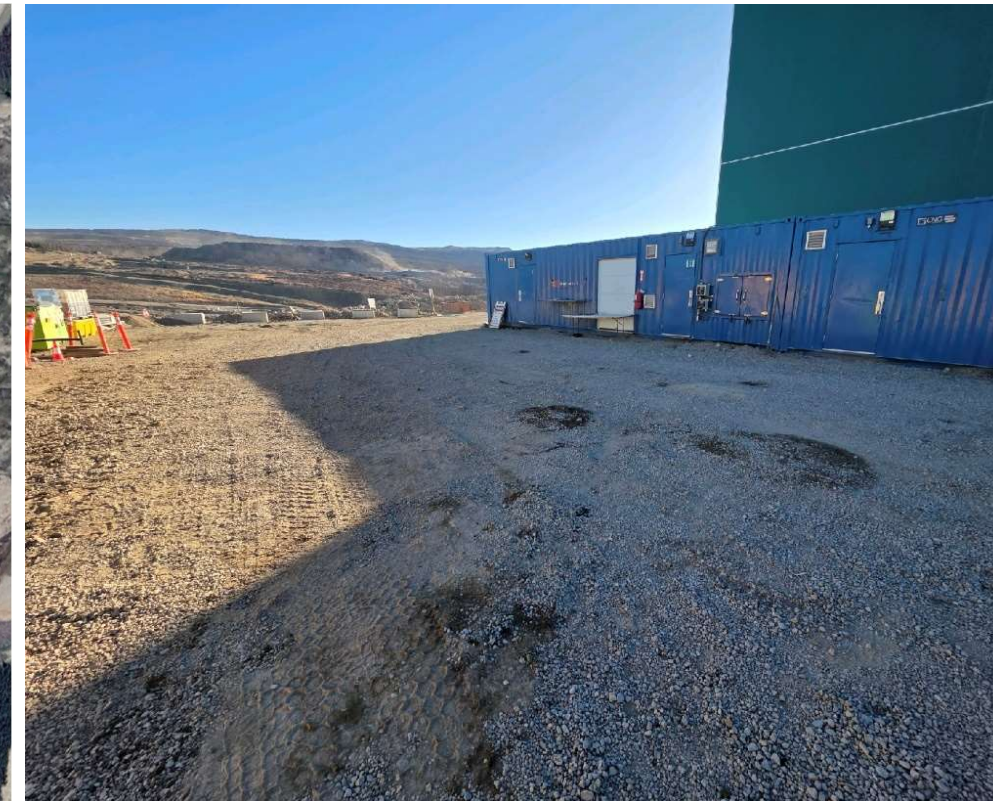
Mine Site Laydowns	
<p>Several hydrocarbon stains were observed on the ground adjacent to a service bay tent at the Mobile Maintenance Yard (Photo 114471-1). Following discussions with BWG, the IEM team understands this location has a liner installed beneath it to prevent spills from migrating into the ground. It was recommended the observed spills be cleaned up to prevent tracking of hydrocarbon outside of the lined area. This matter was submitted as an opportunity for improvement.</p> <p>BWG confirmed all spills had been cleaned up on October 17, 2025 (Photo 4).</p>	No
<p>Hydrocarbon stains were observed on the ground behind an excavator (unit 3703) staged at the western end of the Mobile Maintenance Yard (Record ID-114472). Confirmation the spill had been cleaned up was provided on October 21, 2025.</p>	Closed
<p>Spills to ground were noted beneath three small pieces of equipment staged at the Andrew's Hill laydown. As BWG crews were in the process of cleaning up the spills, this matter was not issued as a non-compliance, however, the IEM team requested notification once the spills had been cleaned up. Confirmation that all spills had been cleaned up was provided by BWG on October 21, 2025.</p>	No

Photo 114471-1. Several spills to ground observed within a lined area at the Mobile Maintenance Yard. Opportunity for improvement issued to prevent tracking of hydrocarbon contamination out of lined area.

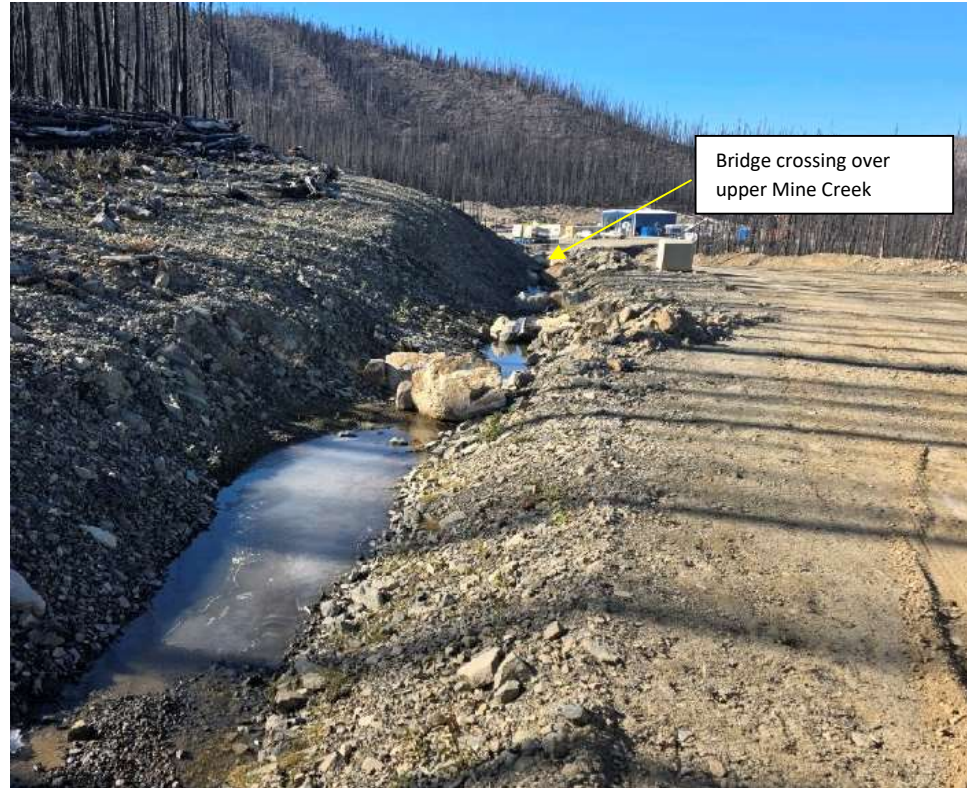
Photo 114456-1. Rock energy dissipaters installed within the ditch line along eastern approach to the bridge crossing over Mine Creek to the explosive magazine area.

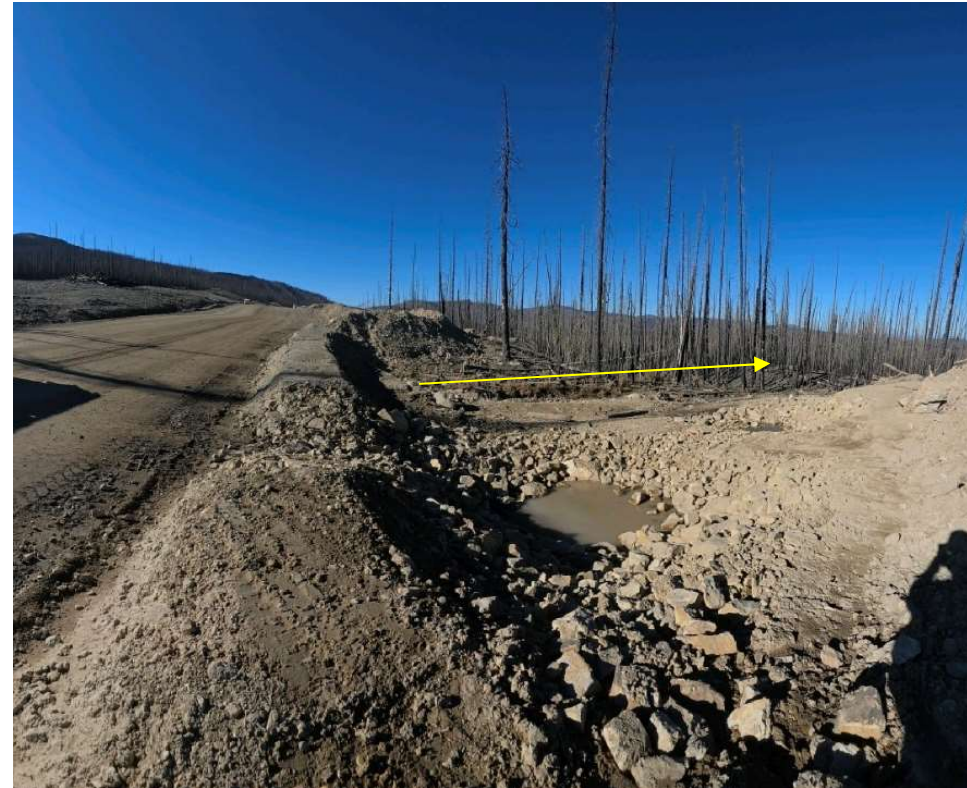
Photo 114455-1. Example of a collection sump installed within the ditch line along the road to the explosive magazine area. Area has connectivity to tributary to Mine Creek. Approximate flow pathway towards tributary indicated on photo.

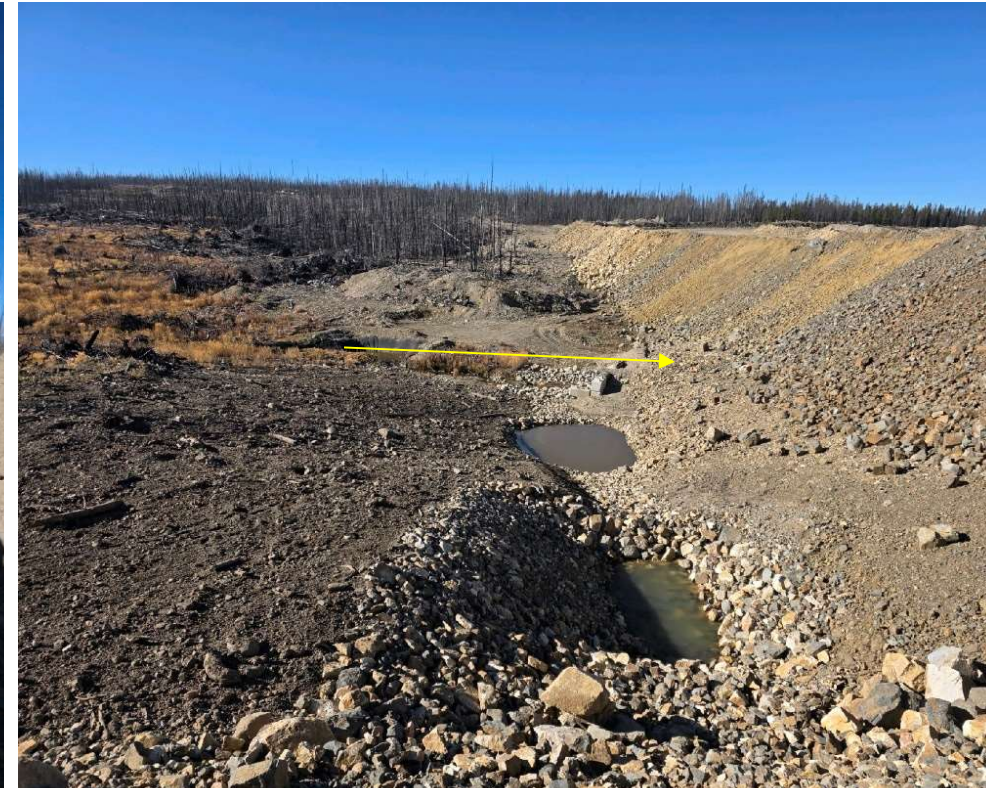
Photo 114457-2. Improvements to drainage (collection sumps, rock armoring) in drainage adjacent to the road crossing of Mine Creek downslope of the LGO stockpile pond. Mine Creek flow indicated on photo.

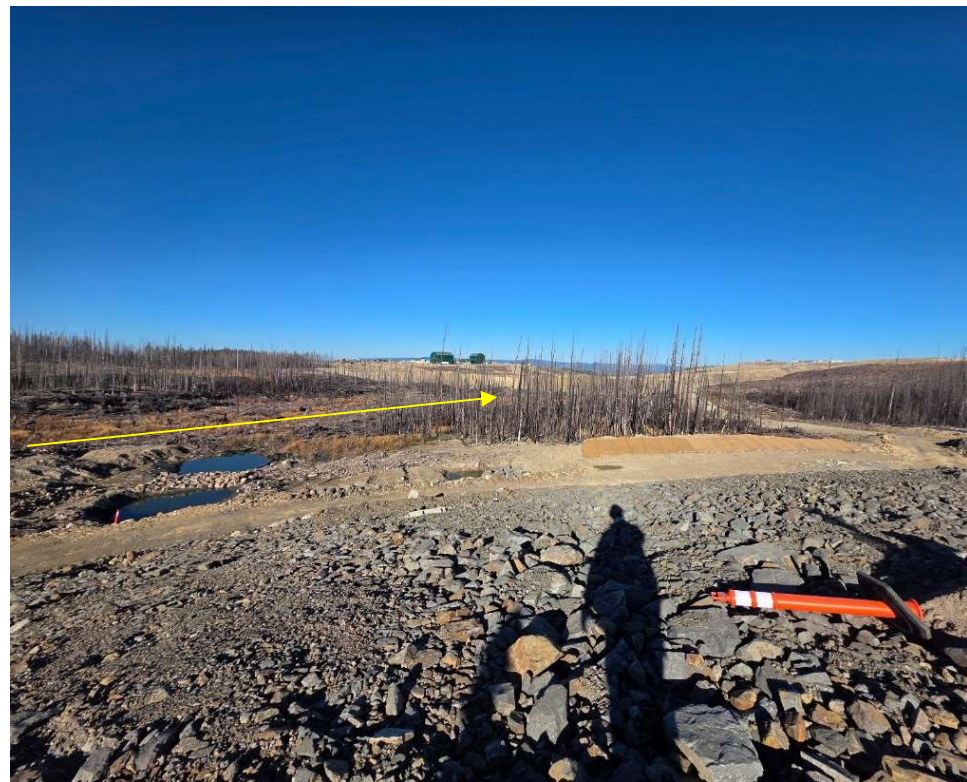
Photo 114470-15. Riprap armoring installed along slopes surrounding the LGO stockpile pond. Approximate pathway of Mine Creek indicated on photo for reference.

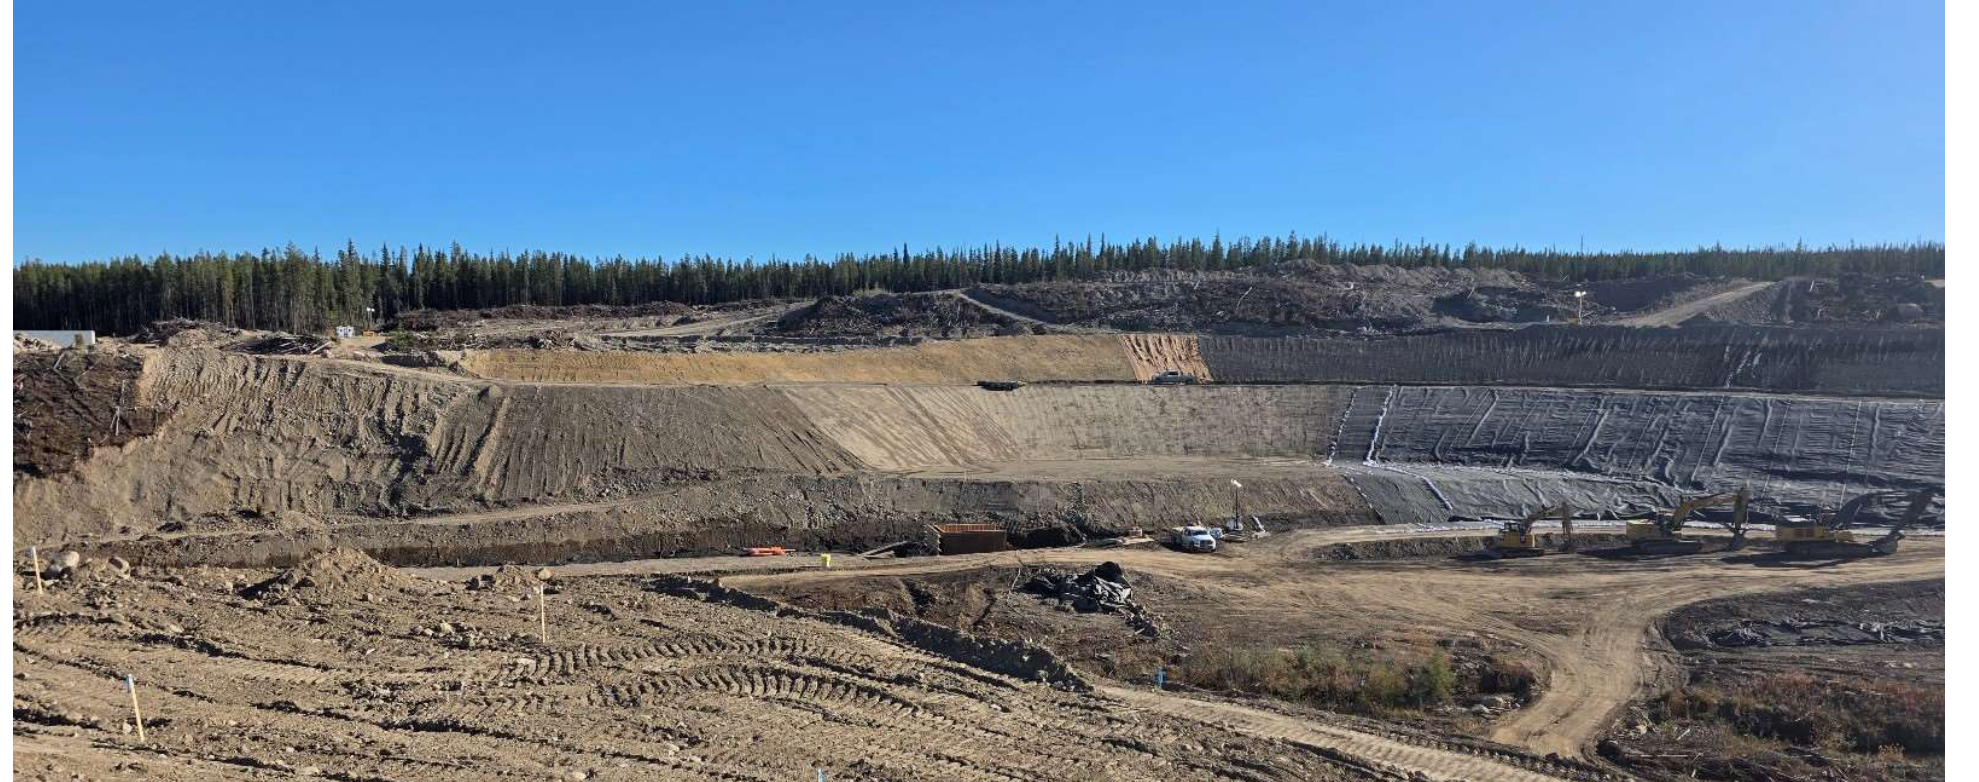
Photo 114458-2. Liner installation continues at the eastern end of the Fresh Water Reservoir.

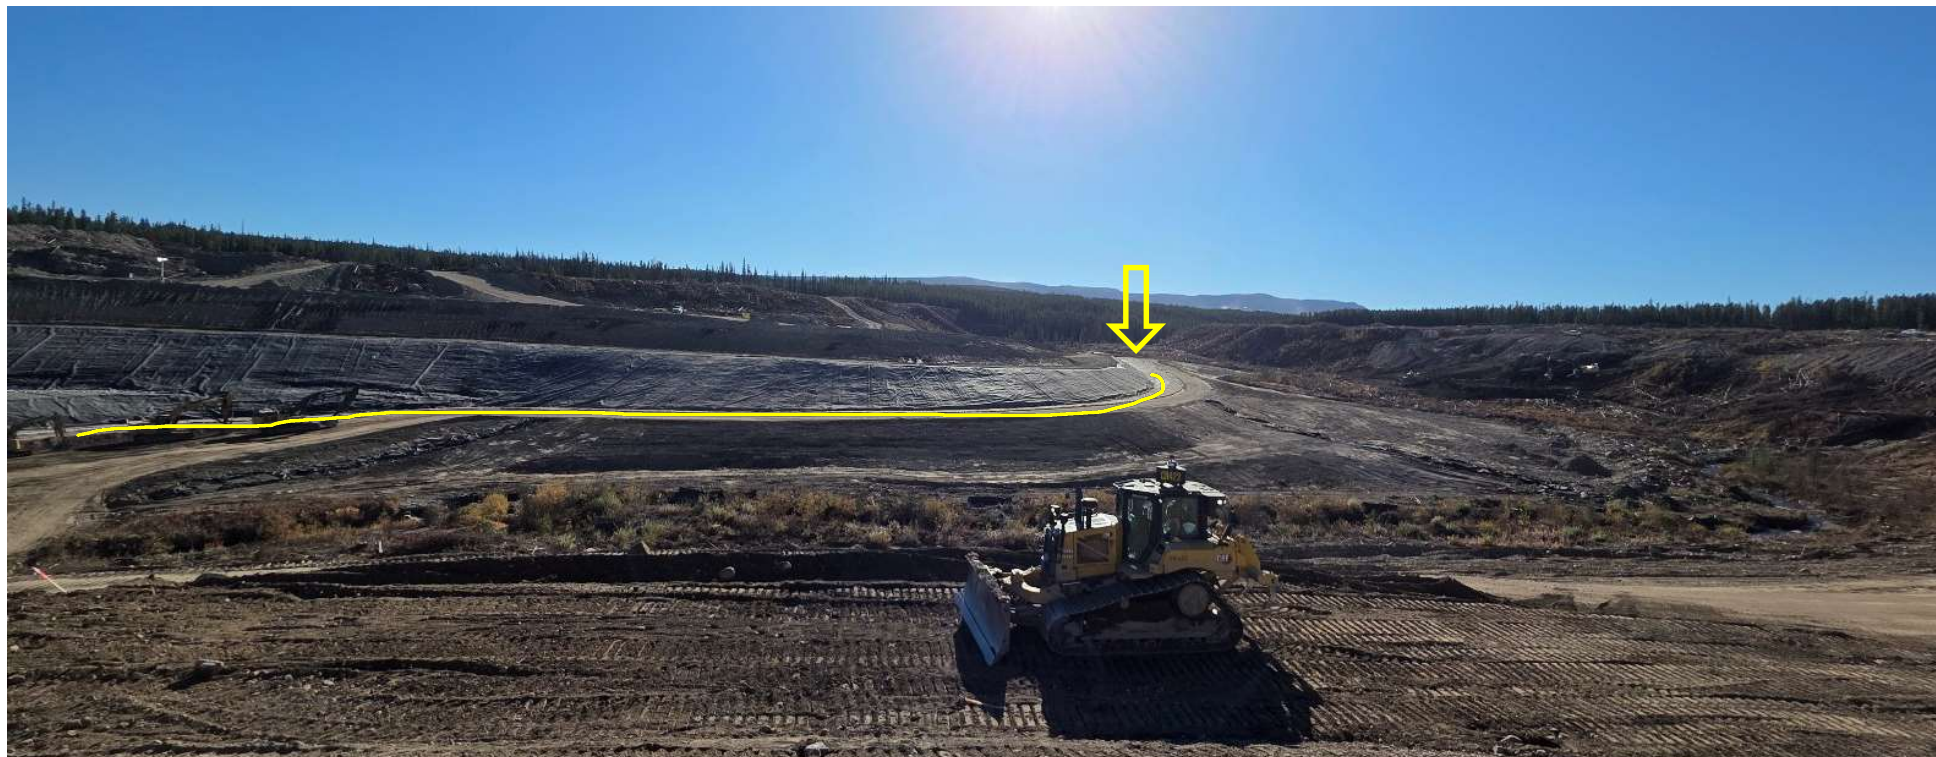
Photo 114458-3. Overview of the status of the Davidson Creek diversion channel construction within the Fresh Water Reservoir. Approximate pathway indicated on photo.

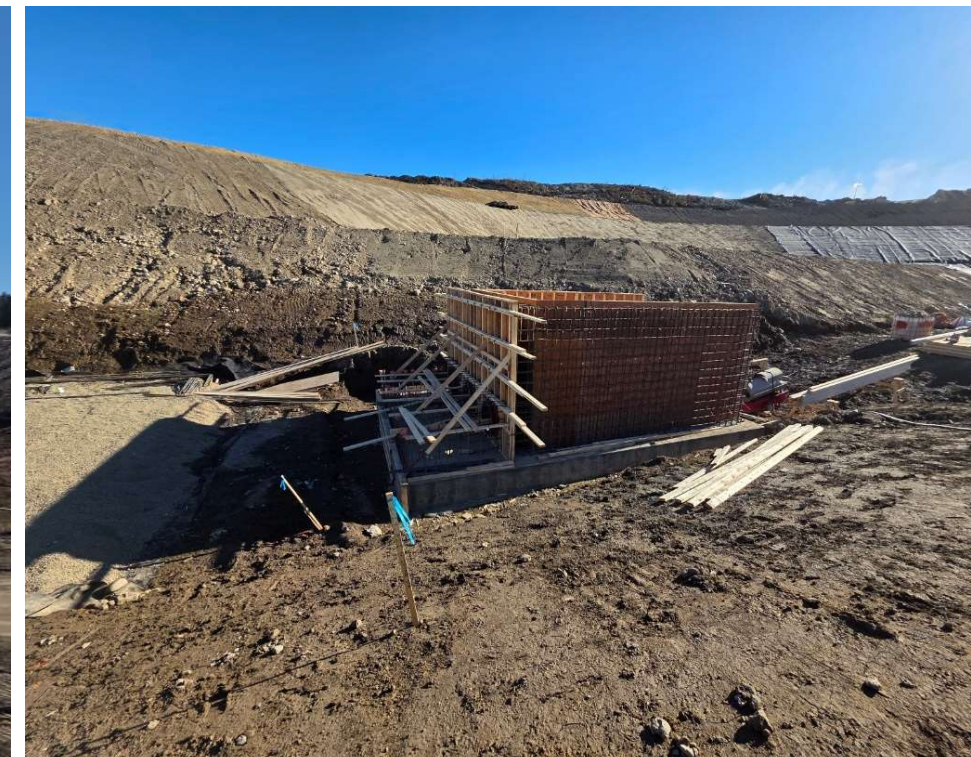
Photo 114458-11. Formwork for a portion of the concrete flow chamber structure being constructed within the Fresh Water Reservoir.
