**Blackwater Gold Mine
IEM Site Visit Report 026
January 27 – 28, 2025**

Prepared By
EDI Environmental Dynamics Inc.
3810 18th Ave
Prince George BC V2N 4V5

EDI Project
21P0403
January 2025

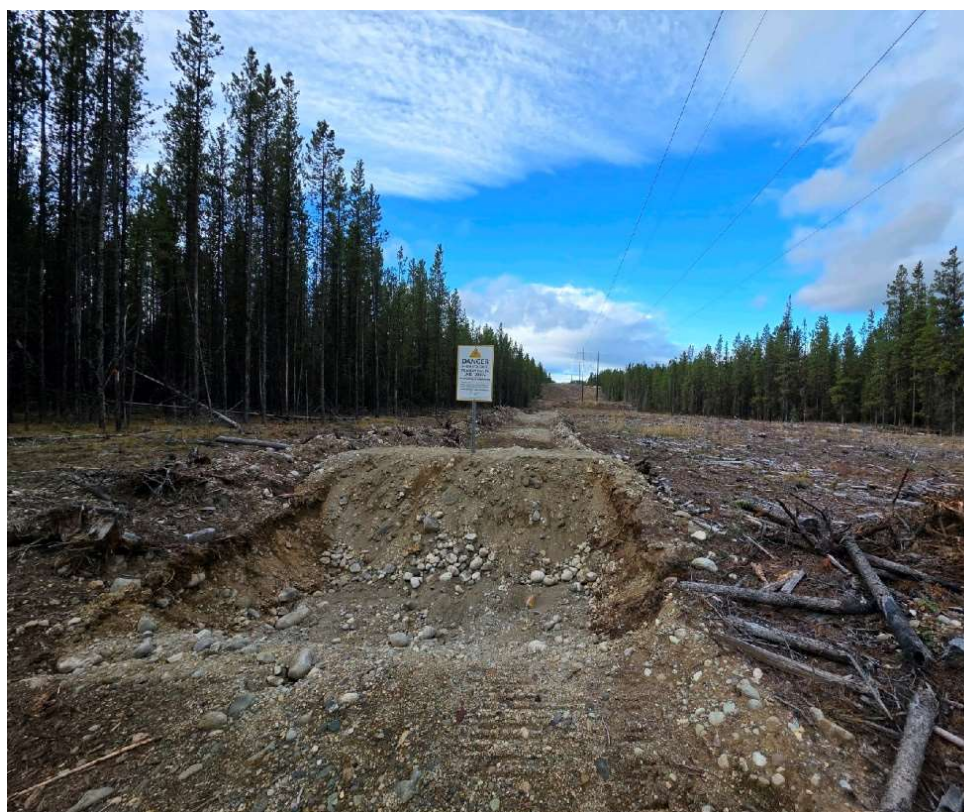
Photo 114490-4. Signage installed on top of an access road deactivation berm on the Transmission Line.

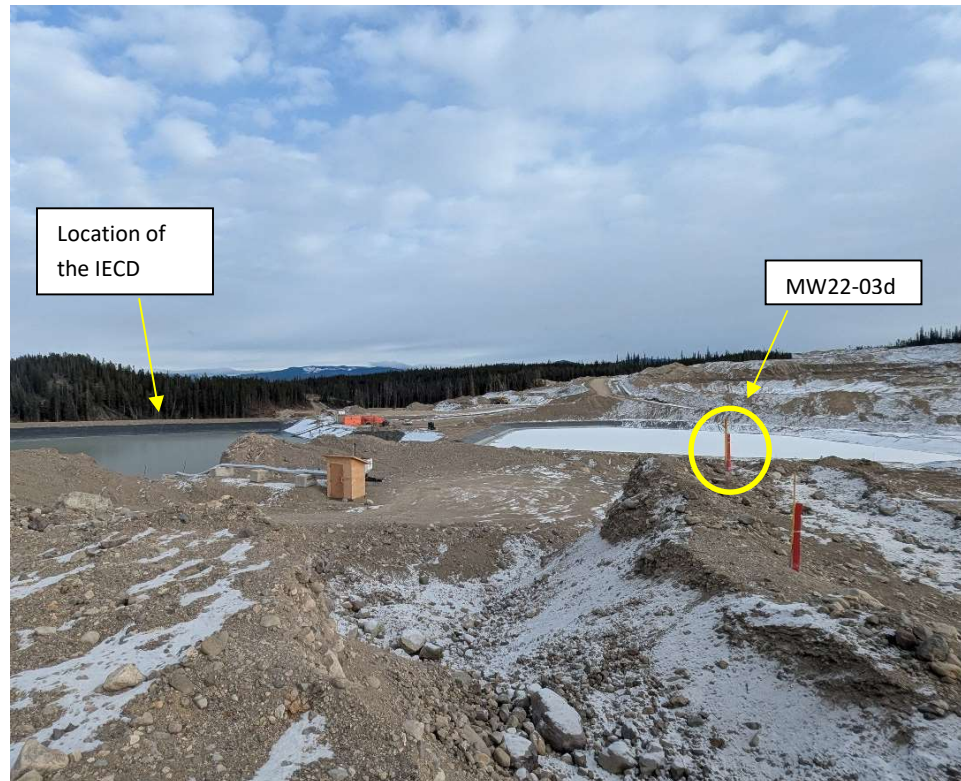
Photo 114707-4. Location of groundwater well MW22-03d between the TSF dam and IECD where WAD cyanide has been detected. Location of downstream IECD indicated on photo.

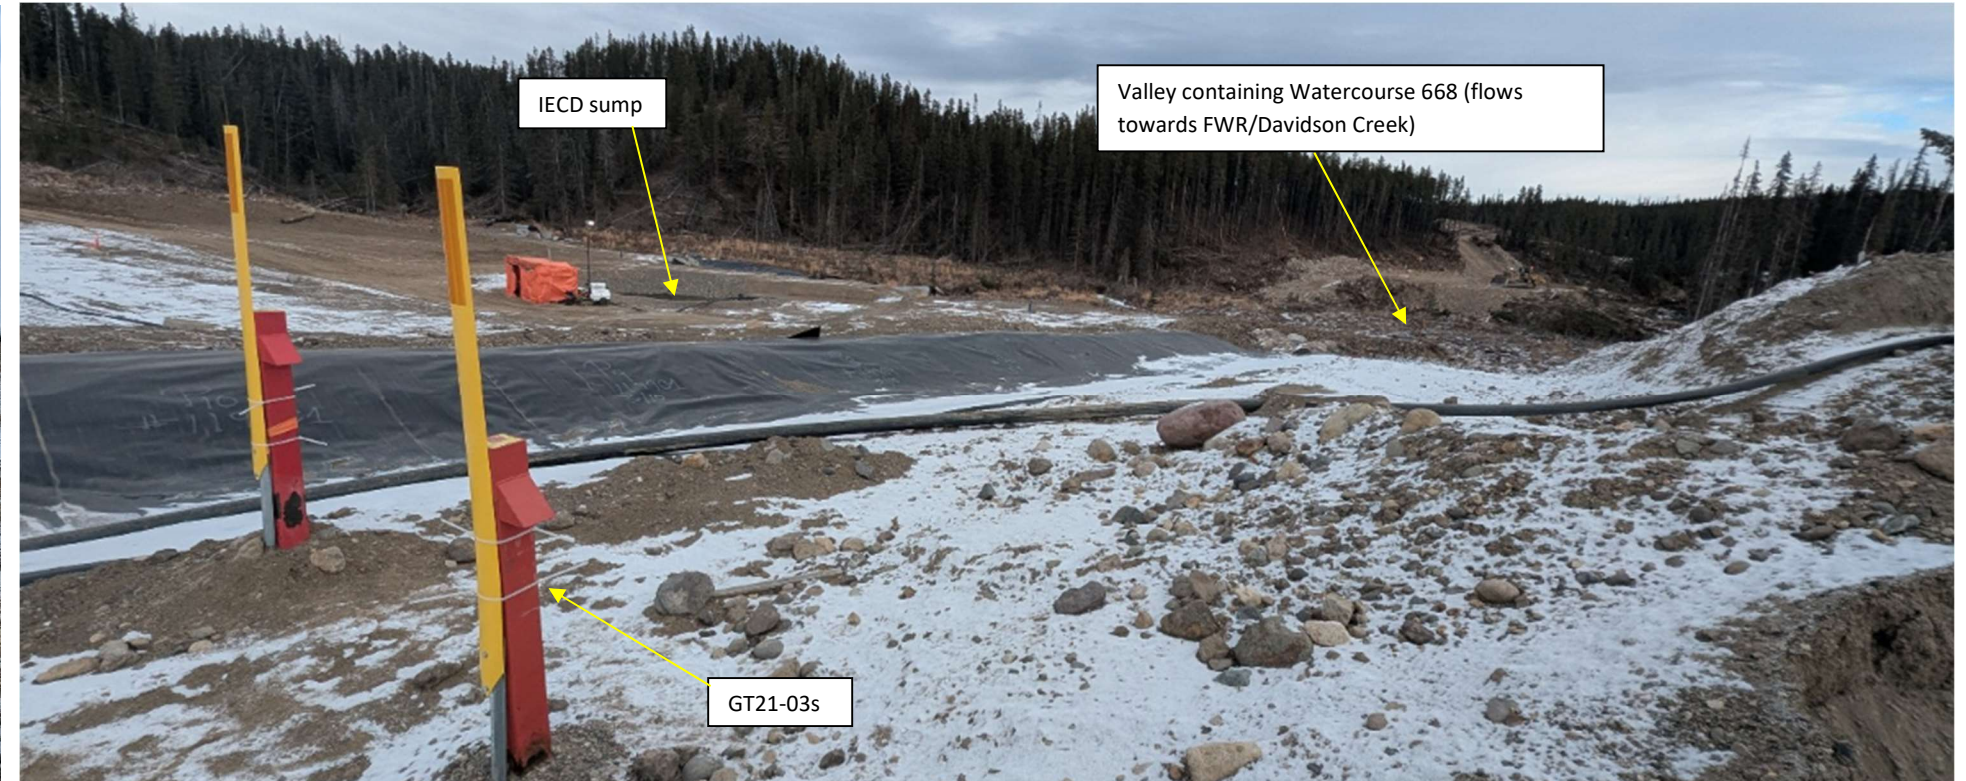
Photo 114712-3. Overview of the location of the groundwater collection point downstream of the IECD referred to as the 'IECD sump' where elevated levels of WAD Cyanide have been detected. Groundwater well GT21-03s and the valley containing Watercourse 668 (flowing towards the FWR) labelled for spatial reference.

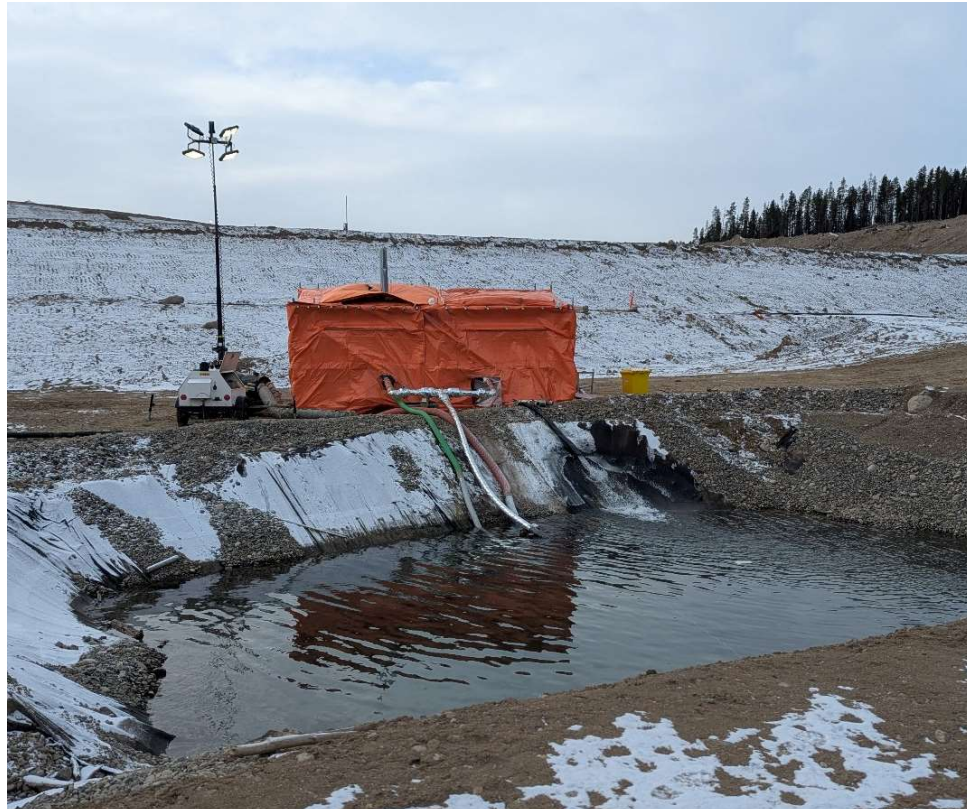
Photo 114712-5. Photo of the IECD sump capturing groundwater downstream of the IECD. WAD cyanide has been detected in groundwater at this location. BWG currently pumping water back upstream to the IECD and TSF.

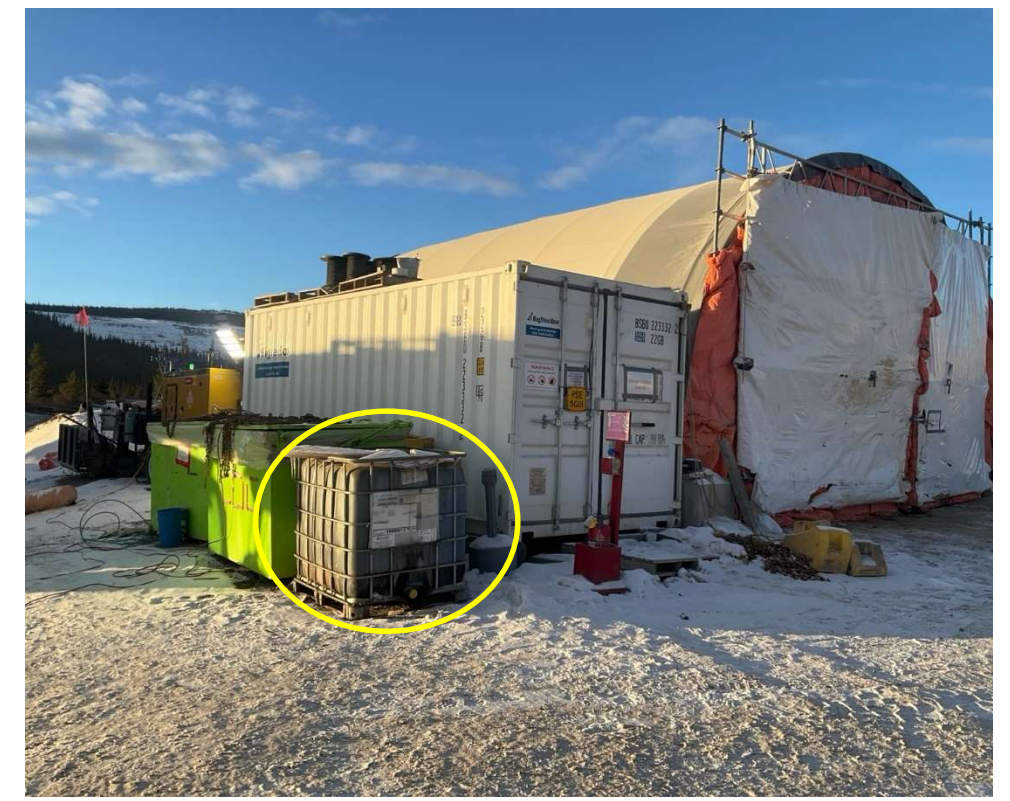
Photo 114728-3. Tote containing what appeared to be a hazardous substance (hydrocarbon contaminated water or waste oil) stored outside of secondary containment at the infrastructure laydown. BWG confirmed tote had been removed on December 4, 2025.

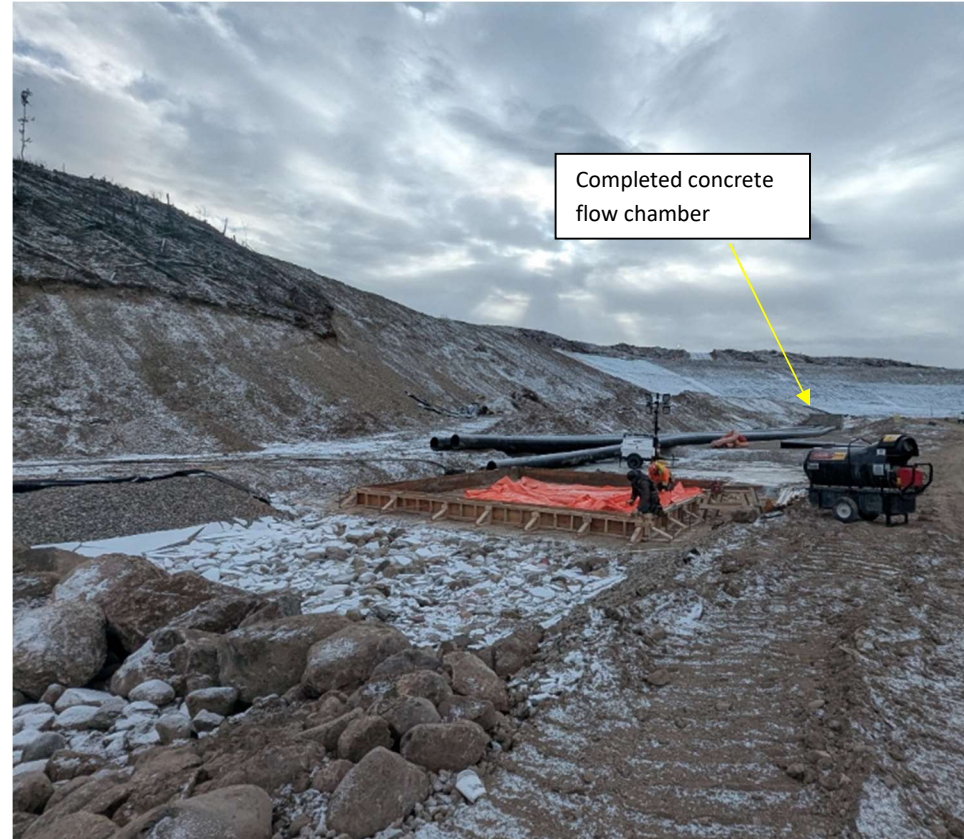
Photo 114705-3. Crews working on discharge channel downstream of the concrete flow chamber within the Fresh Water Reservoir.

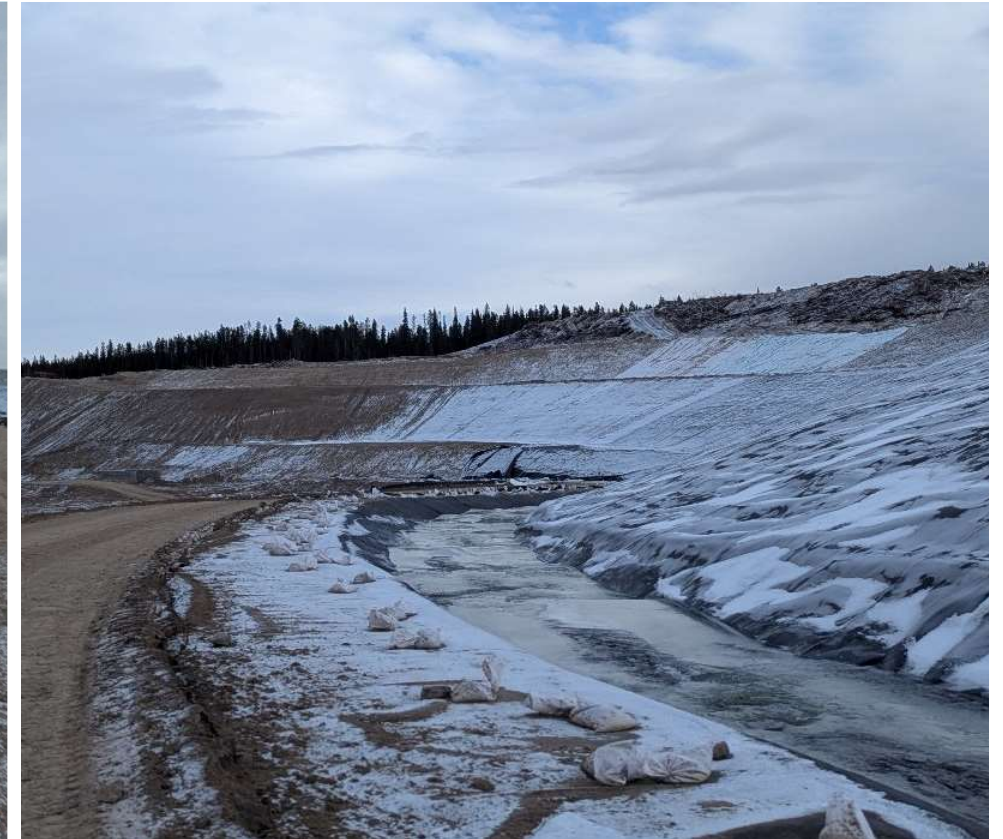
Development of the Davidson Creek diversion channel through the active work area has been completed and Davidson Creek is now flowing within the channel (Photo 114702-2). With works still ongoing around the concrete flow chamber and downstream discharge channel, the diversion channel has not yet been connected to these features and is currently being directed into the lower portion of the existing Davidson Creek channel immediately upstream of the concrete flow chamber.	No
A low point was observed on the haul road adjacent to a portion of the Davidson Creek diversion channel where road runoff could potentially enter the channel (Photo 114703-8). As temperatures are now generally near or below freezing, the risk of runoff and sediment transport is reduced, however this matter was discussed with BWG and provided as an opportunity for improvement.	No
On December 4, 2025, BWG confirmed a material berm had been placed in the area identified by the IEM (Photo 18).

Photo 114702-2. Davidson Creek diversion along the base of the future Fresh Water Reservoir.

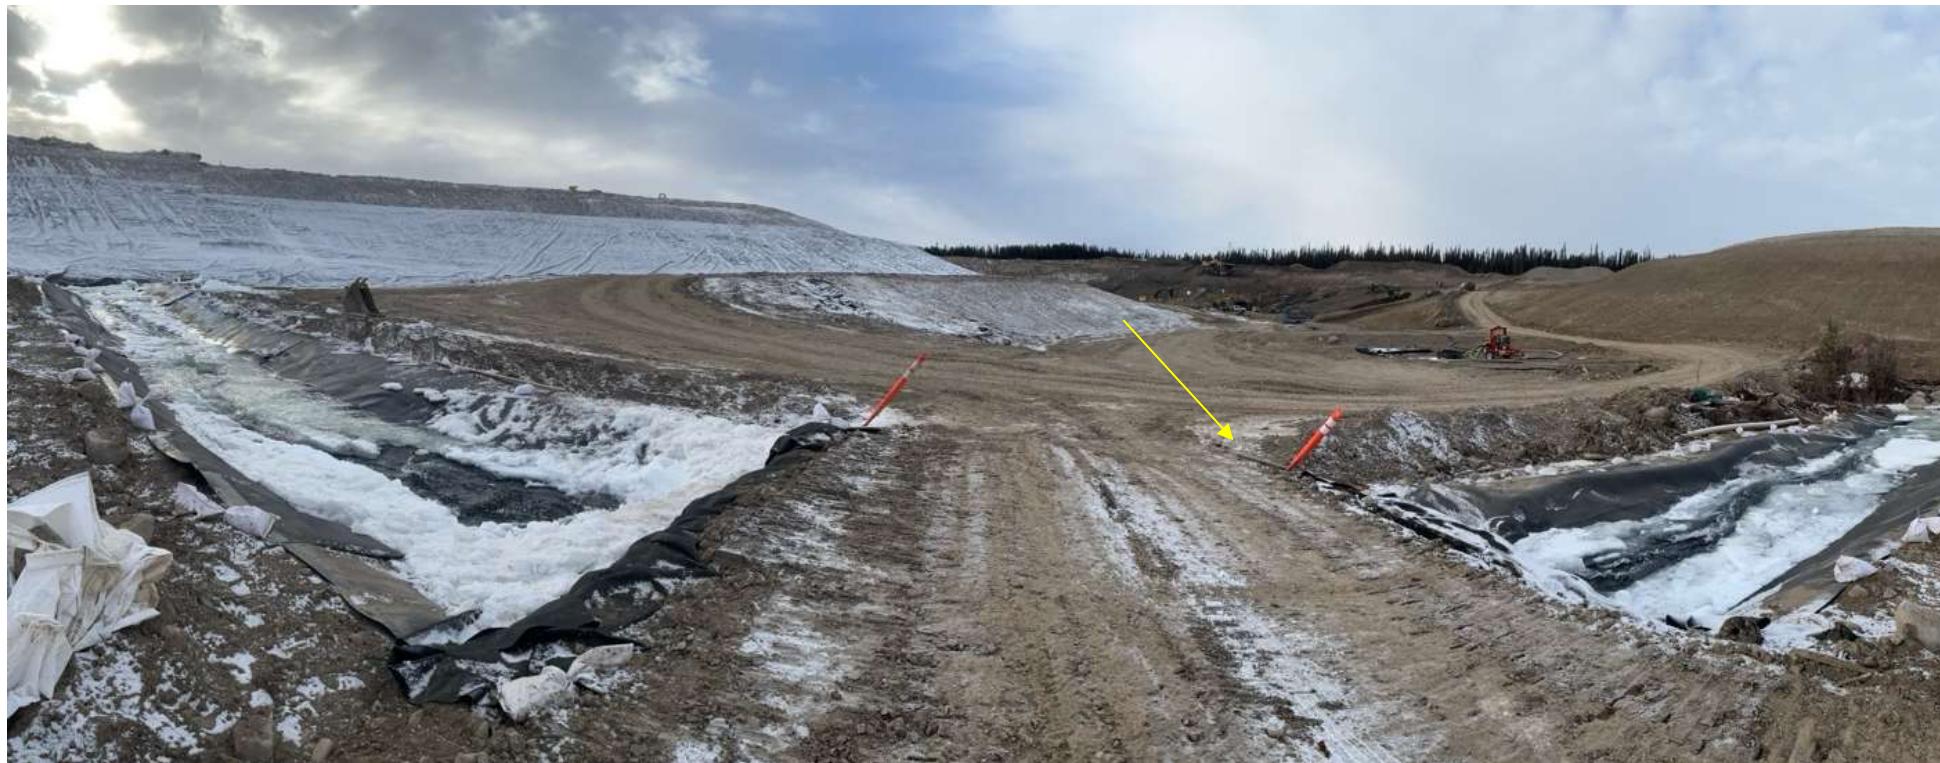
Photo 114703-8. Low spot identified as potential entry point for road runoff to enter into the Davidson Creek diversion channel within the Fresh Water Reservoir. Observation provided to BWG as an opportunity for improvement.

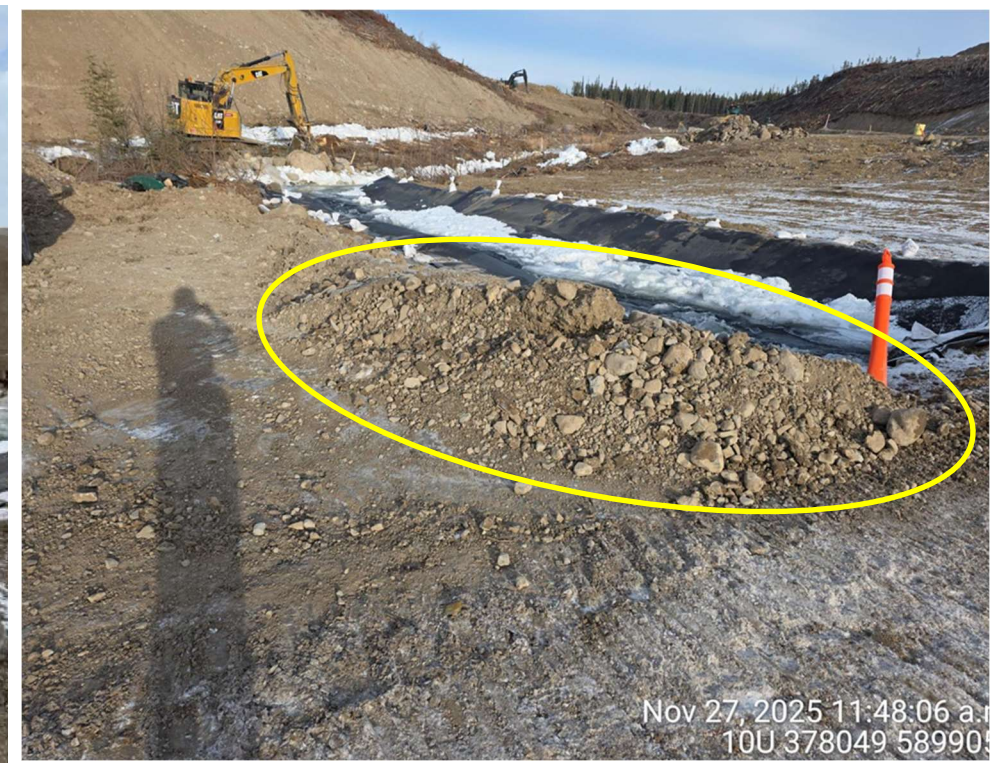
Photo 18. Material berm put in place at low spot identified along the Davidson Creek diversion channel within the Fresh Water Reservoir. Photograph provided by BWG on December 4, 2025.

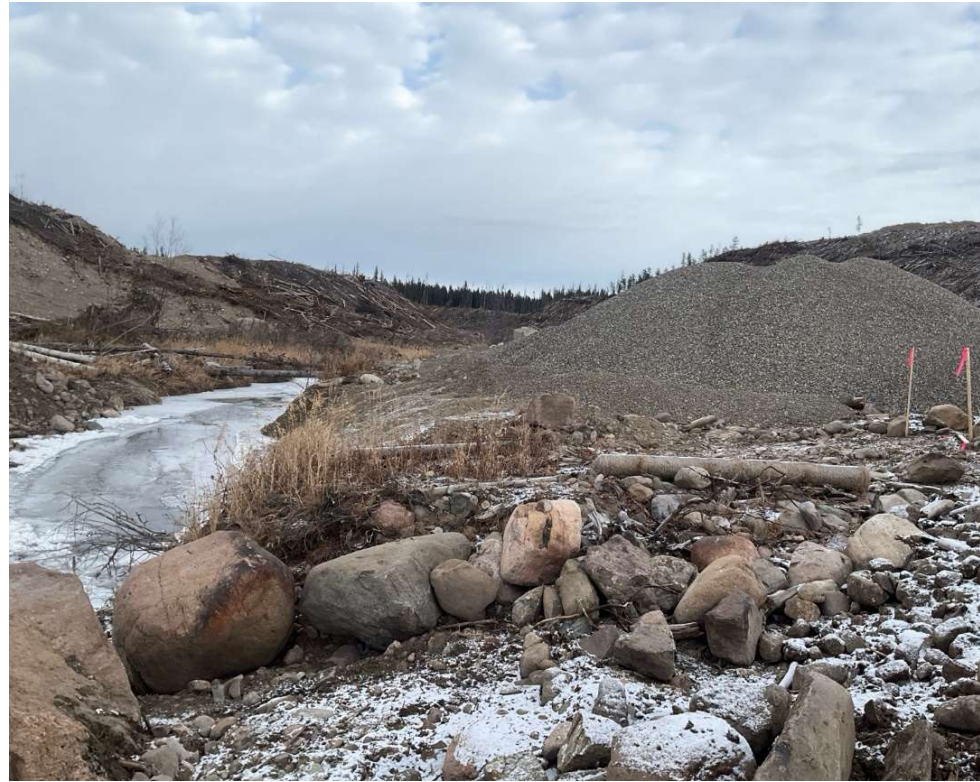
A stockpile of material (aggregate containing some fines) was observed near Davidson Creek downstream of the Fresh Water Reservoir (Photo 114706-1). The IEM recommended the pile be removed from this area or ESC control measures be installed between the pile and the watercourse to prevent any potential introduction of material into Davidson Creek. This matter was issued as an opportunity for improvement.	No
BWG confirmed the stockpile had been moved back from the edge of the watercourse on December 4, 2025 (Photo 20)

Photo 114706-1. Stockpile of aggregate (with some fines) located adjacent to Davidson Creek. IEM recommended this pile be removed to prevent sediment transport into Davidson Creek.

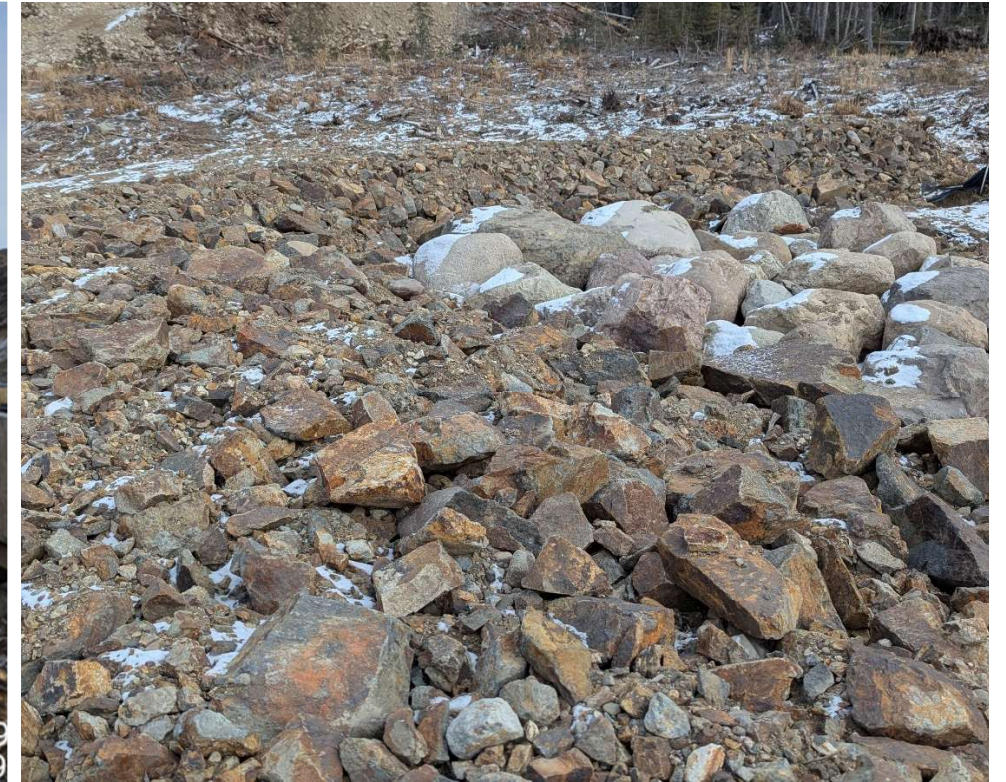
Photo 114723-1. Riprap placed at the IECD emergency overflow channel.

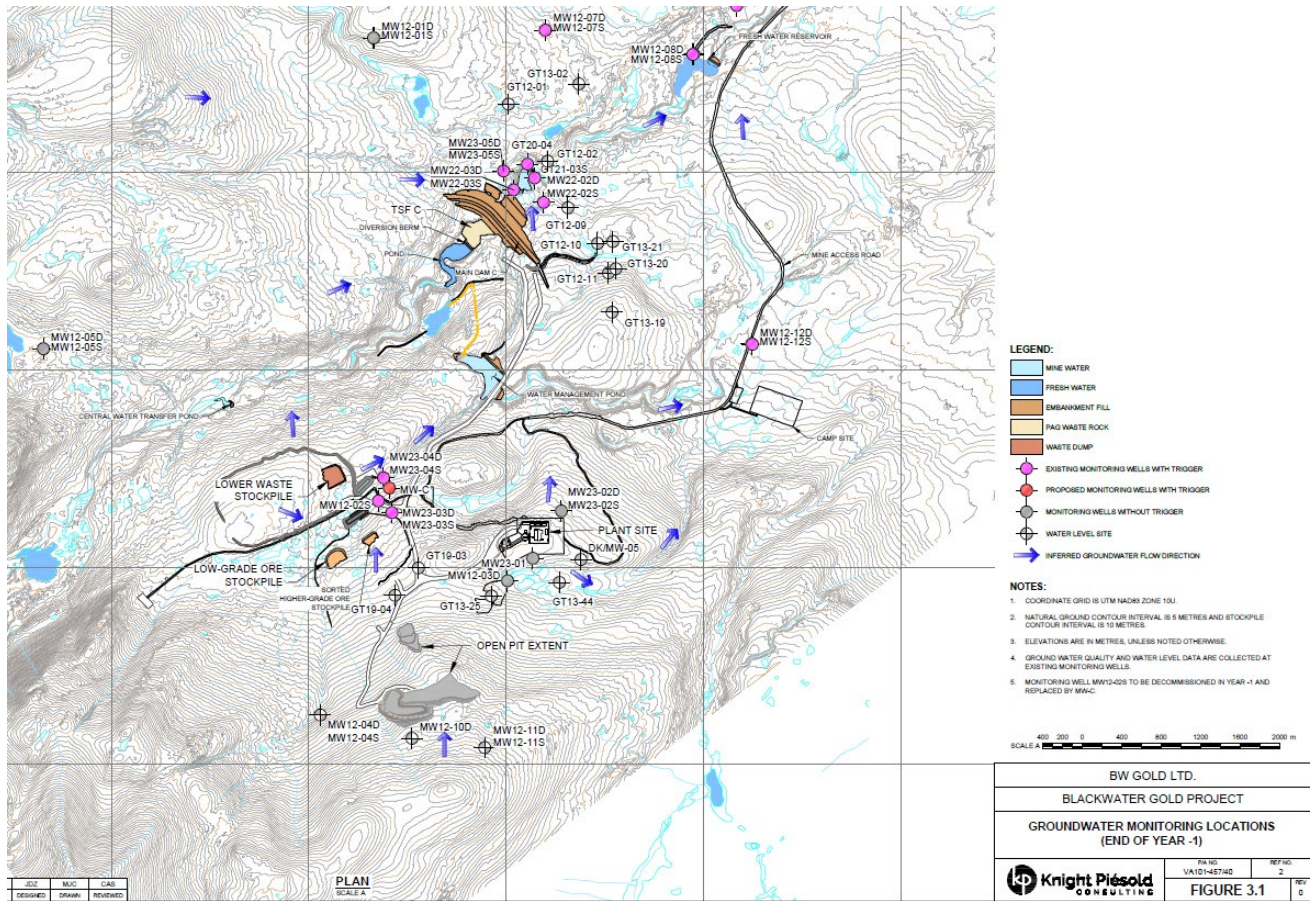
Figure 1.0 Groundwater Monitoring Locations⁴ – End of Year -1

On October 22nd, the NFN received a Level 1 Groundwater Trigger Response Plan (TRP) exceedance at groundwater well GT21-03S (Figure 1.0 and 2.0) for WAD cyanide and nitrite as well as a Level 3 exceedance of cobalt. A Level 1 exceedance in the Groundwater TRP is defined as above 1.5 x's the baseline concentration, while a Level 3 exceedance is defined as exceeding the Contaminated Sites Regulation standard for Aquatic Life.

The quality of TSF C supernatant pond water has impacted the quality of seepage through the TSF C Dam, and the above TRP exceedance indicates that existing seepage capture/groundwater protection measures are insufficient. The consequence of the failure of seepage capture/groundwater protection measures may be greater because of the high levels of cyanide in the TSF C. A fulsome review of the groundwater TRP exceedance is outside the scope of the present memo, but the NFN technical team will provide more detailed comments on this in the future.

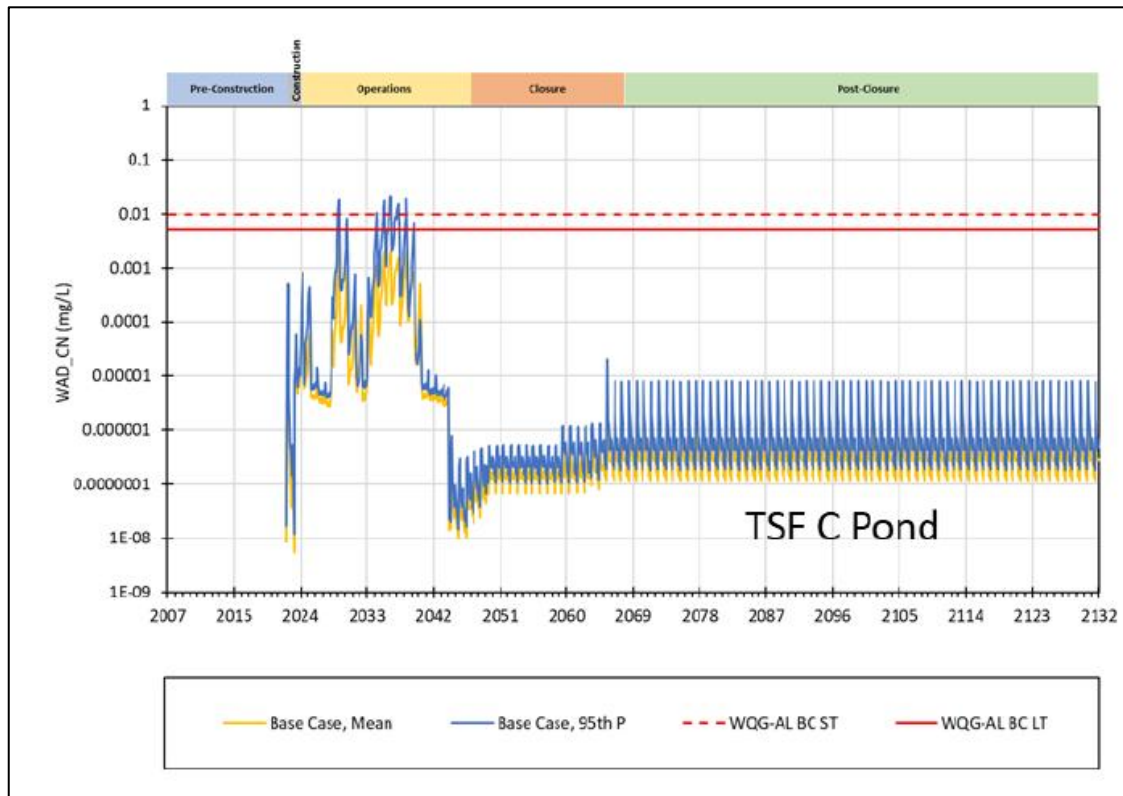
Figure 1. Predicted Weak Acid Dissociable (WAD) Cyanide at TSF C Pond (LORAX, 2021)

- Cyanide levels in the pond have been monitored and are consistently much higher than predicted, in the range of 10 – 60 mg/L. The levels currently pose a significant concern for a number of reasons highlighted herein.
- Cyanide levels in the mill effluent are expected to be very low as a result of the cyanide destruction circuit. The initial predictions of WAD cyanide levels in the TSF-C Pond are

based on full cyanide destruction and are <0.02 mg/L, as seen in Figure 1 (slightly higher than the WQG-AL BC LT of 0.01 mg/L).

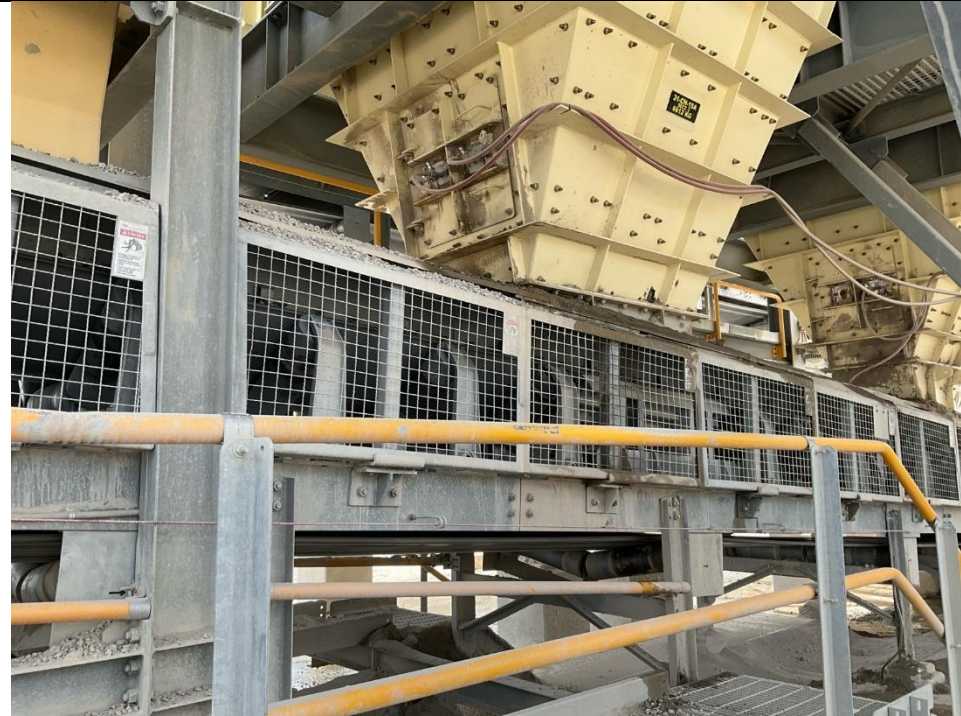
Photo 113867-3 Spray point at the tertiary crusher.

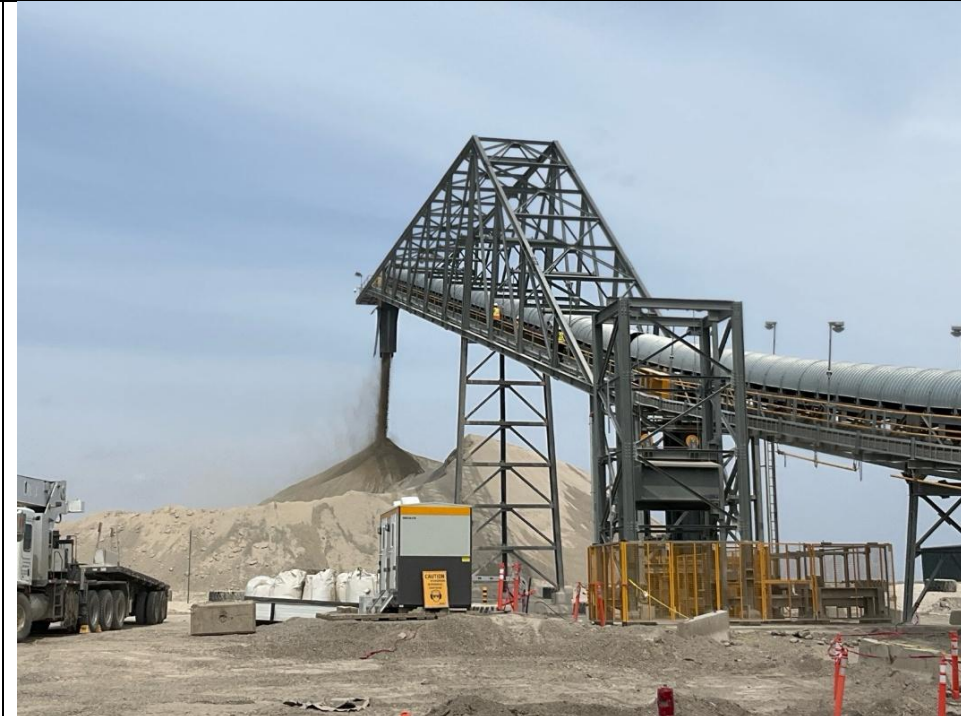
Photo 113867-4 Stockpile of high-grade ore at the drop point of the till conveyor.

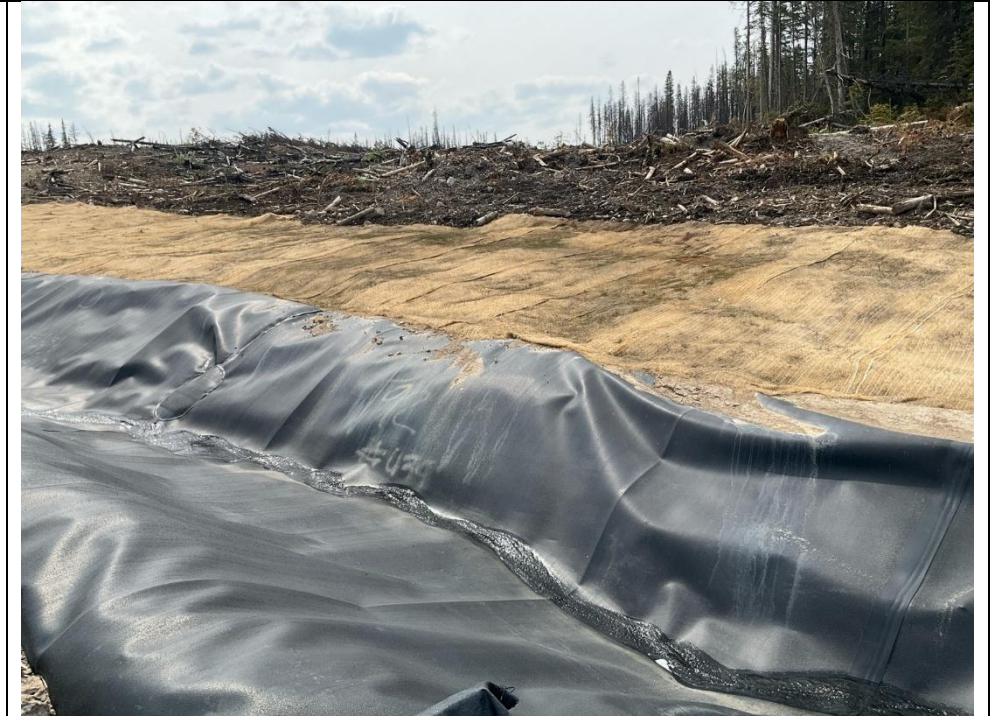
Photo 113870-1 Vegetation has started to grow through the erosion control matting at the Northern Diversion Channel.

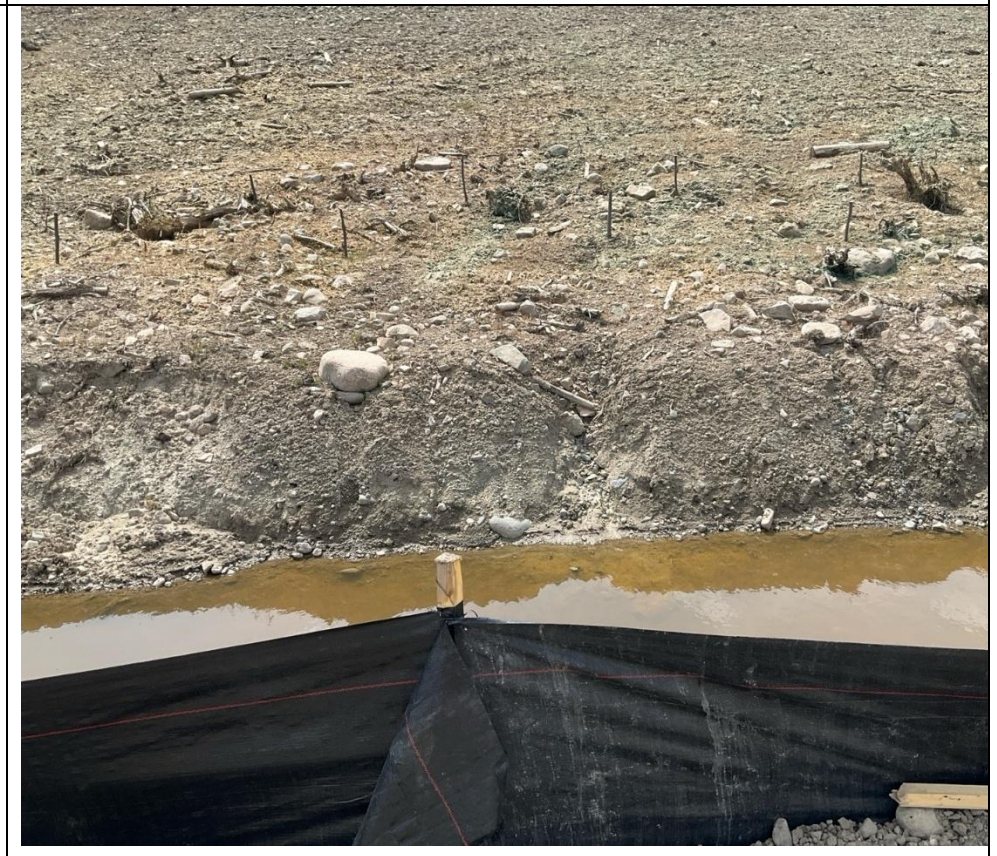
Photo 113866-1 Live willow staking, hydroseeding, and amphibian fence installed near the Operations Camp.

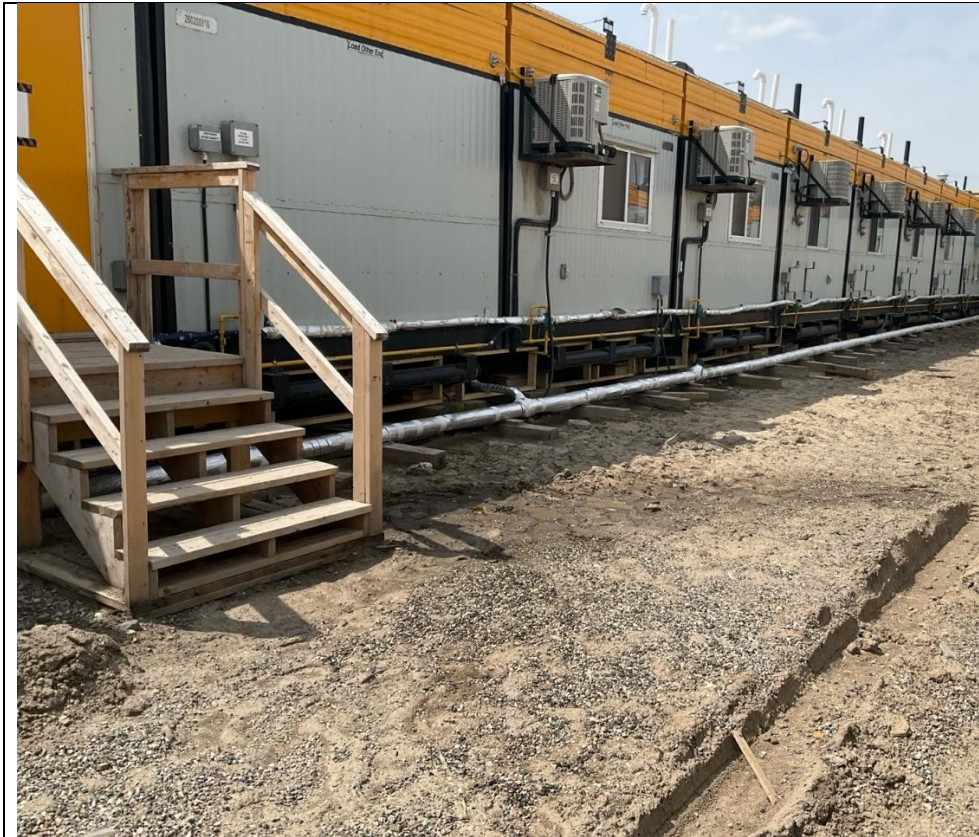
Photo113864-1 No skirting around the base of the kitchen trailers at the Operations Camp.
